### 33. *Surface Faulting Associated with the 1978 Izu-Oshima-kinkai Earthquake.*

By Yukimasa TSUNEISHI\*, Tanio ITO\*\* and Ken-ichi KANO\*\*

#### 1. Introduction

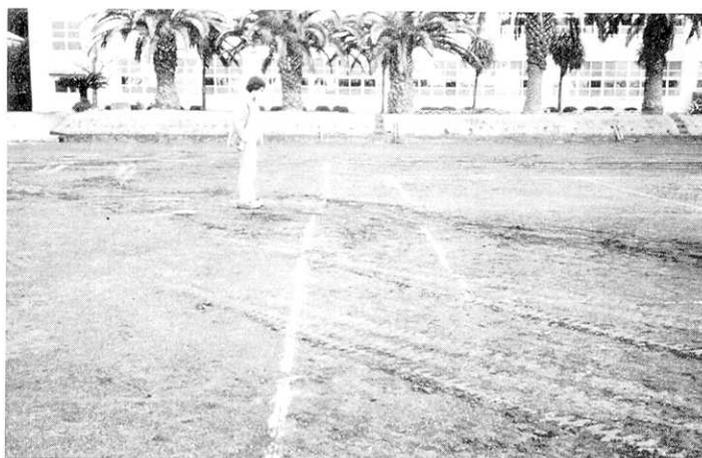
Fig. 3. En-échelon ground cracks and offset white lines on the playground of Inatori Junior High School (Loc. C-2).

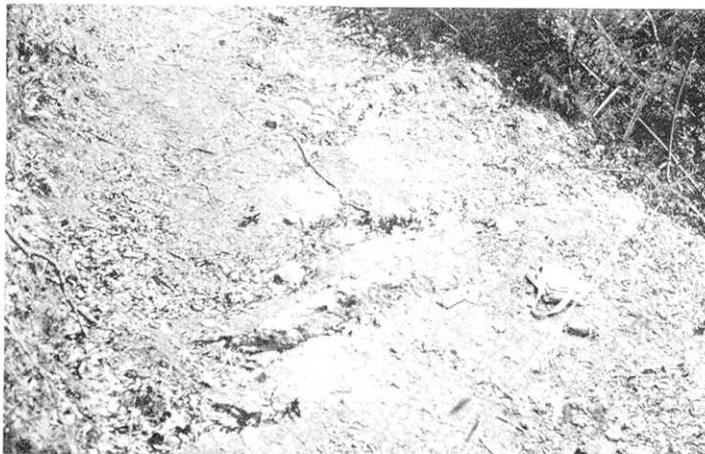
Fig. 4. En-échelon ground cracks on the surface of a country lane (Loc. G-1).

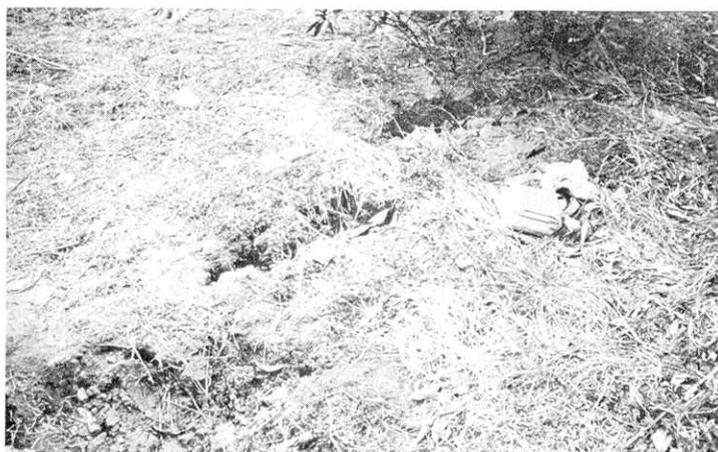
Fig. 5. En-échelon ground cracks on the surface of an orange field (100m north-northwest of Loc. G-1).

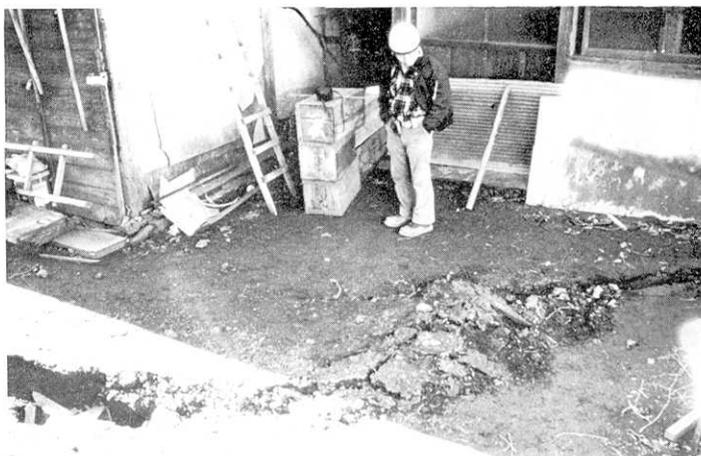
Fig. 6. Pressure ridge formed between adjacent en-echelon ground cracks (Loc. F-2).

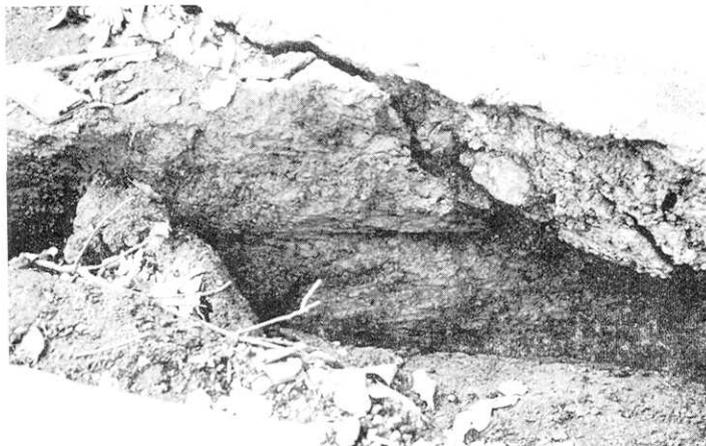
Fig. 7. Slickensided surface on the side wall of a ground crack (Loc. F-2).

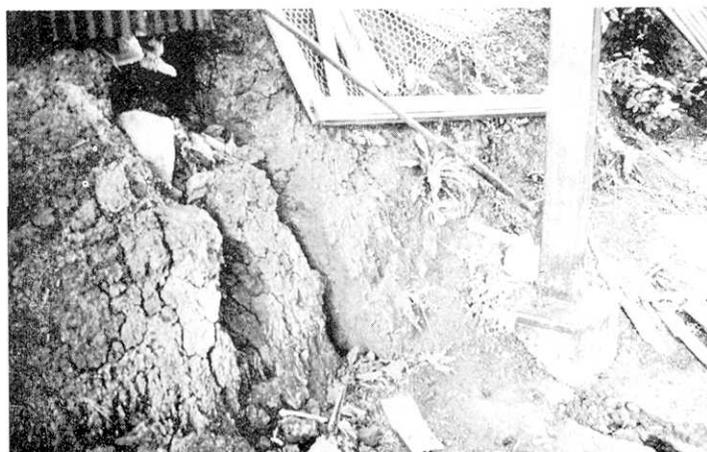
Fig. 8. Displacement of a small cliff in the backyard of a house (Loc. S-1).

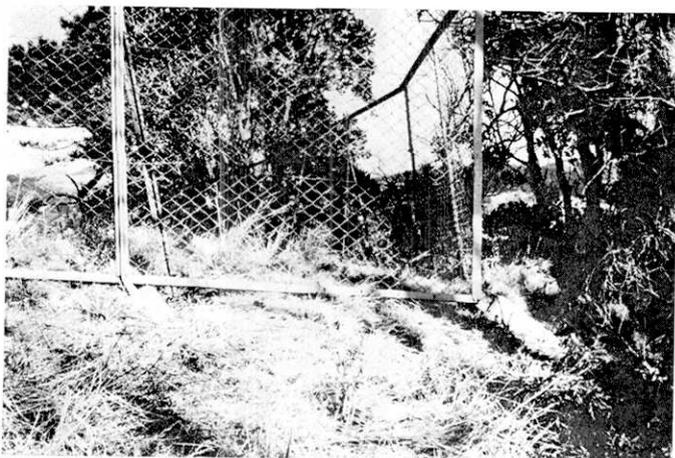
Fig. 9. Offset and stretched fence of a tennis court (Loc. A-1).

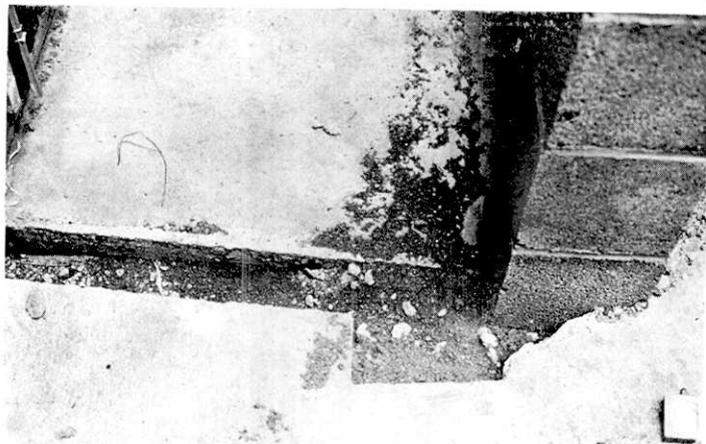
Fig. 10. Relative displacement of two concrete slabs (Loc. A-3).

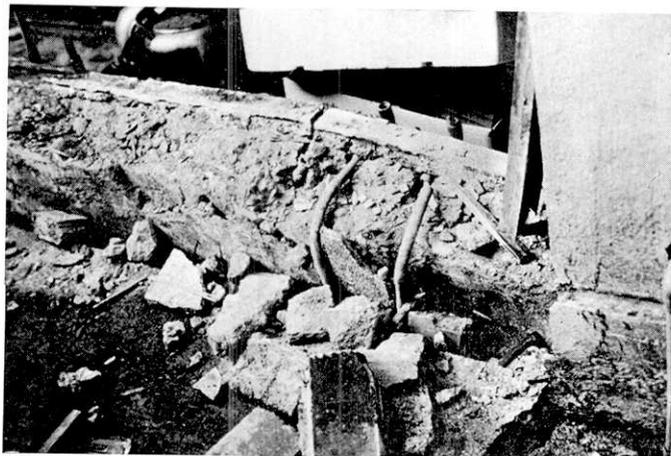
Fig. 11. Disrupted and offset wall of a building of reinforced concrete (Loc. B-2).

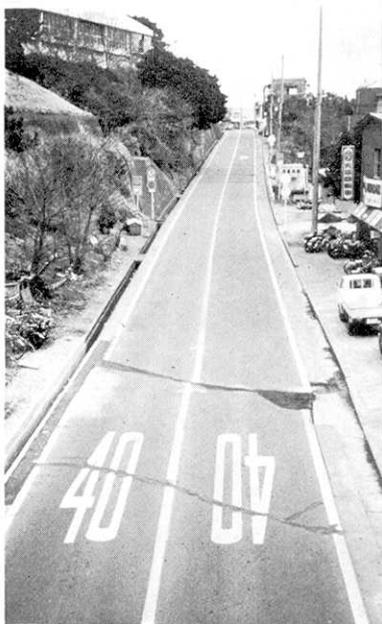
Fig. 12. Offset pavements of the Higashi-Izu Highway. Two cracks in a near view occurred due to displacement of fissure zone-C (Loc. C-1).

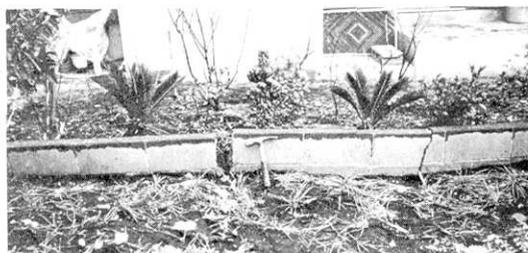
Fig. 13. Displaced and stretched partition of a flower bed (Loc. D-1).

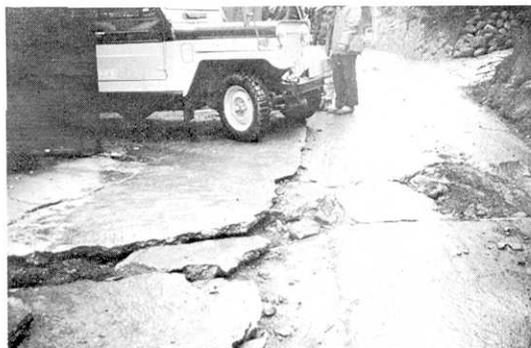
Fig. 14. Thrusting up of a concrete slab onto the pavement of a road (Loc. D-3).

pavement of a road (Loc. D-3). The direction of thrusting is oblique to the fissure zone in a clockwise sense. Fig. 15 shows features of a deformed road pavement (Loc. E-2). Fissure zone-E traversed the road from the upper left corner to the lower right corner of the photo. The road was shortened in a longitudinal direction and was extended in a lateral direction. The roadside concrete slab buckled in a chevron shape and the central main slab rotated in a clockwise sense. Fig. 16 shows a displaced stone wall in an orange field (30 m northwest of Loc. P-1).

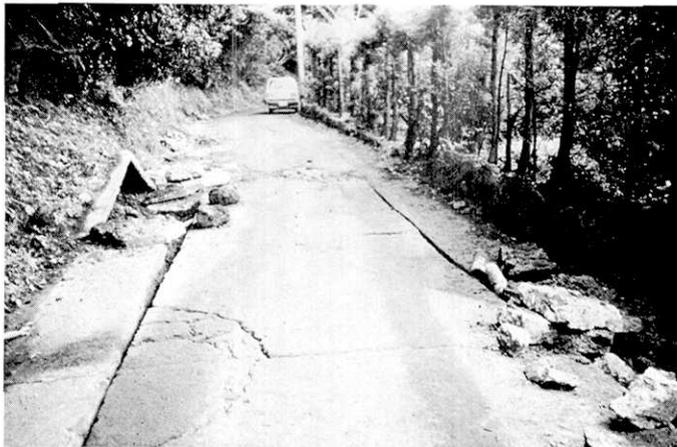
Fig. 15. Roadside concrete slab rotated and buckled in a chevron shape and the central main slab rotated in a clockwise sense (Loc. E-2).

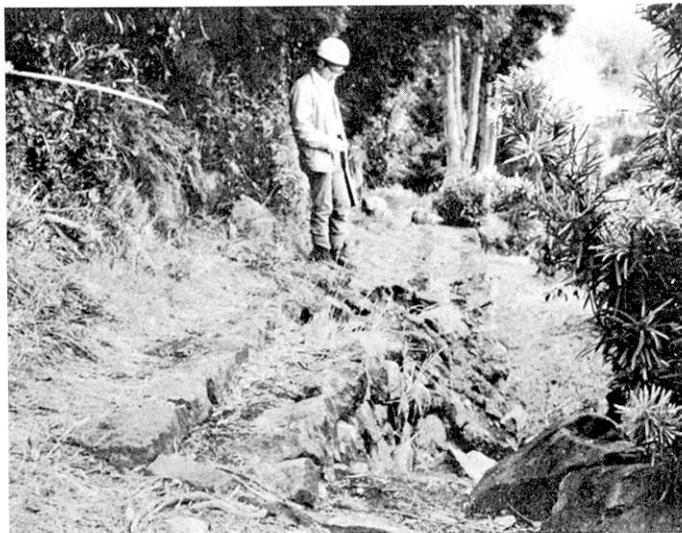
Fig. 16. Displaced stone wall in an orange field (30 m northwest of Loc. P-1).

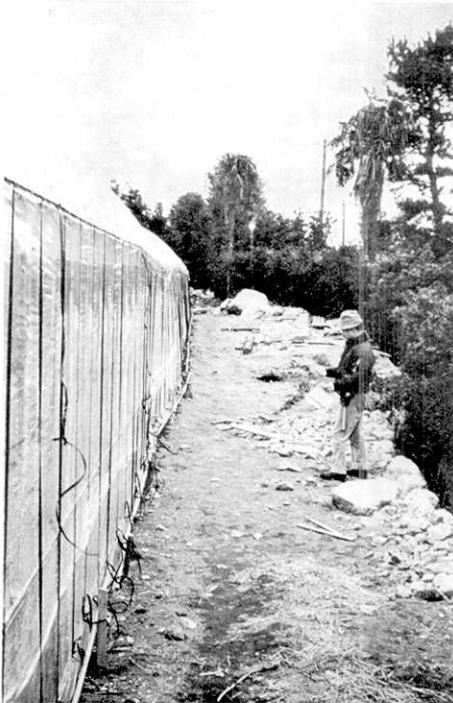
Fig. 18. Displaced wall a-b of the hothouse shown in Fig. 17.

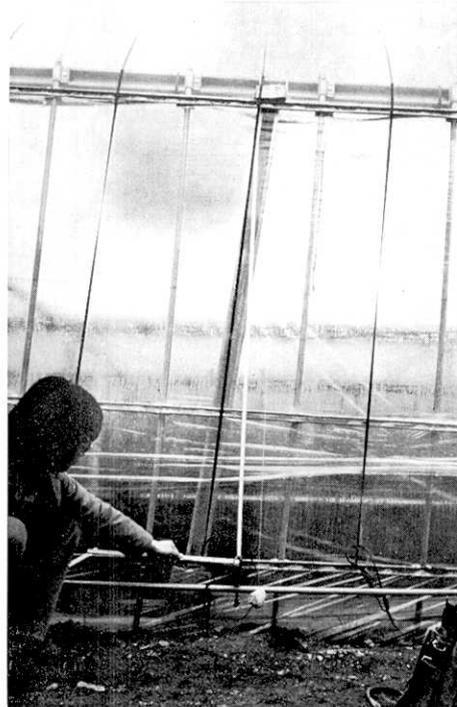
Fig. 19. Close view of one of the hothouse's pillars leaning away from a vertical position (Loc. I-2).

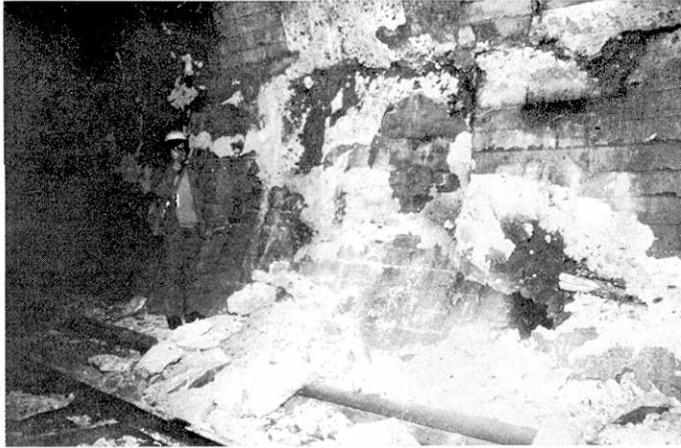
The concrete lining of the tunnel was fractured in many places in a complicated manner (Figs. 25 and 26). Among those fractures we picked up tension cracks that occurred on the side walls of the tunnel and measured their openings. Open cracking is concentrated in the section 540–590 m, as shown in Fig. 24. The most conspicuous open crack observed on the side wall of the tunnel is 9 cm wide (Fig. 27).

Fig. 25. Exfoliation of the concrete lining of the tunnel.

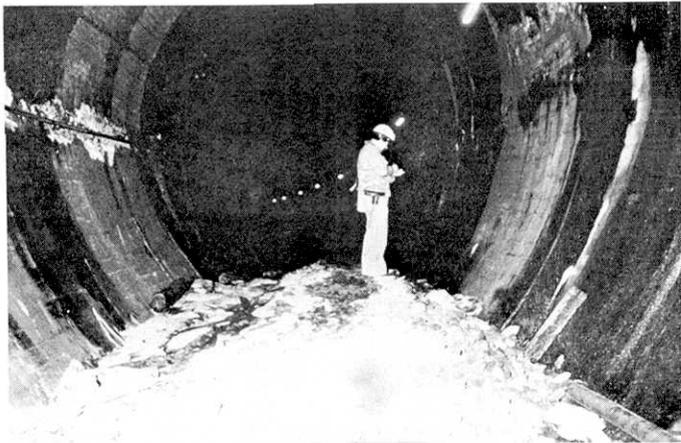
Fig. 26. Squeezing up of ballast due to lateral pushing of the side wall of the tunnel.

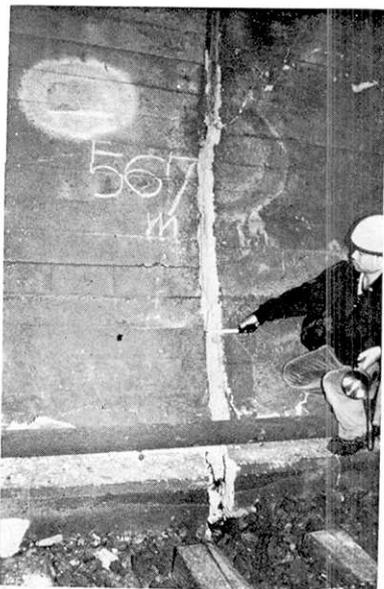
Fig. 27. Open crack on the side wall of the tunnel.

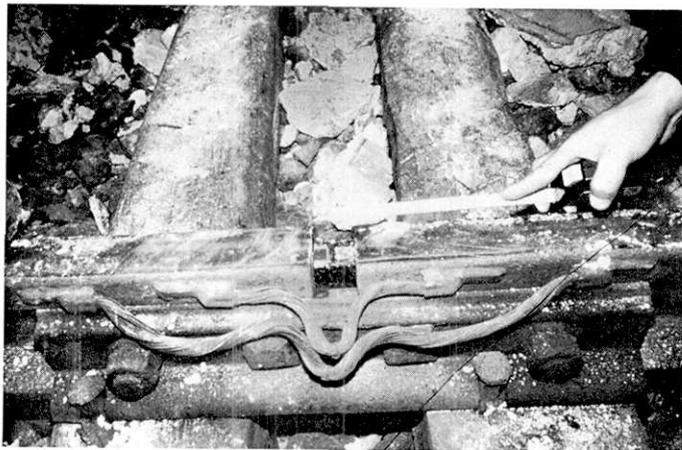
Fig. 28. Abnormally enlarged joint clearance.

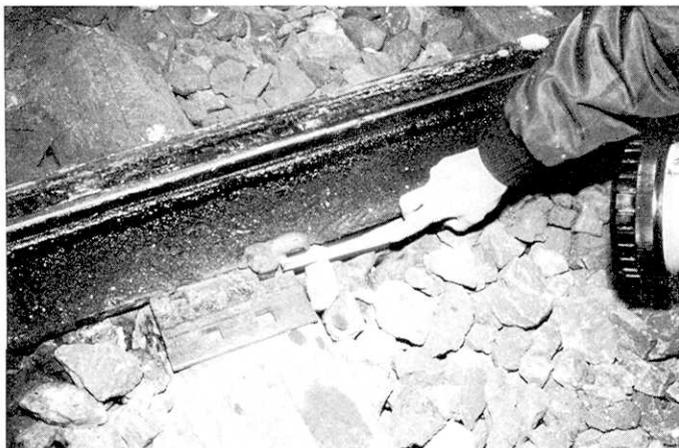
Fig. 29. Slipping of a rail on the tie-plate as revealed by the scratch of the dog-spike on the flange of the rail.

direction. In the Inatori Tunnel, such a slipping of rails was observed extensively, as shown in Fig. 29. As the surface of a rail is coated with oil and dust, we can easily measure the amount of slipping and its direction from the scratch of the dog-spike on the rail flange. Occasionally where tightening between a rail and a rail-tie is strong or the slip is large, even the rail-tie has moved, shoving ballast ahead. In such cases, we can roughly estimate the displacement of the rail-tie by measuring the gap that formed between the rail-tie and the pile of ballast at the rear of the rail-tie.

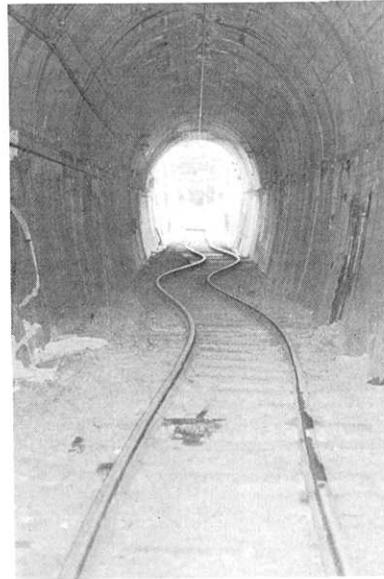
Another conspicuous deformation of the tunnel occurred near the southwestern entrance of the tunnel. Between the points 858 m and 898 m the railway track was made to meander, as shown in Fig. 32. The joint clearances in this portion became null. Therefore, the deformation of the track is considered to have been brought about by buckling in a longitudinal direction. The amount of shortening was estimated to be 16 cm by Prof. Tamura (personal communication). The arch and side walls of

Fig. 32. Meandering of the railway track between the points 858 m and 898 m. (taken by T. Takagi)

なお、下田側坑口に近い858mから898mの区間ではレールの屈曲がみられた(第32図)。ここでは約16cm路盤が長軸方向に短縮したと推定されるが、この短縮をひきおこしたかも知れない断層は地表では発見できなかった。
