Reliability Assessment for Residual Bearing Capacity of a Railway Bridge Foundation after Scouring

H. Nishioka¹, T. Sanagawa² and Y. Otake³

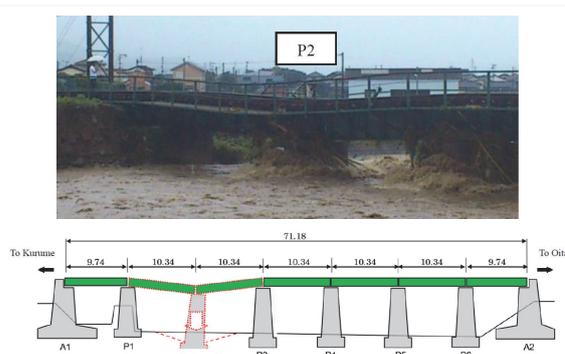
The target case study was a railway bridge across a small river. Its pier's shallow foundation, which rested upon a cobble stone-mixed gravel ground, was subject to significant scouring damage (settlement and tilting) caused by the Torrential Rain in Northern Kyushu region in July 2012 (Kuroki et al., 2018). The state of the damage is shown in Figure 1. Immediately after the disaster, it was presumed that it will be necessary to remove and rebuild the damaged pier, because such a large residual

Figure 1. State of damage

The post-damage measurement results indicated that the pier settled approximately 300 mm and developed a tilt of approximately 49/1000 and 21/1000 rad in the upstream and track terminus directions, respectively. Subsequently, boring inspections were planned. However, due to the restrictions on the installation location of the boring machine, the boring inspections of the ground could not be conducted directly under or immediately beside the damaged foundation. As such, they were conducted at the halfway point to the next pier (5 m away from the center of the damaged foundation). According to the boring data, the average SPT-N value in the range of altitude of 3 m downward from the bottom of the footing was 25.

Based on these results, the damaged pier was considered to have settled and tilted because of outflows in the overburden soils of the side and upper footing, and erosion (removal of only small diameter soil particles) of the base ground under the bottom of the footing. However, there was still some expectation that the subgrade at the base of the foundation would react because the large diameter soil particles (cobble stones and gravel) were in contact with the bottom of the footing. Hence, the temporary remediation approach shifted from removal and reconstruction of the damaged pier, to re-using the damaged pier after emergency restoration. It was hoped that the change to this policy could shorten the train suspension period.

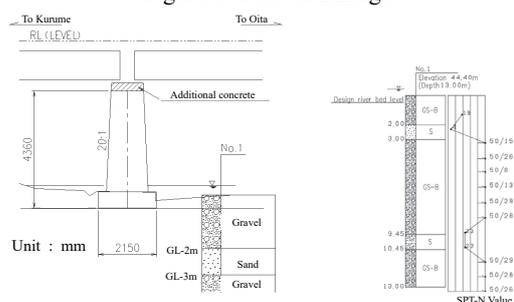
Structural specifications of the damaged pier are shown in Figure 2. The oval-shaped piers supported steel girders with a length of 9.8 m and were supported by a shallow foundation with rectangular footing (4.05 m x 2.15 m). These specifications had not changed since the bridge was constructed in 1931 (approximately 80 years before damage).

Figure 2. Structural specifications and boring inspection results of the damaged pier

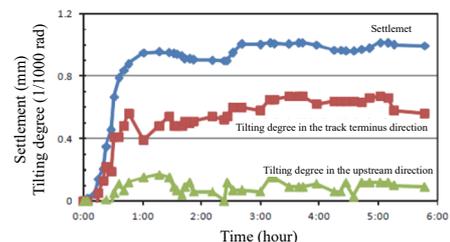
The highest increment was observed during the first cycle for both settlement and tilting. However, cumulative changes were subsequently observed to some extent, with repeated loading. The final residual displacement was approximately 1 mm for the settlement, and 0.1/1000 and 0.6/1000 rad for the tilting degree in the upstream and track terminus directions, respectively. Both values were significantly lower when compared to those due to the scouring damage (i.e., 300 mm, 49/1000 and 21/1000 rad).

Therefore, this indicated that the pier exhibited satisfactory performance of the foundation bearing capacity for the train loading levels, and it was possible to conduct emergency repair work (for e.g., jacking up of

Figure 3. Static loading test results
 (time history of settlement and tilting degree)

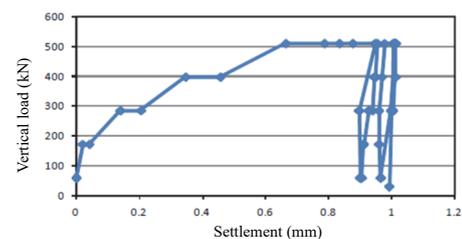
Figure 4. Static loading test results
 (vertical load - settlement relationship)

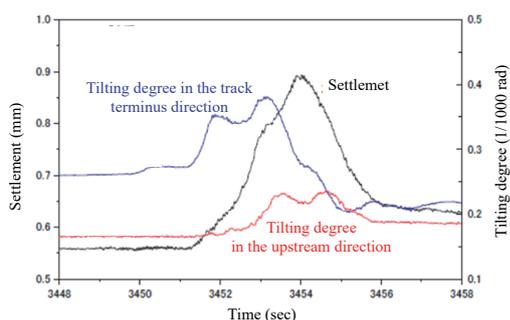
Figure 5. Example of train running test result (time history of settlement and tilting after the passing of a 25-km/h train)

As the result of the train running test, the time history of the settlement amount, and the tilting degree when a train travels at 25 km / h across the bridge, are shown in Figure 5. The settlement amount and tilting degree immediately before the first instance of the train passing were set as the zero values. The dynamic settlement was 0.3 mm, and the tilting degree was approximately 0.1/1000 rad (equivalent to 0.6 mm in horizontal displacement of rail) at half-amplitude when the train passed, and the values were sufficiently low relative to the track maintenance standard. The train test results indicated that when the train was at a slow speed, the foundation exhibited the required bearing capacity performance for train operation, and the pier was deemed re-usable.
