## Quick Report on the Oct. 6, 2000, Western Tottori Prefecture Earthquake

Jörgen JOHANSSON\*, Paola MAYORCA\*, Kazuo KONAGAI\*  
Toshihiko KATAGIRI\* and Daisuke MARUYAMA\*

### 1. INTRODUCTION

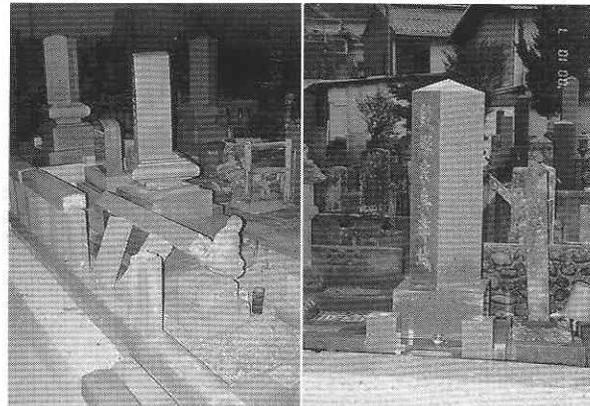
**Location 1**, 133°19.9'E, 35°25.1'N.

Visit to the cemeteries at the Keijuji and Sousenji-temple: A few gravestones were toppled. The gravestones slipped on the average about 1 cm and some 70% of them rotated clockwise.

As first estimate one can assume that to topple the gravestones an acceleration of 0.33 g is necessary since the height to width ratio is about 1:3. For the rotation to occur one can assume that the gravestone where slightly tilted in a vertical plane at the same time as accelerated horizontally in a direction perpendicular to the vertical plane. From the slippage observations, assuming a friction ratio of 0.5 ( $\mu$ ), and using the formula:  $(1/2)mv^2 = mg\mu\Delta$  it is possible to estimate a velocity of 30 cm/s corresponding to the average slippage,  $\Delta$  of 1 cm.

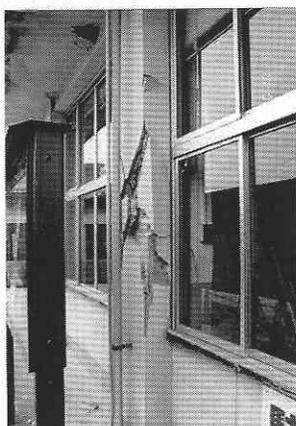
**Location 3**, 133°26.4'E, 35°20.6'N Mizoguchi city hall

The building is closed because of the damaged columns of the 1st story and large cracks in the stair between the 1st and 2nd story. Longitudinal rebars were of plain type and stirrups were widely spaced about 30 cm. A concrete block wall next to the building was also damaged probably due to too few and corroded reinforcement bars. Many of the buildings in the city had damaged roof tiles.

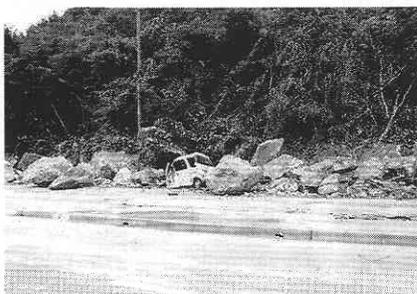
**Location 4**, 133°26.2'E, 35°19.9'N Rock fall at Nakaso area.

A volcanic (igneous) rock wall of Pliocene Epoch was cracked up along its joints into a number of large (about 1-2m sized) pieces. The intact part of the stone is gray with tiny fragments' inclusions of separate substances (most probably Mica). Originally exposed parts are rather brownish with small clusters of moss sticking to the surfaces. The broken rock pieces rolled down the steep slope (38-40 degrees). One piece bounced on the pavement of Prefecture Route rolled into a ditch breaking the concrete wall of the ditch. The front part of a car was squashed, but fortunately the driver survived.

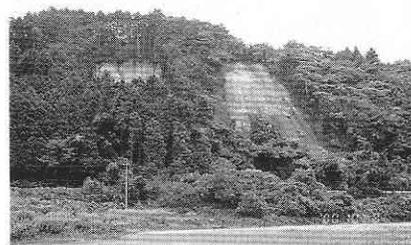
**Location 5**, 133°26.2'E, 35°19.1'N Slope failures at Furuichi.

There is a multi-stepwise configuration in Furuichi. The slope failure took place at the northern slope of the highest (second major) terrace. The terrace consists of weakly-cemented sediments of volcanic soils and rocks. Cedar trees growing on the slope face have a shallow root system and causing the soil mass, being reinforced by the roots, to slip as a large mat.

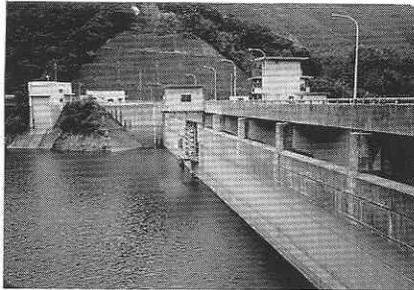
**Location 9**, 133°19.9'E, 35°18.0'N: Kashoo dam

The concrete gravity dam withstood exceptionally high accelerations, 530 gal at the base in the North-South direction and 2200 gal at the crest in the North-South direction. Only some minor damage was observed. The machine room of the outlet sub-gate in the center of the picture (photo taken from east abutment) had some diagonal

cracks in the concrete and the windows were broken. The west abutment parking lot settled about 10 cm causing cracks in the asphalt pavement. An engineer in the control room located at the west abutment told that he could not remain standing during the shake.

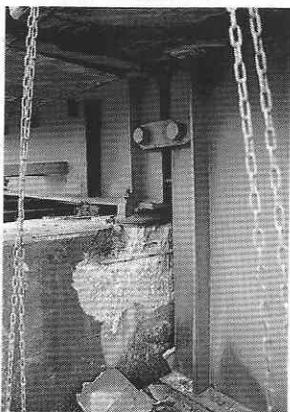
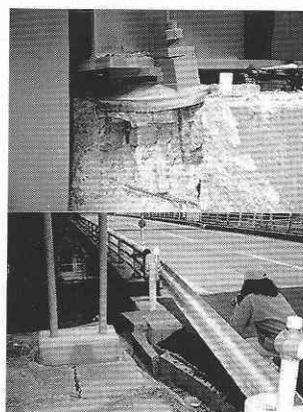
**Location 10**, 133°19.6'E, 35°17.9'N: Hakusan bridge.

A two-span simply supported steel girder bridge located on the west side of the Kashoo dam reservoir. Two abutments and one wall-type reinforced concrete pier in the middle support the bridge. The heights of girders differ reflecting the difference in length of the two spans. The top of the pier thus has a stepwise shape. The road, and the bridge, is slightly inclined upward to the upstream side of the Kashoo dam. The backfill of the southern end abutment subsided by about 18 cm causing the girders for the upstream span of 18m to be pushed downstream towards the middle pier. This seems to have caused the bearings of the girders at the pier to be pushed outward in such a way that the parapet between lower and upper decks of the pier cracked and large pieces of concreted spalled off, which were found remaining on the lower deck of the pier. This damage caused the bridge girders to settle a few centimeters as can be seen from the nut on the bearing bolts. The expansion joints of the bridge deck were almost closed.

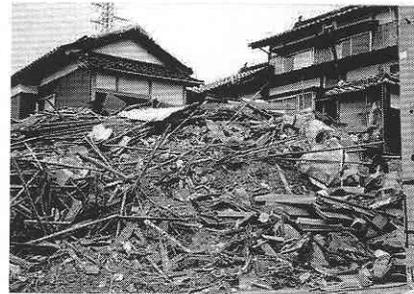
**Location 11**, 133°20.1'E, 35°21.1'N: Collapsed house and

One of the few collapsed buildings. At the nearby cemetery almost all graves were destroyed. One gravestone rotated more than 135 degrees without toppling. Ground acceleration was estimated to more than 500 gal and velocity to some 90 cm/s.

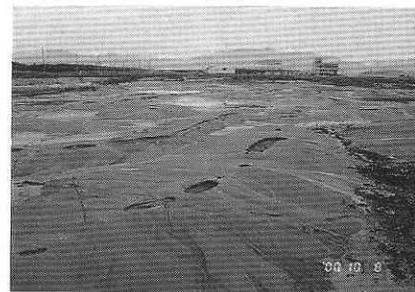
**Location 12**, 133°15.3'E, 35°31.4'N: Sakai Minato dream port park.

Widespread liquefaction causing lateral spreading and sand boils. Quay walls moved slightly outward causing joints between concrete pavement slabs to open up. Some cracks could be seen in the pavement. Numerous large sand boils in parking lot as seen below in the photo. Retaining walls along channel moved towards channel due to heaving failure. The soil was gray very fine silty sand.

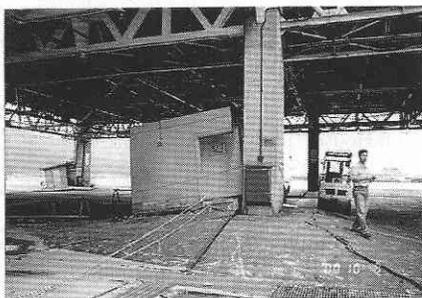
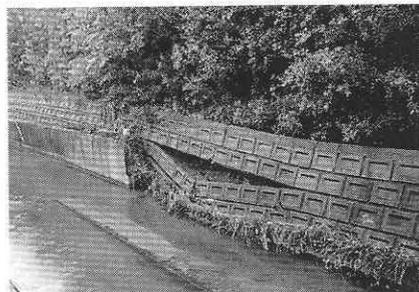
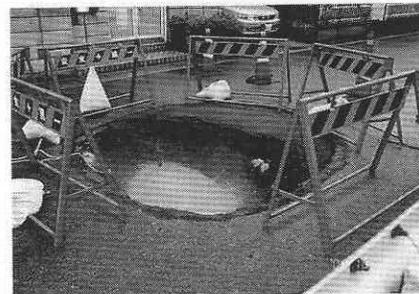
**Location 13**, 133°15.1'E, 35°32.6'N: Sakai Minato fisherman's wharf.

The wharf has a roof along its sides, each side being supported by a two row of concrete columns. The concrete pavement slabs settled down to 1 meter due to liquefaction, while the pile supported columns did not settle. Lateral spreading pushed quay walls towards the water and causing one of the columns to tilt. The area is closed off from use. A large amount of liquefied sand could be seen in drainage channels along the wharf. The two lower photos show the large opening of the joints between the concrete slabs caused by the lateral spreading.

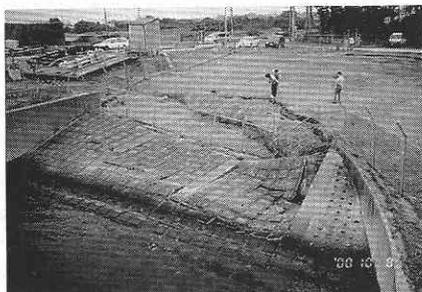
**Location 14**, 133°12.2'E, 35°30.8'N: Nakaura water gate.

Quay wall failure at the Nakaura water gate. A possible scenario could be: The liquefied backfill soil squeezed through openings between quay wall blocks causing settlement behind the quay wall and subsequent failure of the quay wall because the backfill was "eroded" away. Another scenario could be: Lateral spreading caused the quay walls to fail allowing the liquefied soil run out into the water, with subsequent settlement/slope failure behind the quay wall.
