## 25. *Study on the Earthquake Resistivity of Wooden Houses.*

### *Part 1. On the Aseismic Experiment of a Wooden House in Wakaho Town in Connection with the Damage Due to Matsushiro Earthquake.*

By Yutaka OSAWA, Masaya MURAKAMI, Tadao MINAMI,

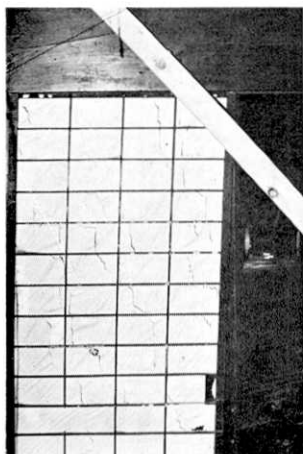
Displacement	Damage
2-3 cm	Doors of Buddhist alter deformed. Corner of walls crushed.
5-6 cm	Sliding screen broke.
7 cm	Sliding door buckled. Cracks in wall.
10-11 cm	Sliding door put out of place.

Fig. 18. Break of sliding screen

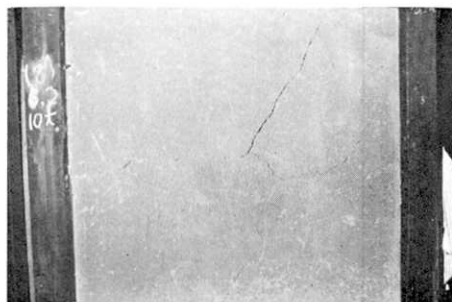
large shear cracks on mud walls and buckling of sliding doors were observed.

Fig. 19. Cracks in mud wall

For earthquakes of the type shown in Fig. 9, more than 20 cm of displacement may be expected when the maximum ground acceleration is around 500 gal. The houses whose yield coefficient is very low, will fall down in such a case. Reinforcement with bracings and other methods which shorten natural periods and improve yield coefficient, might be quite effective.
