Lessons Learned from the Damage of the Erzincan Earthquake, Turkey, March 13, 1992

Kimiro MEGURO* and Yoshiaki NAKANO**

An earthquake of magnitude 6.9 occurred in the eastern part of Turkey on March 13, 1992. Erzincan City which is located near the epicenter sustained damage. The authors visited the area three weeks after the event and investigated the damage as members of a reconnaissance team. Based on their field surveys, this report briefly describes the damages to buildings, human casualties, and response activities.

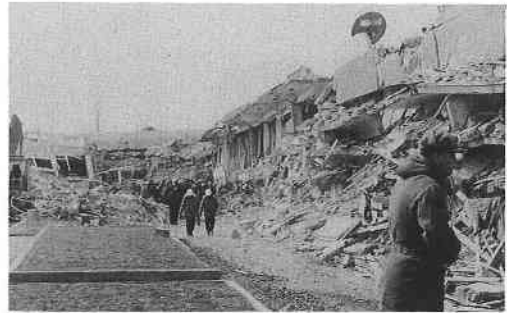
Hotel Urartu, a four-story RC building completed in 1974 and located in Kizilay District, totally collapsed as shown in Photo 1. This hotel suffered structural damage during the 1983 earthquake, but it was put into use again without any adequate retrofit. The hotel was more than 50% full at the time of the earthquake²⁾ and 8 guests were killed. The Municipal Annex Building located next to Hotel Urartu also collapsed totally as shown in the left

Photo 1 Totally collapsed Hotel Urartu (right) and Municipal Annex Building (left) [Kizilay District]

hand side of Photo 1. This building also suffered damage in 1983, and as was the case with Hotel Urartu, was put into service with no adequate retrofit. Photos 2 through 4 show damages to residential buildings observed in Kizilay District. In most cases, as shown in Photo 4, the damaged buildings showed poor detailing of reinforcement such as (1) inadequate anchorage of reinforcement to connected members and/or (2) wide spacing of shear reinforcement with a small diameter, having 90-degree hooks at both ends which cannot provide sufficient confinement when subjected to a strong seismic excitation.

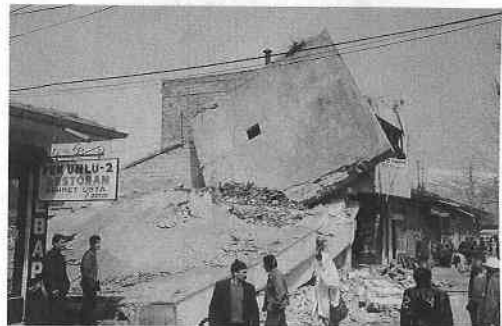
Photo 2 Totally collapsed residential building [Kizilay District]

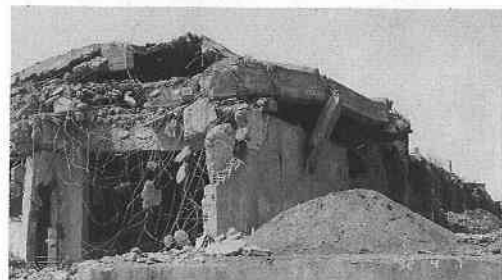
Photo 3 Residential building collapsed in upper stories [Kizilay District]

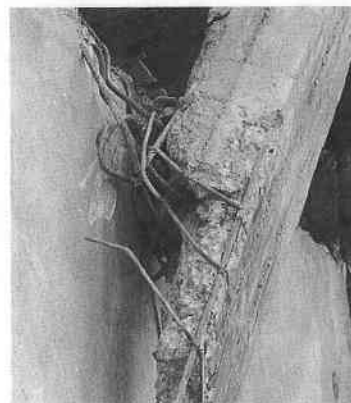
Photo 4 Close-up view of column with pullout failure due to inadequate anchorage of column reinforcement to beam

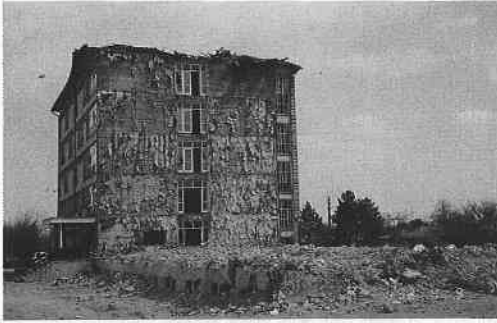
Photo 5 Collapsed State Hospital

Photo 5 shows the five-story State Hospital in Karaagac District. The hospital consists of two buildings with an expansion joint between them. The east wing suffered heavy damage but survived the earthquake probably because the masonry infilled staircase contributed to the

strength and stiffness of the building. Photo 6 shows the four-story Communication Building located near the State Hospital. The second story of the building failed, making it look like a three-story building.

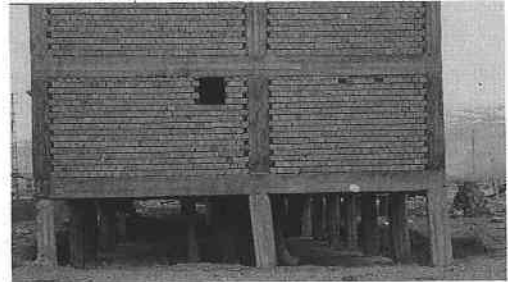
Photo 9 Soft story failure

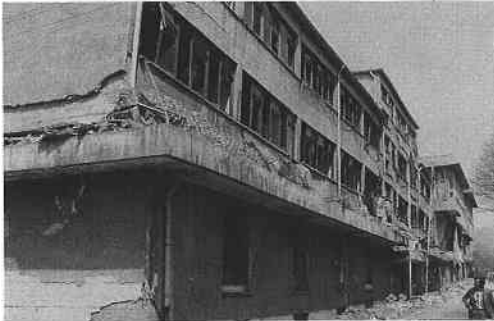
Photo 6 Communication Building collapsed in the second story [Karaagac District]

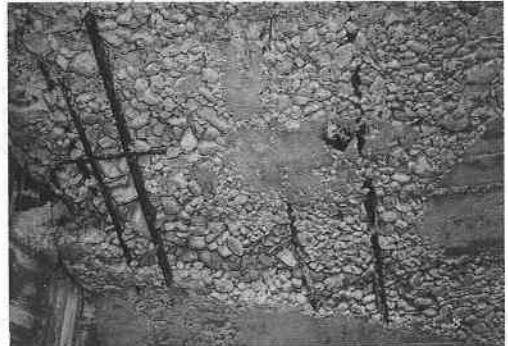
Photo 10 Honeycombs exposing embedded reinforcement

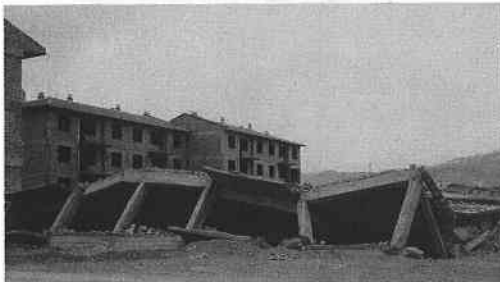
Photo 7 Totally collapsed apartment building [Yavuz Selim District]

Three-story apartment buildings with basement, located in the central area of Yavuz Selim District, totally collapsed as shown in Photo 7. In this area, more than forty buildings, each consisting of two identical but mutually independent structural units, were under construction on the ground excavated to 2 m below the surface. Since the spaces surrounding the basements were not refilled in most buildings, these buildings were essentially four-story at the time of the earthquake. Major damages were observed in the exposed basement. Extensive cracks in columns, poor confinement resulting from the absence of lateral reinforcement in beam-column joints (Photo 8), and concrete crushing in columns were common in the buildings which suffered substantial damage. In some buildings, the soft story mechanism in the basement due to flexural failure in columns was observed as shown in Photo 9. In general, the quality of concrete was poor, and honeycombs exposing reinforcement were seen in many buildings as shown in Photo 10. It is interesting to note that the damages to these buildings ranged from slight to total collapse although they had identical structural plans. To investigate the correlation between the concrete strength and damage level, Schmidt hammer tests were made for several buildings in the central Yavuz Selim District. Table 3 summarizes the test results. Although the quality of concrete was generally poor, no obvious correlation was found. On close examination, however, it was found that the buildings with less than slight damages had concrete block infills in the frames of basement, which seemed to have contributed to the strength and stiffness of the buildings.

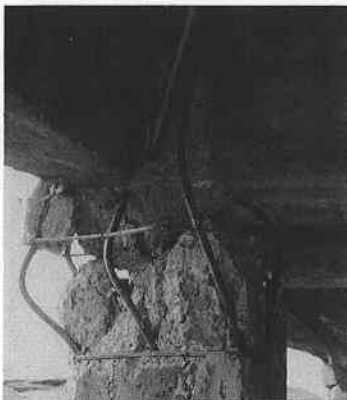
Photo 8 Buckling of longitudinal bars due to absence of lateral reinforcement in beam-column joint

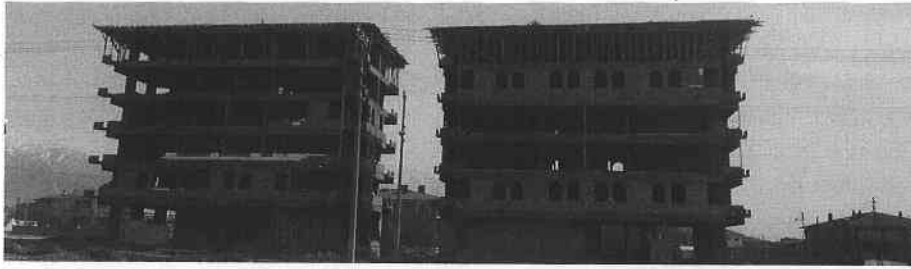
Photo 11 Neighboring six-story apartment buildings

Photo 11 shows two neighboring six-story apartment buildings with identical structural plans having RC core

wall in the center, located in Bahcelievler District. Major damages were seen to have taken place in the first story. In the central core wall, shear cracks and failures were observed in the transverse (EW) direction as shown in

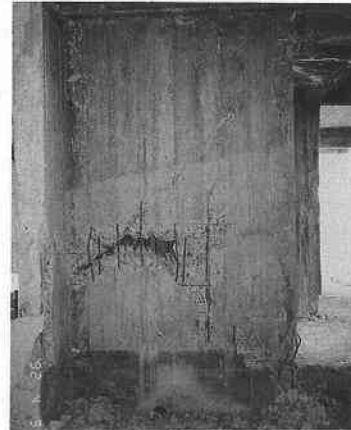
Photo 12 Shear failure in the central core wall

Photo 12. Flexural failures were noted in many columns especially in the EW direction and slight damages in the NS direction. Shear failures were found in short-span beam, extending cracks into the slab. In general, damages were more extensive in the EW direction of the building than in the NS direction.

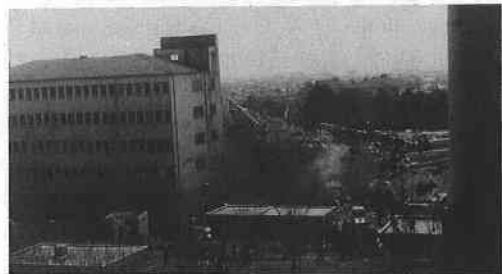
Photo 13 Collapsed Social Security Hospital
[Inonu District]

The Social Security Hospital with four stories (partially five stories) in Inonu District, completed in 1968, totally collapsed in the south wing as shown in Photo 13. This hospital had a Z-shape in plan, with the two wings connected to the main building by staircases. An expansion joint was provided between the collapsed wing and the staircase, but torsional responses around the rigid staircase might have affected the performance of the building, resulting in total collapse. The failure of the building caused 59 fatalities including doctors, nurses, and patients.

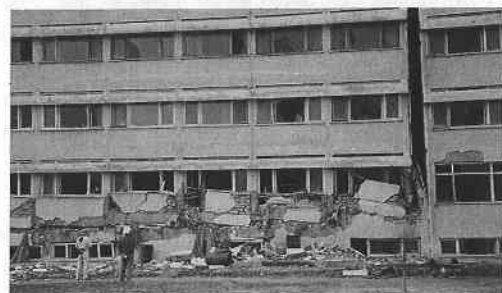
Photo 14 Collapsed Military Hospital

Photo 14 shows spectacular damage to another hospital. The west-most wing of the five-story Military Hospital totally collapsed and its middle-west wing failed in the second story.
