Floods in Ormoc City, Leyte on November 5, 1991

Srikantha HERATH*

1. Introduction

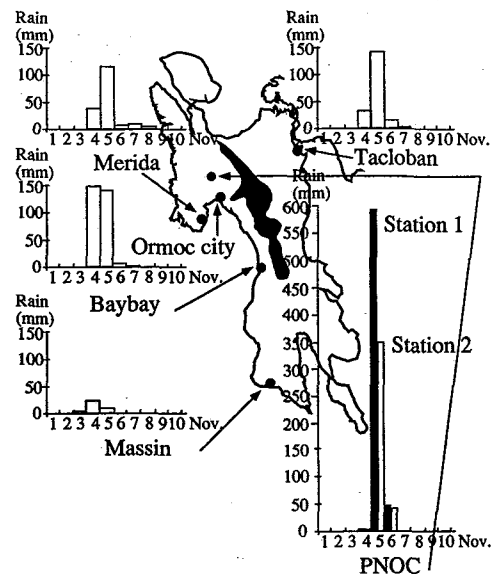
Fig. 1 Layout of Leyte Island and Rainfall Records

Unfortunately there is no record of rainfall in Ormoc City or within the Anilao-Malbasag catchments. Daily rainfall amounts for the period of 1-10 th of November within the Leyte island are shown in Fig. 1. Significant rainfall records among them are shown in Table 1.

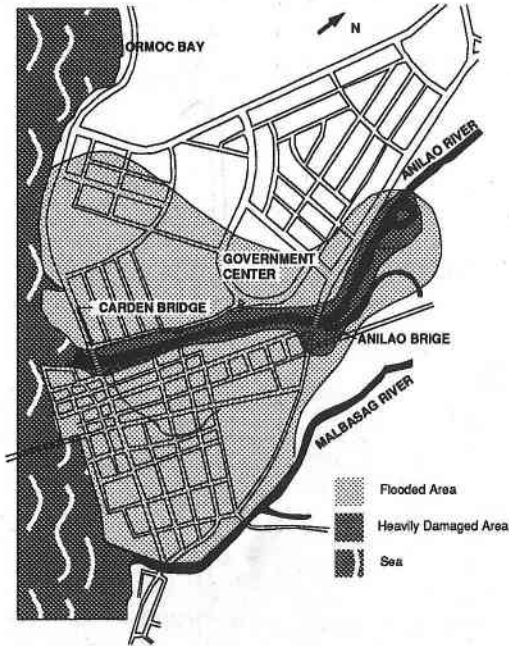
Fig. 2 Flooded Areas of Ormoc City

held by hyper concentrated flood waters. In that brief period over 6,000 lives were lost in Ormoc City. The heavily flooded area of the city is shown in Fig. 2.

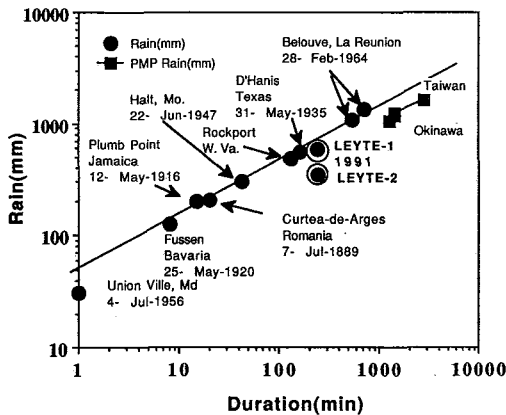
Fig. 3 World's largest recorded rainfalls.

The rainfall records of National Irrigation Administration (NIA) at Valencia, Ormoc City, from 1980-1989 shows the highest monthly rainfall for the 10yr. period to be 223.5 mm for the month of September. By comparison, the PNOC records show extremely high precipitation for the region. Fig. 3 shows a comparison of these records with some of the highest rainfalls recorded in the world.

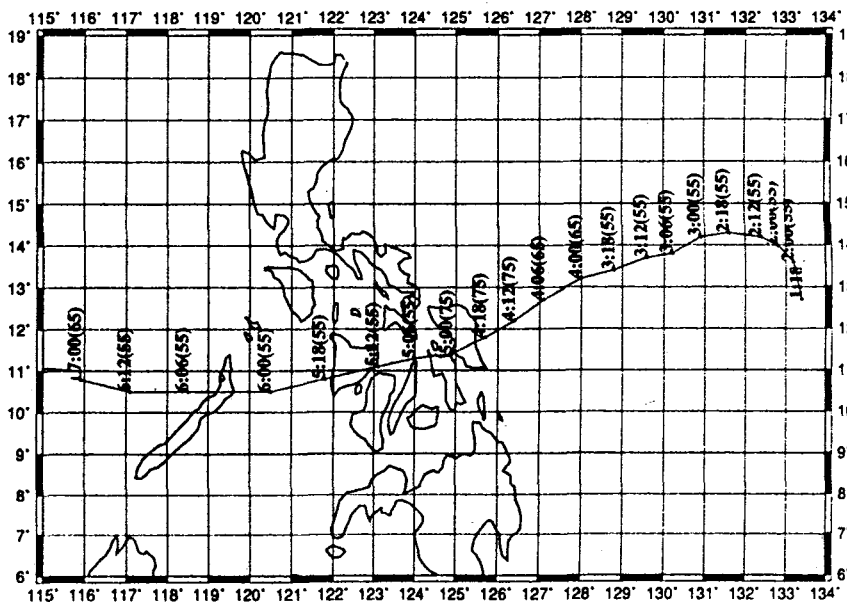
Fig. 4 Path of Typhoon Uring

maximum winds of 20 to 21 m/sec. Uring, however had a strongly developed cumulonimbus of up to 15,000 m in height as of a big-sized typhoon. This cumulonimbus brought the intense rainfall to the mountainous area. Three factors can be considered as contributory to this extreme event.

1. The typhoon occurred late in the year, when the cold front coming from the north is already in the lower latitudes (approximately north of Luzon island).
2. The slow speed of movement of the typhoon (Westward at 11 kph).
3. The presence of a high mountain range in its path (Mt. Alto Peak, more than 1,000 m above sea level).

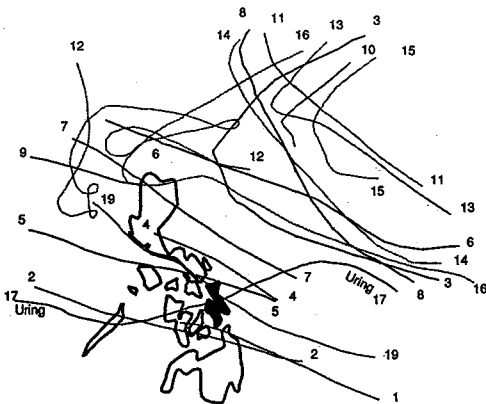
Fig. 5 Paths of typhoons in 1991

The 'normal' typhoon route is northwest towards Samar and Bicol/Southern Luzon. In the case of typhoon Uring, pushed by the cold front, it followed a south-westerly direction. The paths of all the typhoons to hit Philippines in 1991 are shown in the Fig. 5.

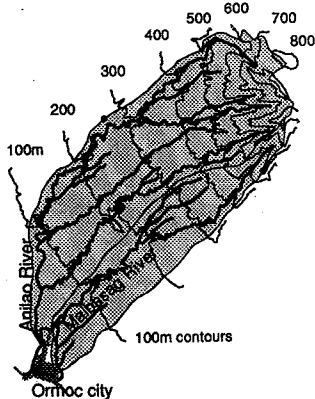
Fig. 6 Anilao-Malbasag basin

Fig. 6 shows the location of Ormoc City and the two rivers, Anilao and Malbasag. The bed of Anilao river near Anilao bridge at Ormoc City is 5 m above sea level. It gently slopes upward between 2%–10% up to an

elevation of 500m above sea level and then rises up to 20%–40% in its highest reaches at about 820m above sea level. Malbasag river follows a similar course reaching a maximum of 10% at its upper reaches at elevation of 800 m. The main features of the two rivers are summarized in Table 3.

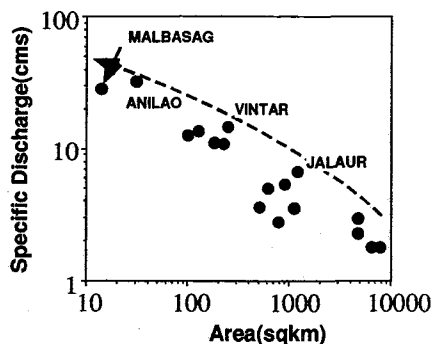
Fig. 7 Comparison of Ormoc Flood with the largest floods recorded in the Philippines

Comparing with the average stream discharges from the DENR measurements, it can be seen that the rainfall is closer to the higher value of the rainfall record. These flood peaks are compared with the highest flood discharges recorded in the Philippines in Fig. 7.
