Observation and Analysis on Damage of Reinforced Concrete Buildings from the 1985 Mexico Earthquake

Shunsuke OTANI*

The 1985 Mexico Earthquake caused a serious damage to buildings in Mexico City, especially in the old lake-bed zone. Reliable statistics on damaged and undamaged buildings over the heavily damaged metropolitan areas were established by Architectural Institute of Japan and Ohbayashi-gumi Investigation Teams.

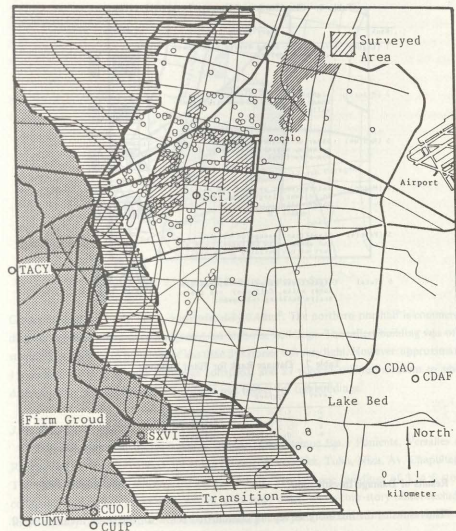
Fig. 1. Seismic Zoning, Severely Damaged Buildings, and Earthquake Recording Stations.

An investigation⁸⁾ immediately after the earthquake reported severe damage in the lake-bed zone as shown in Fig. 1, in which each circle indicates the location of a severely damaged building. The AIJ investigation team decided to concentrate the investigation in selected areas (shaded areas in Fig. 1) in the lake-bed zone due to the limit of working time and man power. A group of two to three experienced structural engineers and researchers went through every alley and surveyed the damage of each building in the area by the external appearance. This investigation may be called a damage inventory survey.

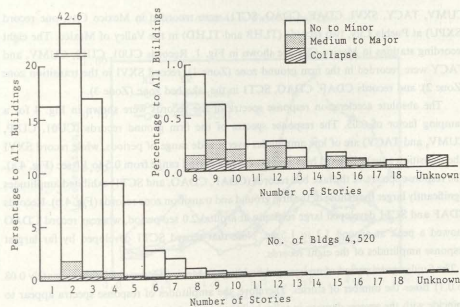
Fig. 3. Summary of Damage Inventory Survey.

The area surveyed covered slightly more than 20 percent of the central area of the city, the results are summarized in Table 3 and Fig. 3 for all data obtained. The number of buildings less than 4 stories high was approximately 73 percent of the 4,520 buildings surveyed; the number of buildings decreased with the number of stories.

No to light damage was observed in 82 percent of the all buildings, and in 85.2 percent of the buildings of less than 6 stories. The collapse occurred only in 1.8 percent of the buildings surveyed, however, in 9.0 percent of the buildings of more than 5 stories. Note the increase

in the percentage of damaged buildings with the number of stories; the damage was relatively light in low-rise buildings.

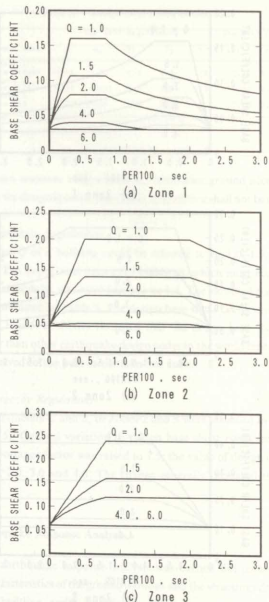
Fig. 6. Design Seismic Load for the 1985 Code.

The spectral parameters C and a_w in Zones 2 and 3 were modified in the 1985 Emergency Regulations (Table 5). General variation of design base shear coefficients with periods was not altered. The importance factor was raised to 1.5; the value of design ductility factors were changed to 1.0, 1.5, 2.0, 3.0 and 4.0. The change generally increased the design base shear coefficient (Fig. 6).

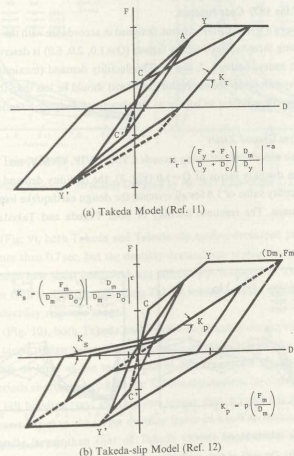
Fig. 7. Hysteretic Models.

Takeda¹¹⁾ and Takeda-slip¹²⁾ models were selected to simulate the response of reinforced concrete buildings, in which Takeda model (Fig. 7.a) represents a building with a large hysteretic energy dissipation, while Takeda-slip model (Fig. 7.b) dissipates less energy. The skeleton curve under monotonically increasing load was of tri-linear type with stiffness changes at cracking point (D_c, F_c) and yielding point (D_y, F_y). Fixed relations were used for the cracking and yielding points;

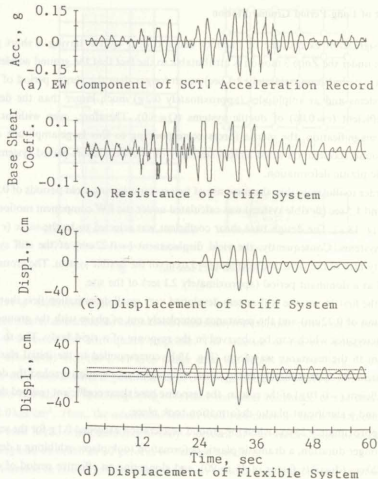
Fig. 18. Response Waveforms of Stiff and Flexible Systems.

For the first 16 sec, the stiff system developed very small deformation (less than the yield deformation of 0.22 cm) and the resistance completely out of phase with the ground motion, the characteristics which can be observed in the response of a rigid body. The short period component in the resistance waveform (Fig. 18.b) corresponded to the initial elastic period of the system. At approximately 16 sec, when the ground acceleration reached the design base shear coefficient ($=0.10 \text{ g}$) of the system, the response base shear coefficient reached the yielding capacity and a significant plastic deformation took place.
