AN ARCHITECT'S NOTES ON THE GREAT EARTH-
QUAKE OF OCTOBER, 1891.

By JOSIAH CONDER, F.R.I.B.A.

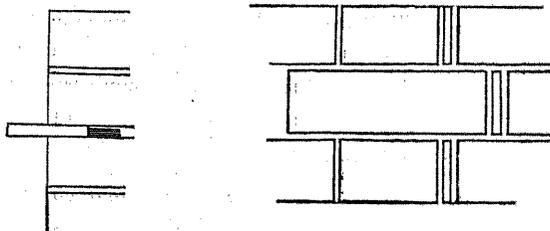
Fig. 1.

in thickness and those of the upper story one brick and a half. The total height of the walls to the cornice was from thirty-two to thirty-three feet. There existed only a few cross walls which were of large span, one brick and a half thick below, one brick thick above, and placed about 60 feet apart. The remaining external walls were framed in wood, but they were few in number, and, for the most part, the building was divided into offices of very large size. The floor beams were of minimum dimensions, shallowly and loosely let into the brick walls, their ends resting on stone templates, wooden wedges and shavings being in some cases driven between the stone and the beams to give them a level bearing. The outer $1\frac{1}{2}$ brick wall of the upper story had large windows, and no piers or cross walls for a length of sixty feet. On inspecting the fractures of walls it was found that they had nearly all occurred at the mortar joints. In fallen masses of brickwork only the bricks receiving super-incumbent weight during the fall were broken. Perfect bricks were without difficulty detached from the brickwork, and such mortar as still adhered easily knocked off with a hammer, crumbling to powder in the fingers. An examination of portions of the walling still standing showed fissures in which the brickwork had separated at the mortar joints, leaving the mortar loose (see Fig. 1). In some cases the cakes of mortar in horizontal joints had been shot partially out, thus showing no adhesion to the bricks (see Fig. 1). In other

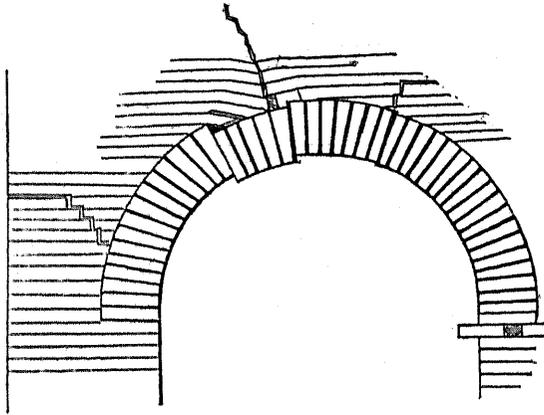
Fig. 2.

cases loosened bricks had been partially shot out (see Fig. 2). Also, the brick voussoirs of arches had been loosened at the

mortar joints and had dropped (see Fig. 2). Remaining standing was a smaller secondary building for service, also constructed in brick, and of two stories, but somewhat lower than the main building, with walls of limited span, and having smaller windows. A projecting cornice of plastered brickwork had been forced out on the North side by the action of the roof; the tiles were loose, and the roof bent, but there were no other serious injuries.

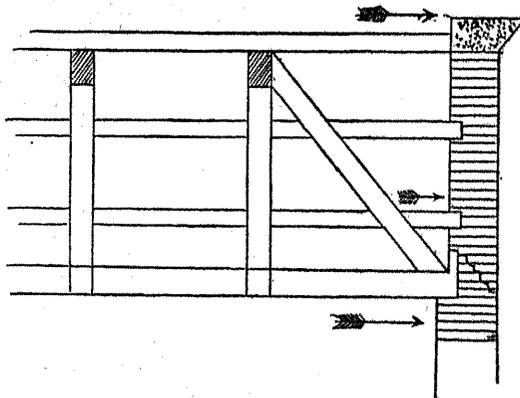
Fig. 3.

GABLE FORCED OUT BY OSCILLATING ROOF.

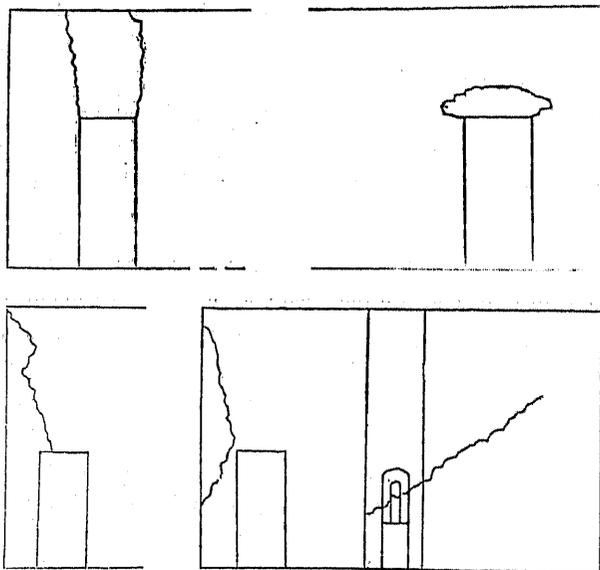
Fig. 4.

wide cracks had occurred near their junction with the outer walls, and other large diagonal cracks were observed running across these walls from the chimney stacks and top corners of the rooms (see Fig. 4). When seen by the writer, these

cracks were large fissures a quarter of an inch or more in width, and gradually attenuating, but the evidence of people present during the earthquake should that only hair-cracks were formed after the first violent shock, which had since gradually widened during the subsequent frequent small shocks. A curious oval crack was noted over a doorway in a brick wall roughly corresponding with the line of the relieving arch and lintol (see Fig. 4). There were other instances of two vertical cracks extending from the top corners of a doorway to the ceiling. Internally, cracks were visible over all window arches on the upper floor. An examination of the interior of the roof showed it to be apparently in perfect condition with the exception of the holes made by fallen chimneys. It was of strong and substantial construction, with large ties and queen-post framework, having strong iron bolts. The joints of the timbers remained almost perfect, and iron straps and bolts were not twisted or loosened. The rocking of the roof had, however, shoved over the brick gables, cut off the chimneys, and pushed out parts of the stone cornices.

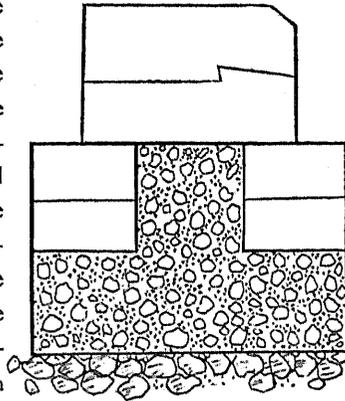
Fig. 6.

earth, which had been first well rammed with a layer of broken stones. A curious method of notching had been used between the stones of the plinth, and concrete had been filled in between the rows of squared stone footings (see Fig 6). These unusual methods of construction seemed to the writer more attributable to amateur work than to any scientific intent, but as this was one of the only brick buildings in Nagoya entirely uninjured, the responsible authorities were inclined to take credit for these details, as if devised in view of earthquake. The notching of plinth stones might, as will be exemplified later, form a most useful expedient against the effects of earthquake in the case of stone bases to light wooden buildings, where a sliding between plinth stones could take place, but in a heavy brick building the advantage does not easily appear. Ideas of preventing penetration of damp between straight joints had most probably influenced the designer in this instance.

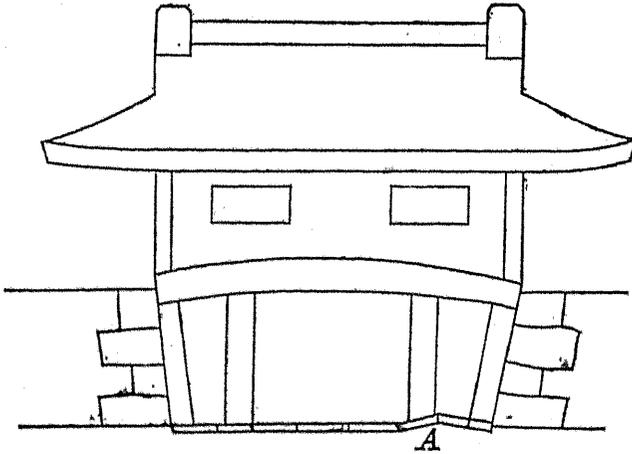
Fig. 8.

faced *doté* (earth mound) had collapsed, a part of the *doté* crumbling into stones and dust, and tearing the building off in the middle. A curious effect was observable in connection with the *Omotte Ichi no Mon*,—one of the principal gateways—the upper story of which consisted of a heavy wood-and-plaster structure spanning a space between two stone-faced embankments (*doté*), this space being occupied by heavy posts supporting the superstructure and forming the gateway. The heavy stone-faced *doté* on either side had by their movement squeezed and doubled up the slabs of granite-paving, as shown at A in Fig 8.

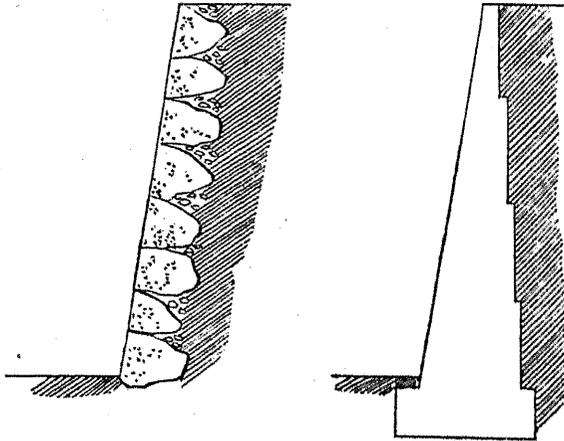
correctly described as *stone walls*; they had no stability apart from the earthworks they assisted in supporting. They had not even the stability of ordinary European retaining walls built in horizontal beds with mortar, of increasing thickness towards the bottom and with proper footings; such requiring overturning in mass. They were constructed of enormous stones, triangular towards the back, bedding upon one another only a few inches at the joints, the cavities behind being filled with loose gravel. No mortar or bond of any kind was used; see (Fig. 10).

Nothing but the enormous weight of the individual stones prevented the pushing out of these walls by the mere lateral pressure of the earth, and when to this was added the shaking and kneading of these embankments by the earthquake, they easily collapsed. Similar effects might frequently be seen in stone-faced embankments of less colossal dimensions in which small stones were employed; a continuous fall of rain was often sufficient to cause them to collapse. The Japanese retaining-wall was a sham and unstable *facing*. It seemed important to record such observations, because, in

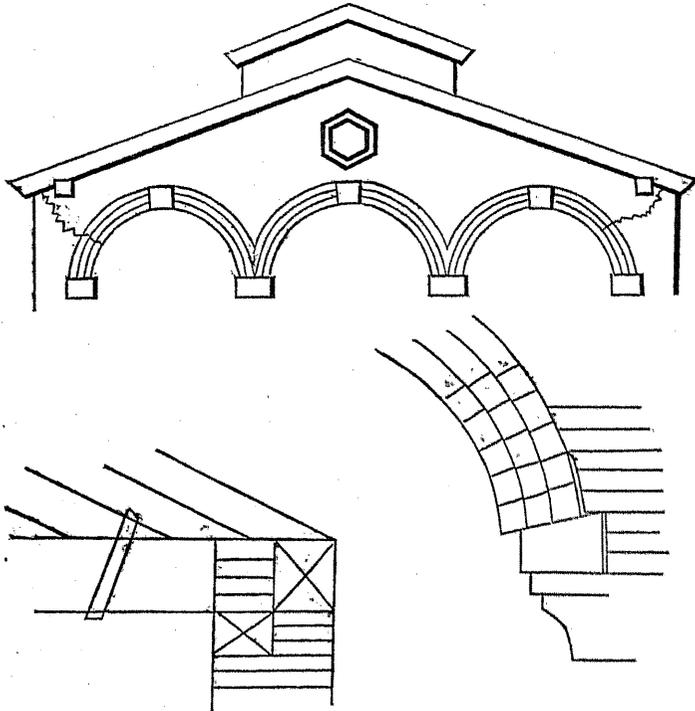
Fig. 12.

The next building examined was a large brick Engine-shed 200 feet long, 45 feet in span, and with walls two bricks thick and about 18 feet high. It was covered by a flattish queen-post roof and had a wooden lantern and end gables of brick. The large arches of the triple entrance were constructed in three half-brick rings with key-stones and abutment stones. There were cracks over the arches, and the key-stones had opened, one falling out. In one case a brick arch had slipped bodily at its junction with the stone abutment. There were also large cracks at the corners of the gable ends running from the projecting wall plates diagonally downwards through the corner arches; these were in some places as much as two inches open (see Fig. 12). In the case of one arch in which the key-stone was intact the lower ring of bricks had loosened and dropped back (see Fig. 12). The movement of the wooden roof had much disturbed the tops of the walls. *The brick beam-

filling between the tie-beams, above the wall plate and behind a continuous outer roof plate, had been loosened and pushed in by the vibration of the roof (see Fig. 12).

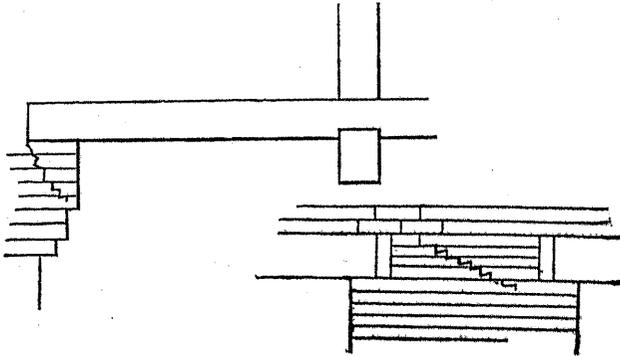
Fig. 13.

The Nagoya Cotton Mill, next inspected, was a combined wood and brick building. The first Cotton-spinning Hall was a one story wooden building about 16 feet high, and 170 feet long by 72 feet wide, covered in two 36 feet spans of queen-post roof, and containing three rows of wooden pillars one under the centre of each truss and one under the central valley. At the end of the hall was a brick Engine-room, the end wall of the hall being of brick, two bricks in thickness. In the wooden hall there was no damage except that the glass of the windows had been smashed by the shock. Against the brick wall the roof timbers had been carried on brick corbelling, and this corbelling had been dragged and broken by the vibration of the roof (see

Fig. 13). The tops of the doorways in this and other brick walls had no relieving arches but were carried on thick wooden lintols, and these lintols had moved, some being drawn partly out, the brickwork between their ends being battered and cracked (see Fig 13).

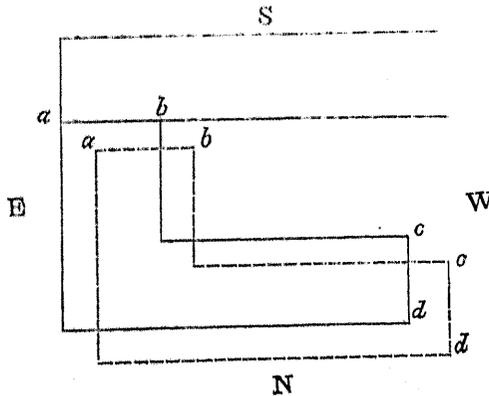
Fig. 16.

constructed with thin posts, covered on the outside with Japanese weather-boarding, with low walls and a light roof divided into many spans. In another part of the compound a portion of a large low wooden building having thin uprights and a heavy king-post roof had completely fallen, East by North, being torn away from the rest of the structure (see Fig. 16).

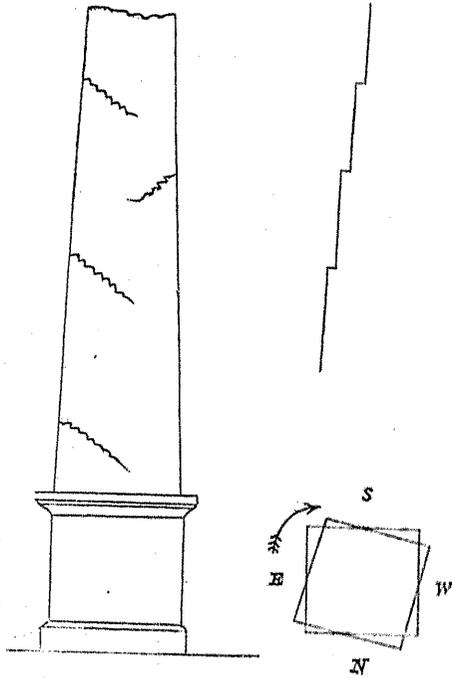
the kiln chimneys were all broken off. There was a large square brick chimney, originally about 78ft. high, of which about 25ft. had fallen, partly E. and partly W. In the remaining portion the brick joints had been loosened in many places and a twisting had taken place from E. to W. by S. causing curious effects at the angles creating an indented appearance when viewed diagonally, as sketched in Fig. 18.

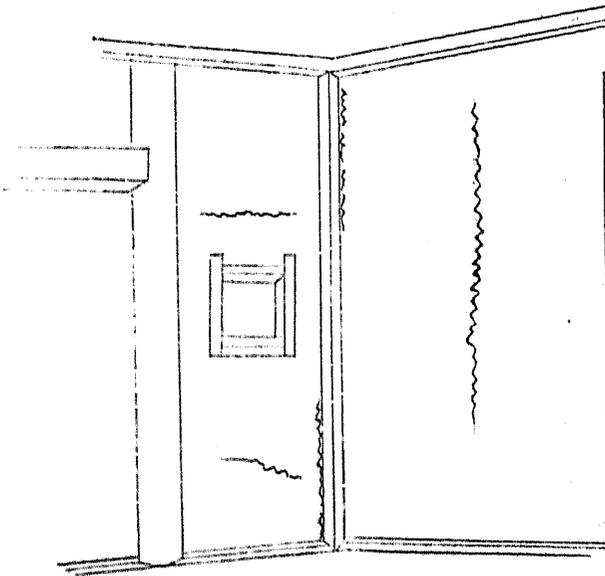
Fig. 20.

owing to the fall of the upper walls of the adjoining Post and Telegraph Office. A large two story annex of this hotel, consisting of a number of tea rooms and small chambers below with a large 120 mat room above, had at its West end a heavy Japanese Store, close to the Eastern end of the Post and Telegraph Office. The falling brickwork had knocked over this heavy Store crushing in the top portion of the hotel annex. The lower story posts and parts of the lower ceilings remained standing, and a portion of the East end remained complete *in situ*. Those parts of the hotel which had not been damaged by adjacent objects showed signs of terrible shaking in large cracks and rents, horizontal and vertical, in the plastered (*kabe*) panels of the rooms, and the edges of these plastered panels were separated from the posts, but the posts and beams remained intact, as well as the wooden ceilings (see Fig. 20).

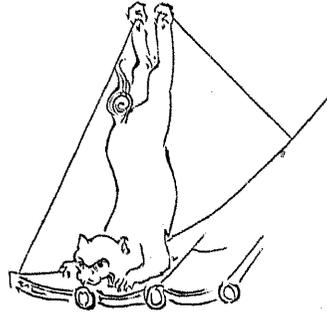
of a porch to one of these buildings was shoved out. In some of the secondary gateways, having thatched roofs with tile ridges, the terminals of the tile ridges had fallen and the ends of such roofs were bent over. On the other hand, the ends of the curved lean-to roof extending over the porch of the Hondo had large terra cotta terminals of high rearing lions steadied only by thin wires, and these were not injured, showing that the roof had moved in one block, see Fig. 22.

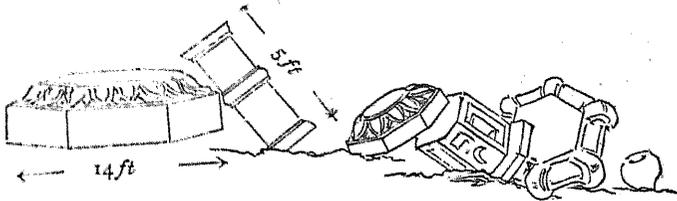
Fig. 26.

the sliding movement at the base in a South direction, with a twist toward the West. The cap had also slid about 1 inch East; and the top ball had fallen and rolled to a considerable distance South. The above lanterns were of no very great size. Another colossal stone lantern about 16ft. high had fallen to pieces, spreading out in a direction S.W. by W. (see Fig. 26).

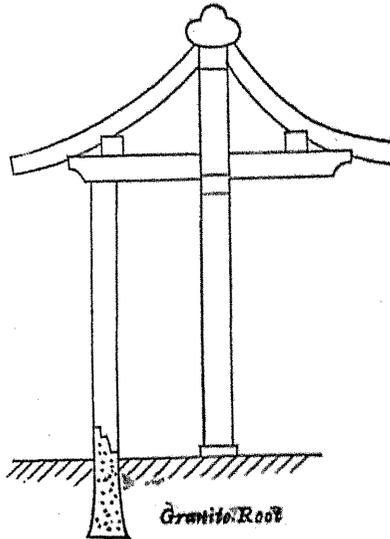
Fig. 28.

This was in front of the fifteen enclosed tomb-courts containing the remains of the Bishiu Tokugawas from the 2nd to the 16th, inclusive. The stone railings round these burial enclosures, which were of stone posts and rails tenoned together like wood construction, had fallen to pieces in various directions, but mostly N. and S. Most of the wooden entrance gates of these courts, which had heavy roofs, two supporting posts, and buttresses on one side, had fallen forward on the side having no buttresses. The construction of these buttress posts was peculiar. They consisted of wooden pillars tenoned above into the cross beam of the roof and scarved and strapped below to a granite end let into the ground (see Fig. 28). In

some cases of overthrow the scarf joint had given, in others the granite root had been drawn out from the earth. Some gateways had the posts merely loosened, but the handsomely carved wooden doors thrown out of their sockets and the panels smashed. Some of the stone cenotaphs, of flattish form curved at the top, had been thrown over in a S. direction

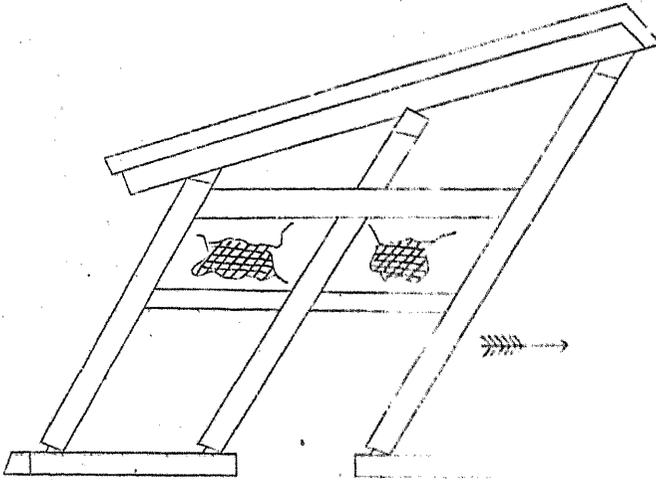
Fig 30.

over bodily in a W. direction at an angle of about 60 degrees, the posts having their dowels drawn out of or broken into the ground cills and the intermediate plaster-work broken and fallen (see Fig. 30).

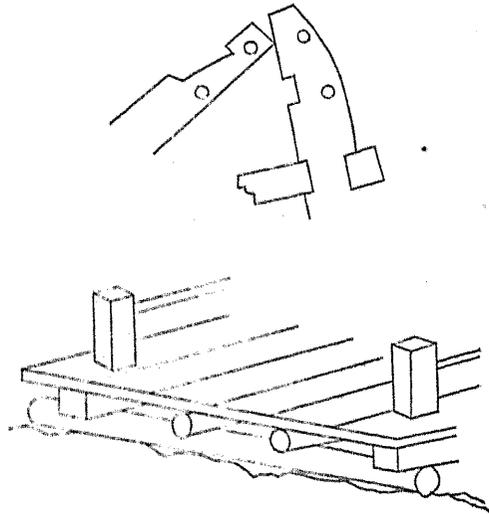
Fig. 31.

An excursion through the suburbs of Nagoya and the neighbouring villages on the road to Gifu was the occasion of an examination of the more ordinary Japanese buildings. In the suburb of Higashi Biwajima, long rows of street houses were leaning longitudinally in a Western direction (not over the street as at Atsuta.) Further on there was a large area occupied by houses which had completely collapsed, the tiled roofs having flattened out on the top of the fallen posts, beams, &c. The long wooden bridge of the Biwajima river was broken and waded in the centre with a large swoop towards the S. E. The stout wooden piles about 15 inches in diameter, supporting it from the bed of the river, had some of them sunk down, some broken in the middle, and some torn away at the scarved and bolted joints (see top of Fig. 31).

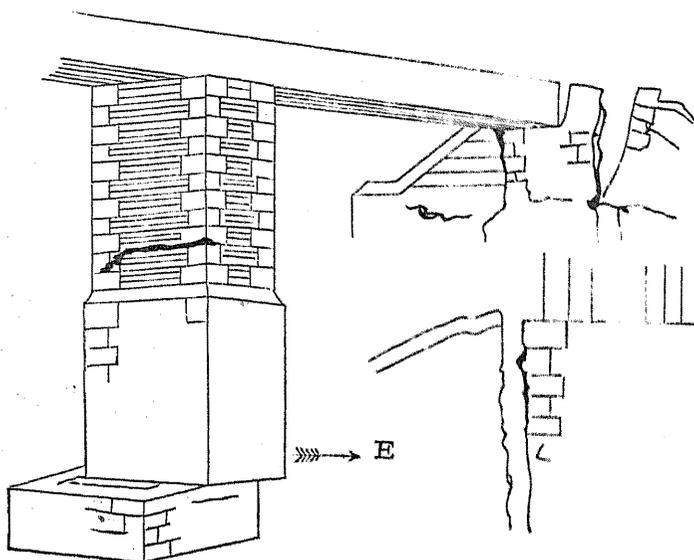
Fig. 35.

tween the bridge over the main stream and the secondary bridge over the tributary, had sunk several feet. One of the large brick piers of the tributary bridge, having granite quoins, had slid on its base of brickwork in an Easterly direction. The end piers supporting the main girders had separated from their wings which supported the ends of the earthworks (see Fig. 35).

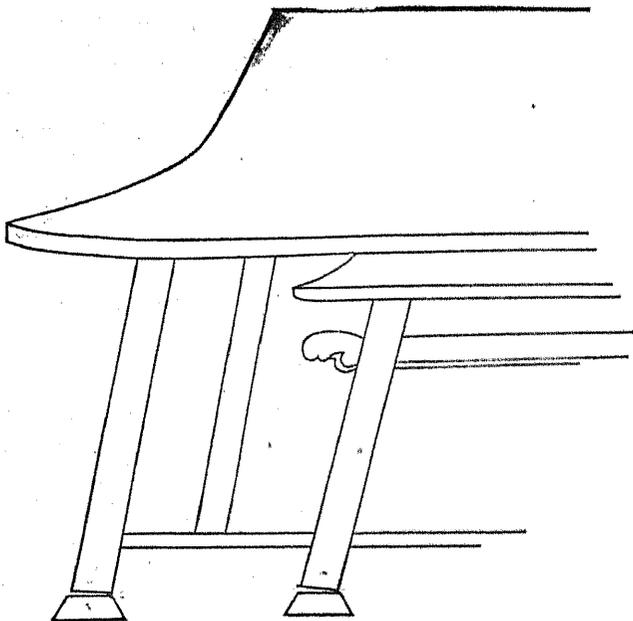
Fig. 39.

The most important and monumental of the purely Japanese buildings in Gifu was the Hongwanji Temple; and, contrary to the experience in similar structures at and near Nagoya, this had been considerably damaged (see Fig. 39).

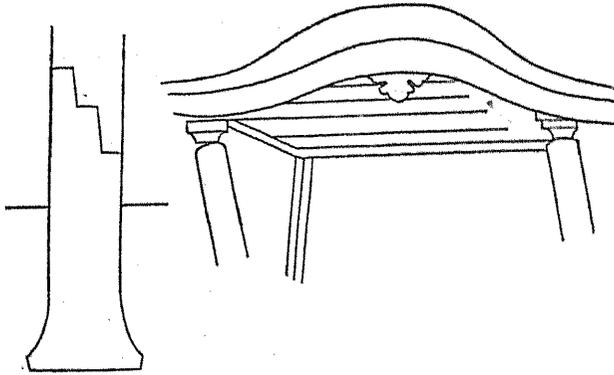
Fig 42.

Another example was here noted of gate posts scarved to granite bases let into the ground, and in this case, though the granite base was root-shaped, (wider below than above), it had been drawn out bodily from the soil (see Fig. 42).

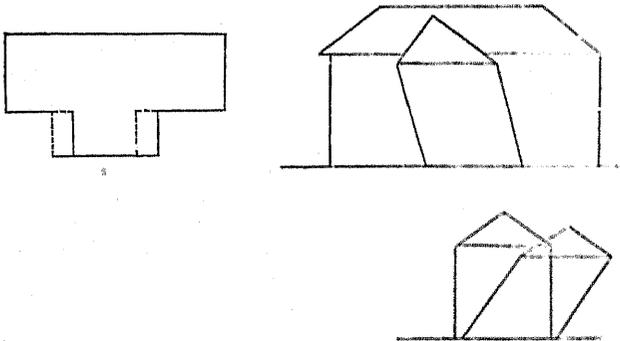
Fig. 43.

The Police Office, a wooden building of mixed Japanese and European style, had its central projection broken and leaning (see Fig. 43). The Post Office, a wooden plastered building in European style, showed signs of severe shaking, the joints of the frame-work being broken and the plastering damaged, but it preserved its erect form.

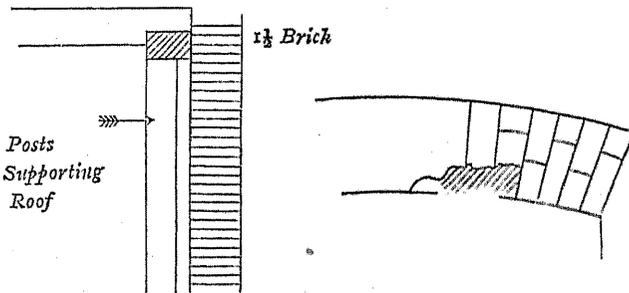
Fig. 47.

surprising that so little damage had occurred, only a few arches being injured (see Fig. 47). The lightness of the flattish roof and the moderate size of the openings had no doubt been favourable. Some architects have been inclined to detect a virtue in the method of constructing the upper story with wooden pillars free from the brick walls, carrying the wooden roof. Considering the report made by eye-witnesses, that the brick walls and woodwork had opened as much as 2 ft. during the shock, and also

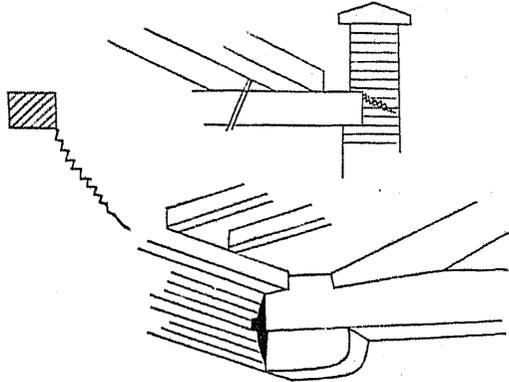
Fig 52.

been cracked or loosened, in some cases large cracks extending down the walls below these timbers (see Fig. 52).

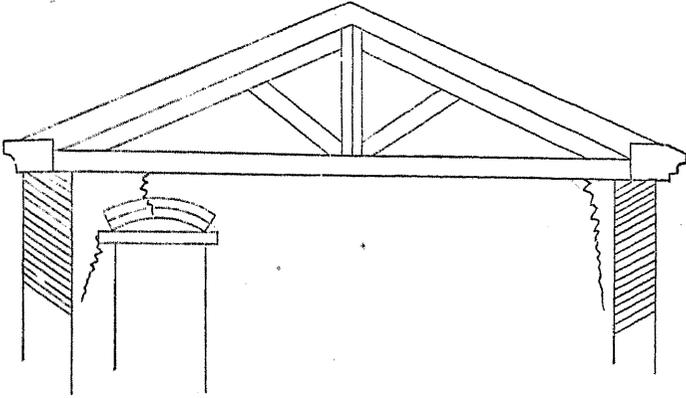
Fig. 57.

truss—one being over a door arch in the corner, and one extending right down the solid wall (see Fig. 57).
