Investigation and Analysis of Damage to Buildings during the 2003 Bam Earthquake

Hossein Mostafaei* and Toshimi Kabeyasawa

Earthquake Research Institute, The University of Tokyo

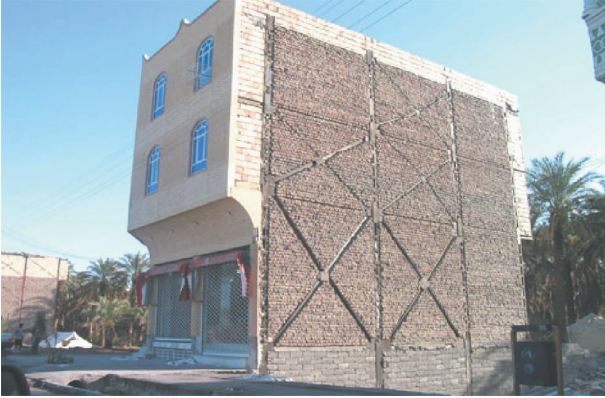
mic code in 1990. It is preferred by owners of conventional buildings, due to the fast and convenient construction process and economic benefits in comparison to a reinforced concrete structure (Fig. 14).

Fig. 14. Steel frame structures with bracing, S-B type.

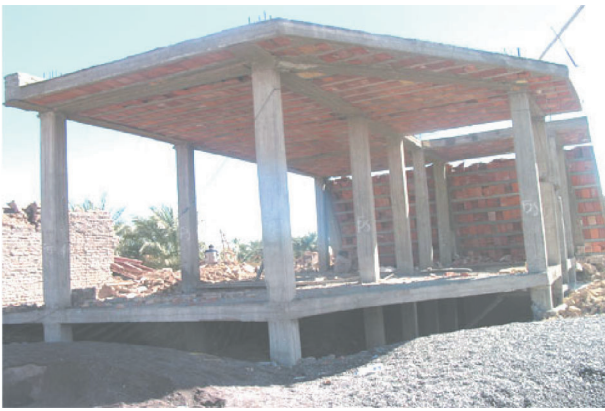
Reinforced concrete frame, the RC type shown in Fig. 15, and special steel frame with masonry walls, M-S-F type shown in Fig. 16, occupy the remaining 3% of structures in the city of Bam. The proportions of the different structural types in Bam city are illustrated in Fig. 17. It can be inferred from the figure that 24% of the surveyed buildings (M-C & M-S, S-B & S-F, and RC & M-S-F) in the city have structural systems that are defined in the Iranian seismic code as systems with a seismic resistant design.

Fig. 15. Two-story RC structure, RC type.

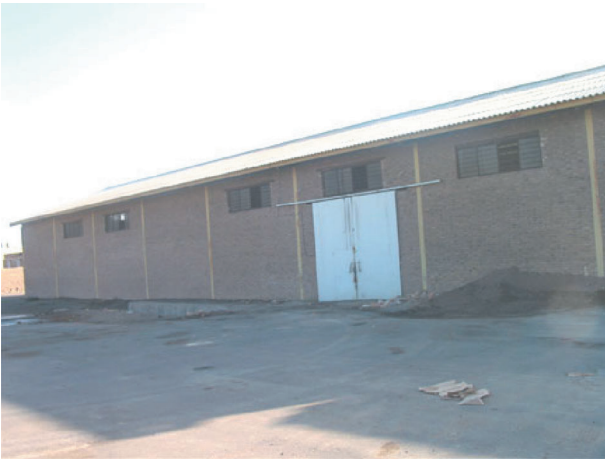
Fig. 16. Special steel frame-masonry structures, M-S-F type.

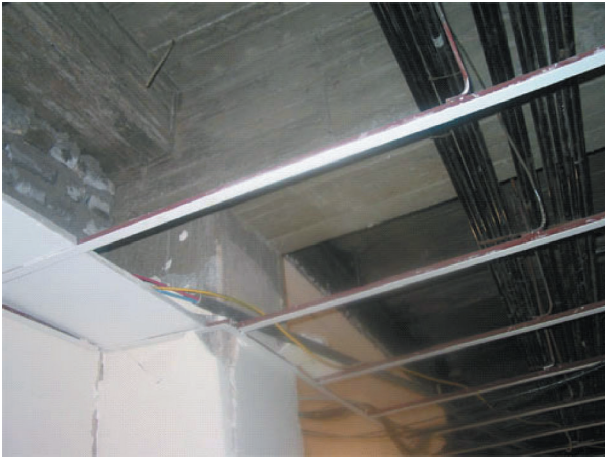
of telephone centers in Bam city (in Zone 1 of Fig. 18, the same zone as the strong motion station's zone) and Baravat village (in Zone 8), as shown in Figs. 21 and 22, respectively. The steel structure of Bam Azadi hotel (in Zone 4) also performed without significant structural damage, as shown in Fig. 23. Based on these observations, it is estimated that the effects of infill masonry walls might be an important factor for the almost linear response of this kind of frame structure. To find the answer, in addition to the statistical damage evaluation presented, a case study of a 3D nonlinear time history analysis for the RC building of the Telephone Center in Bam city,

Fig. 21. A beam-column connection on the first floor of the Bam telephone center, which had no damage (about 1,000 m north of the strong motion station).

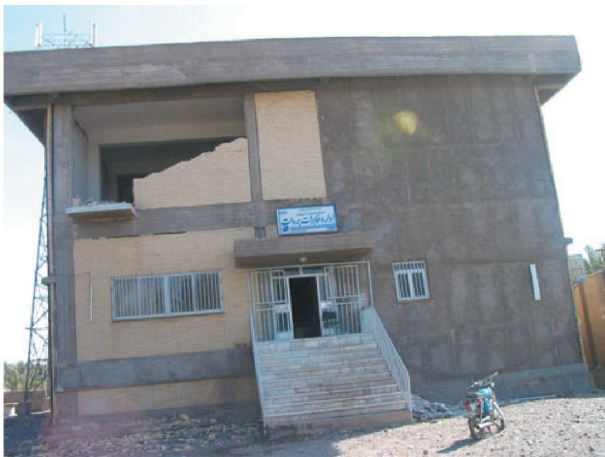
Fig. 22. Baravat village telephone center, which had no structural damage.

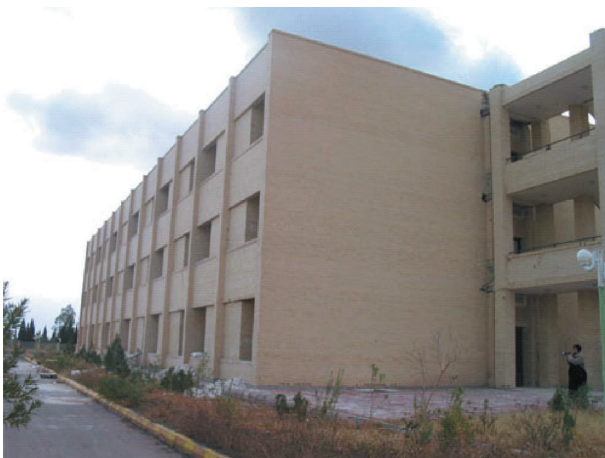
Fig. 23. Bam Azadi hotel which had no structural damage (about 2000 m SW of the strong motion station).
