Damage to Buildings Caused by the 1999 Chi-Chi, Taiwan Earthquake and Earthquake Response Analyses Using Recorded Strong Ground Motions

Yuki SAKAI, Kazuki KOKETSU, Shingo YOSHIOKA and Toshimi KABEYASAWA

Earthquake Research Institute, University of Tokyo, Tokyo, Japan

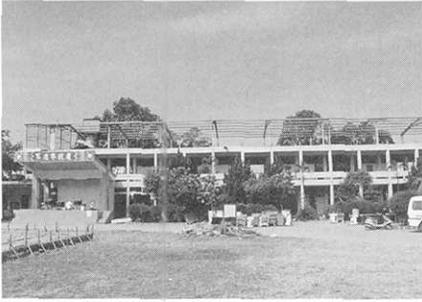
Photo 1. Building C of Shikang National Elementary School, which was severely damaged

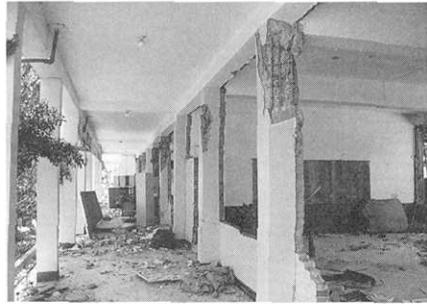
Photo 2. Severely damaged tops of columns at building C of Shikang National Elementary School

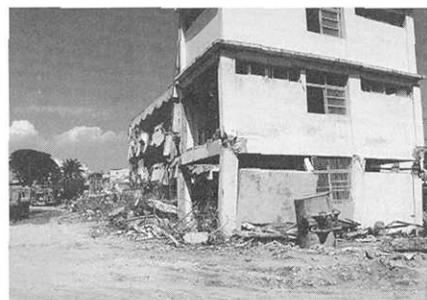
Photo 6. Building A of Nankuang National Elementary School in Puli, which was severely damaged and was being demolished

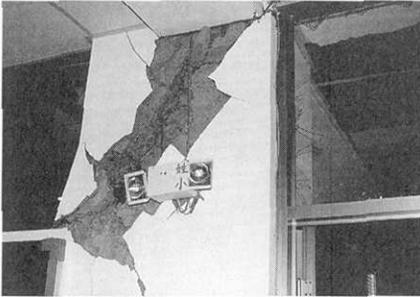
Photo 9. Shear failure of non-structural wall at building B of Kuoshing National Elementary School

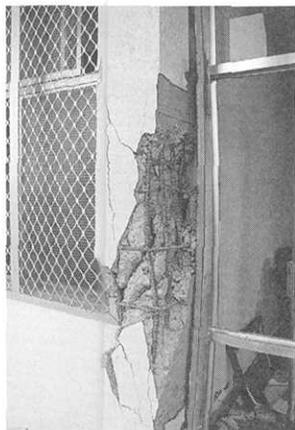
Photo 13. A damaged column by the first story front entrance at Jryetan Meteorological Agency

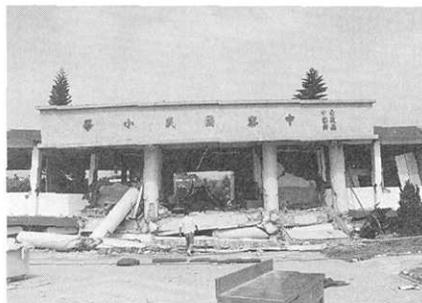
Photo 14. The front of building A at Chungliao National Elementary School which was originally a two-story but looked like one-story building

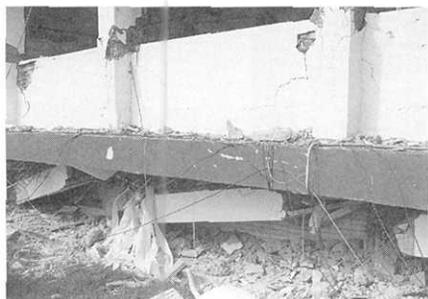
Photo 15. Collapsed first story of building A at Chungliao National Elementary School

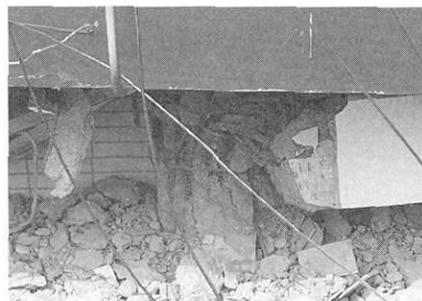
Photo 16. Close-up of Photo 15 (Longitudinal bars buckled although there were many longitudinal bars.)

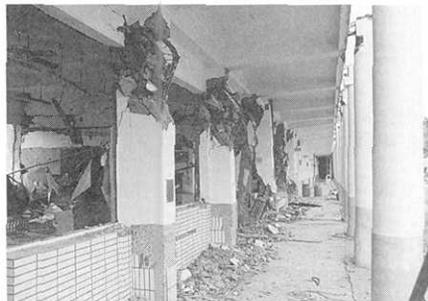
Photo 17. Severely damaged first story of building B at Chungliao National Elementary School

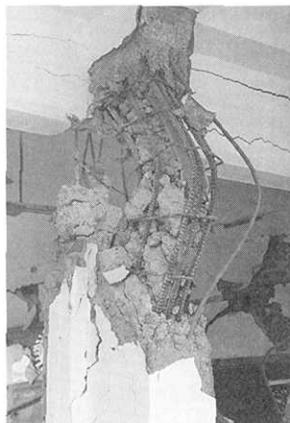
Photo 18. Close-up of Photo 17 (Longitudinal bars buckled. Pipes were found.)
