13. Landslides in the Epicentral Area of the Matsushiro Earthquake Swarm—Their Relation to the Earthquake Fault.

By Ryohei MORIMOTO, Kazuaki NAKAMURA, Yukimasa TSUNEISHI,
Joyo OSSAKA and Nobuko TSUNODA,

Earthquake Research Institute.

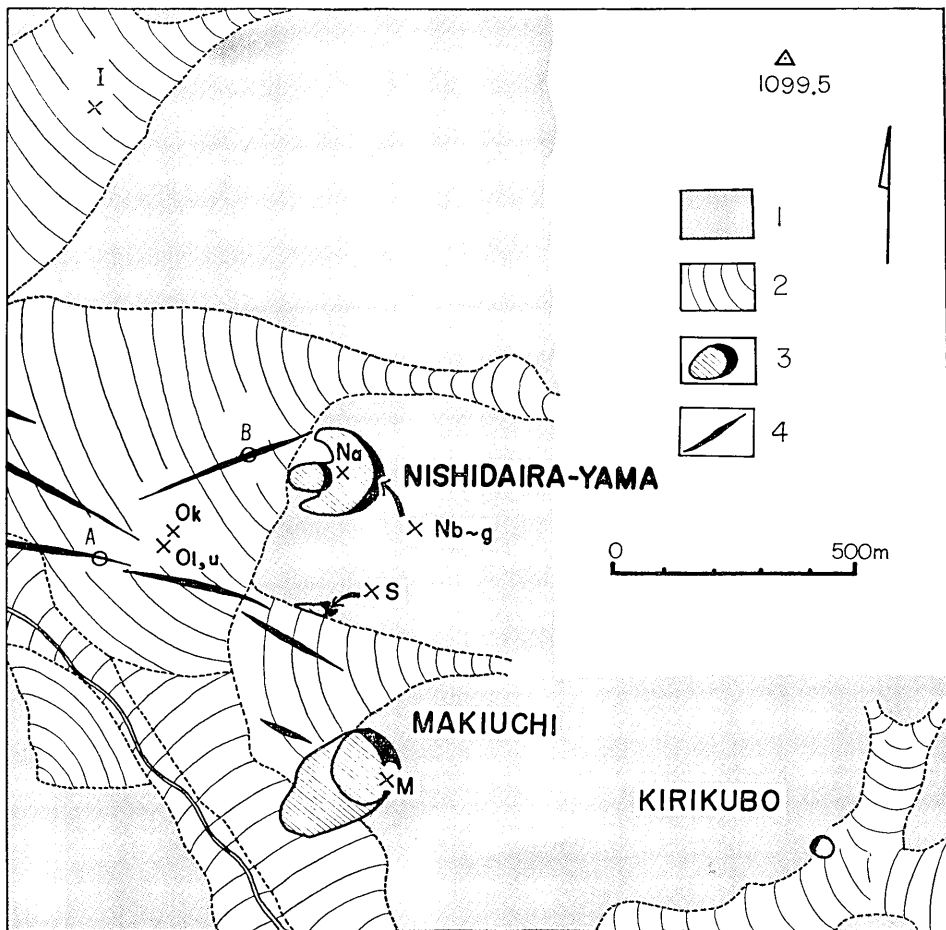
Fig. 2. Distribution of landslides and "fissure zones".

The mud-flow and the three actual and two suspended landslides occurred exclusively on the middle and lower skirt of the mountain region (Fig. 2) where basal rocks are covered with talus debris less than a few metres in their thickness. The basal rocks at the three localities are all deeply altered porphyrite or fine-grained diorite*. But at Nishidaira-yama, a part of the basement rock consists of pebbly mudstone or sandstone** which lies on the depression of the diorite and is overlain by thin talus debris. In this mudstone, fresh and nearly horizontal slicken-sides which seemed to have been formed by the present movement were frequently observed.

Localities of the three landslides are exclusively situated on the "fissure zones" or on their extension: Makiuchi and Kirikubo are on the southeastward extension of the "fissure zones" of WNW-ESE direction and Nishidaira-yama on the WSW-ENE "fissure zone" which might have been opened under the same stress distribution. The mountain skirt of the same geological condition as that of above-mentioned displaced areas is extensively developed in the meizoseismal area. But no surface changes of this type were found on these mountain slopes out of the "fissure zones" and their extension. Thus the skirt of the mountain region composed of deeply weathered basal rocks which were disturbed to make cracks by the movement of some concealed earthquake faults, satisfies necessary geologic conditions giving birth to these landslides.

The places where the landslides occurred were selectively in the lower slope of the mountain region (Fig. 2). The region has been an area for weathering and erosion and part of the slope is regarded as a remnant of the original valley wall, the corresponding bottom of which is now buried under the alluvium. On the contrary, area of alluvial fan has been the place of deposition. Thus, the slope is originally less stable for gravity force than the surrounding alluvial fans as indicated by the difference in their mode of formation.

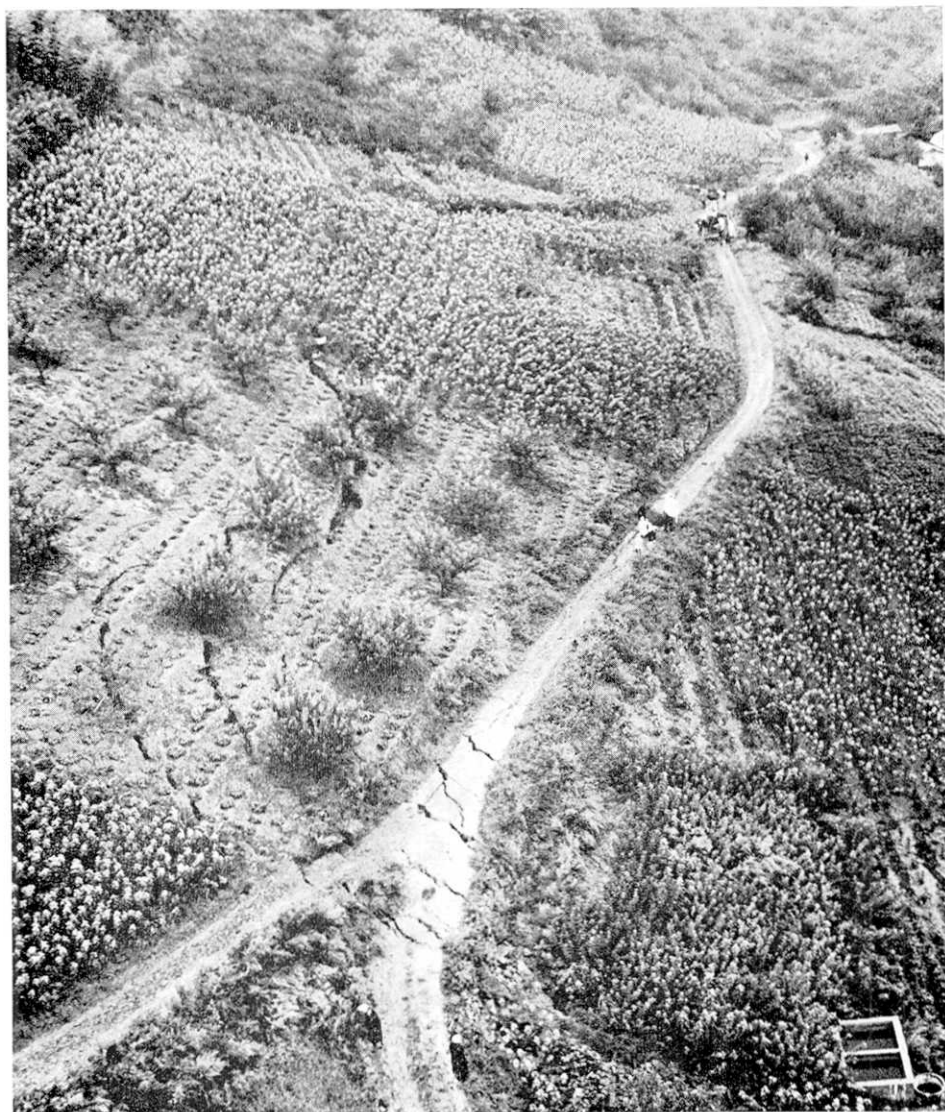
Fig. 3. An aerial view of the ground cracks formed at the head of the impending landslide at Makiuchi. Photograph was taken by Mr. Sakurai of the Shinano Mainichi Press from a plane 50 m above the land two hours before the visible sliding which started at 14h05 m, 17th September 1966. Upper right of the rural road is cut by one of these cracks to make a step, where several persons are standing. Fig. 4. is a close-up of this part.

intuitively as those usually found at the head of a landslide in its initial state.

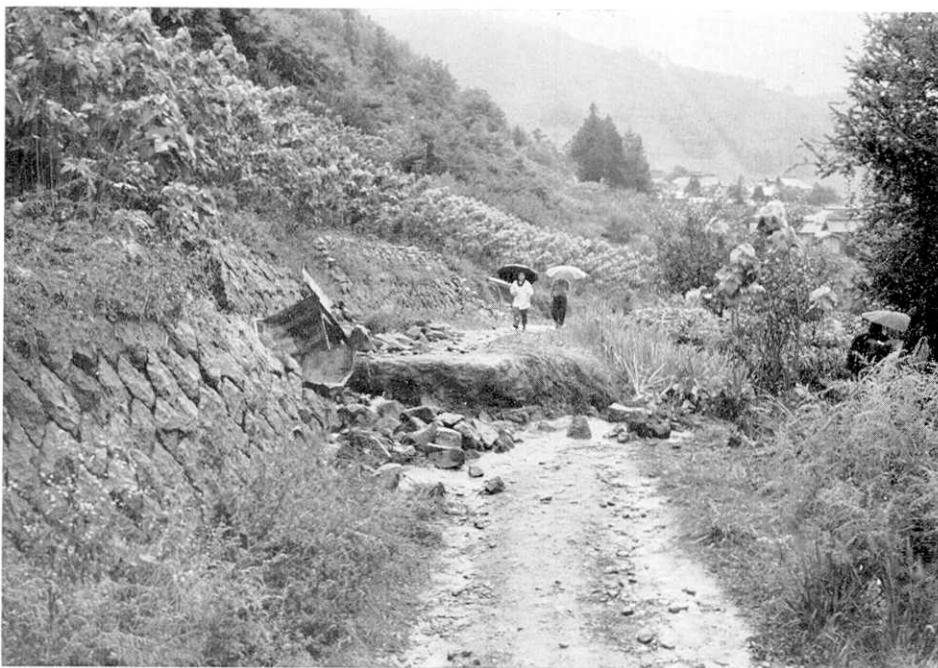
Fig. 4. A rural road was cut through by one of the cracks along which the anticipated landslide was going to occur. Displaced height was about 80 cm, 20 minutes before the visible sliding started. Horizontal lines were marked for levelling on the stone wall at the left side of the road.

Under the above-mentioned circumstances, the writers decided to advise the officers of the town hall to evacuate the inhabitants from the dangerous area and to control the water flowing into the cracks in order to minimize or to retard the impending disaster. The officers and people accepted the writers' advice. The inhabitants were evacuated at midnight. No visible landslide did take place in the morning of next 17th September. Legality and validity of "last night's evacuation" were discussed, while slow but still faster invisible sliding had continued on.

Appropriate work of preventing the water pouring into the cracks was done by the firemen of the town during the night of 16th September and probably retarded the starting of rapid sliding. This must have decreased the velocity of moving earth, and would have protected the inhabitants from the anticipated danger due to dashing water and earth if it had occurred.

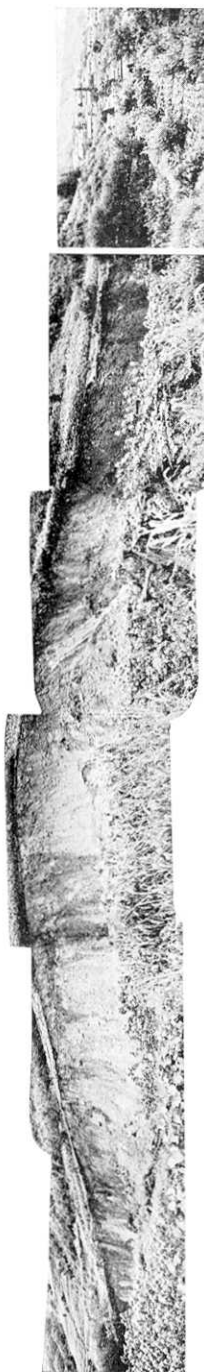
Fig. 5. A panoramic view of the semi-circular cliff at the head of the Makiuchi Landslide about 10 minutes after its first visible movement. The underground water which was previously concealed is shown running down in the middle of the cliff. To the left of the water, many inclined striation are seen on the cliff. These are probably formed during the slide. The curved surface of the cliff still preserved its perfect crescent-like shape at that moment. Top of the head broke down at the second collapse, 30 minutes later (Fig. 6 and Fig. 7 below).

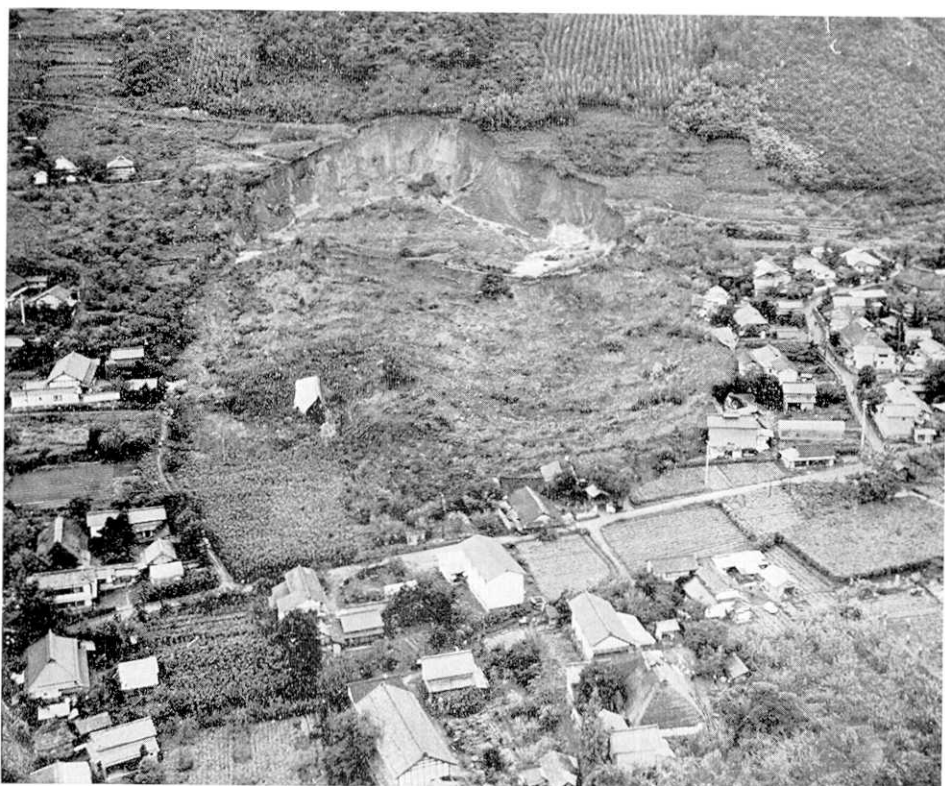
Fig. 6. An aerial view of the landslide at Makiuchi, an hour after its occurrence. Underground water pouring out from the curved scar at the head of the collapsed area is dammed up behind the ridge of the rotated mass. Mulberry trees intermingled with slid earth draw the flowage patterns to wards the front, similar to a big surface pattern of ropy lava flow. Smaller embayed portion at the top of the cliff collapsed secondly, about 30 minutes after the sliding down of main mass. Photo. by Mr. Sakurai, Shinano Mainichi Press, around 15h, 17th September 1966.

to make talus cones beneath there. At about 14h40 m a remarkable collapse took place in the central rim of the cliff (Fig. 6), which caused a second movement to start appearing as slumping behind and swelling up in front. The swelled up mass collapsed and flowed downwards. This continued for about 20 minutes with the velocity of ten to twenty centimetres per second. Most of the destroyed houses were collapsed down by the earth flow during this second movement (Fig. 6). The cross-section of the moved mass is shown in Fig. 8.

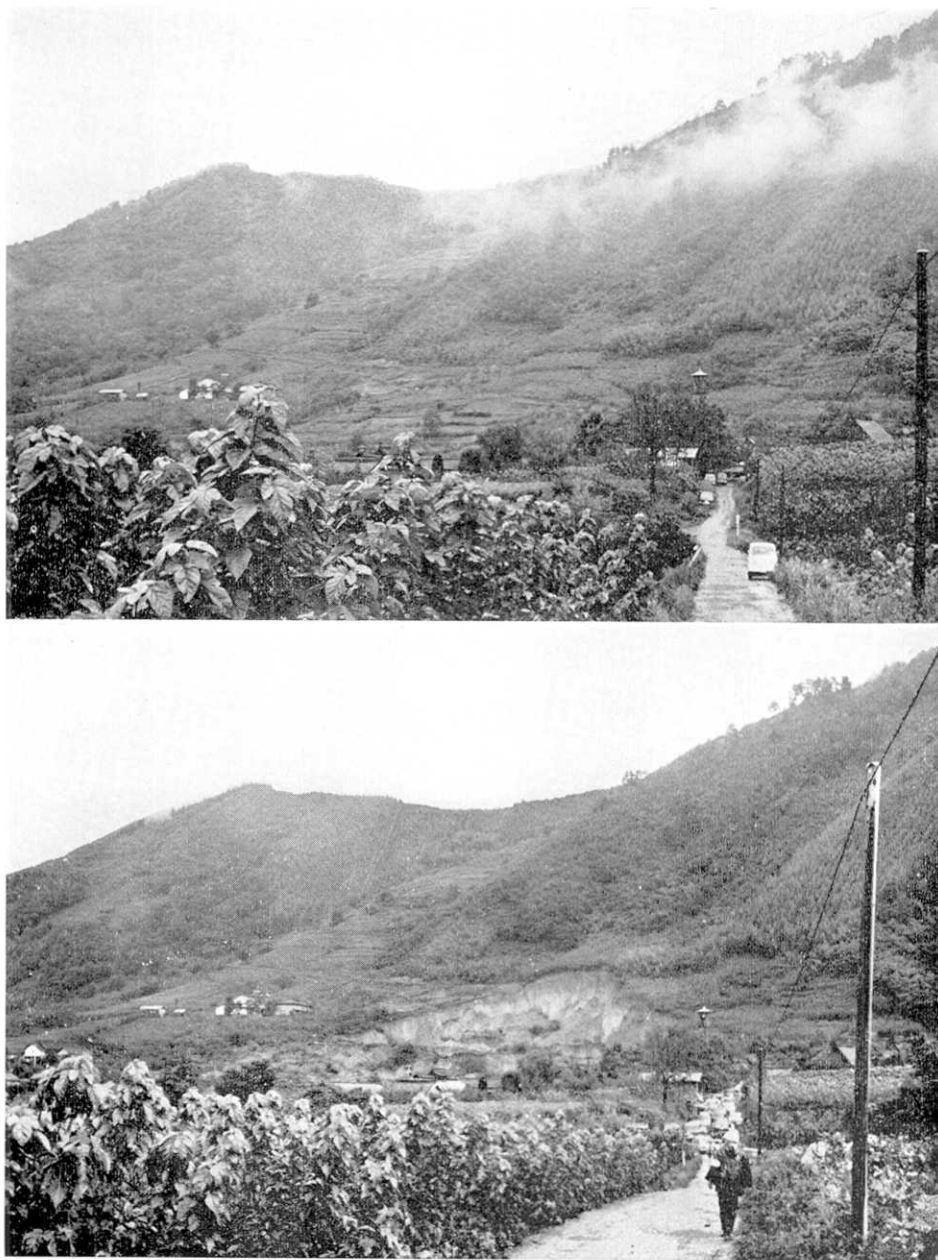
Fig. 7. Site of the Makiuchi Landslide viewed from a point about 1,000 m southwest of the spot before and after the event. Upper photo was taken at 13h30m, and the lower at 15h30 m, 17th September.

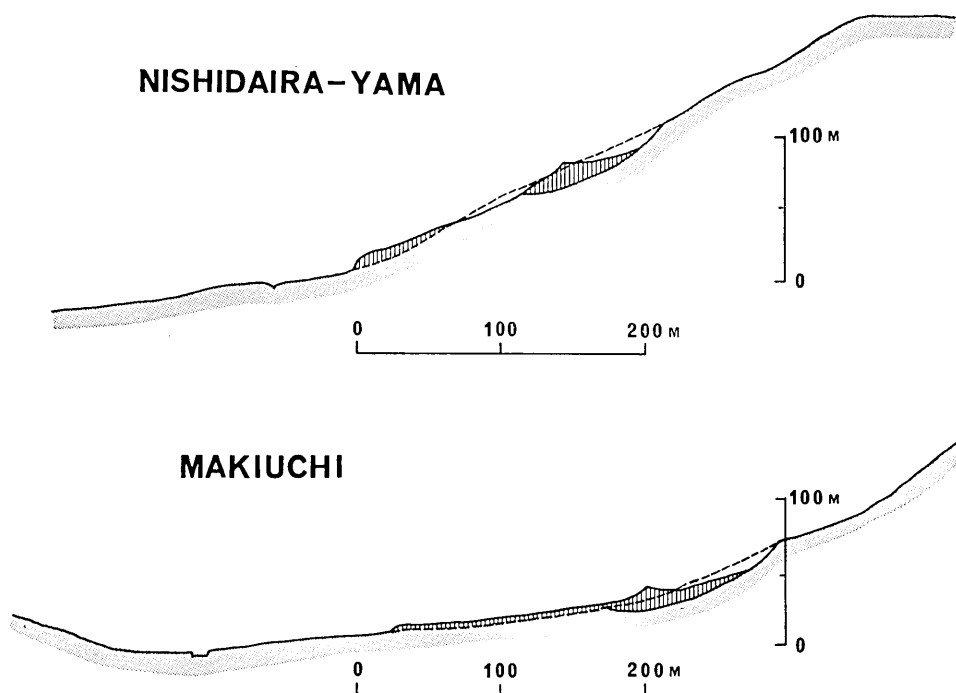
Fig. 8. Cross-sections of the sites of two landslides at Makiuchi and Nishidaira-yama. Higher parts of the moved masses show rotational slumps whereas the lower parts represent flowed masses which bear flowage pattern on their surface (Fig. 6) at Makiuchi, and rock fall and avalanche at the Nishidaira-yama.

No landslide occurred on the slope of alluvial fan deposits even where they are deposited at the slope (about 20°) just adjacent to the site of landslide (Fig. 8). Taking the mode of formation of the present topography into account (Chap. 2), it may be concluded that the alluvial fan area has been immune from disturbance or that the area is more stable against gravity force than the above-mentioned mountain slopes.

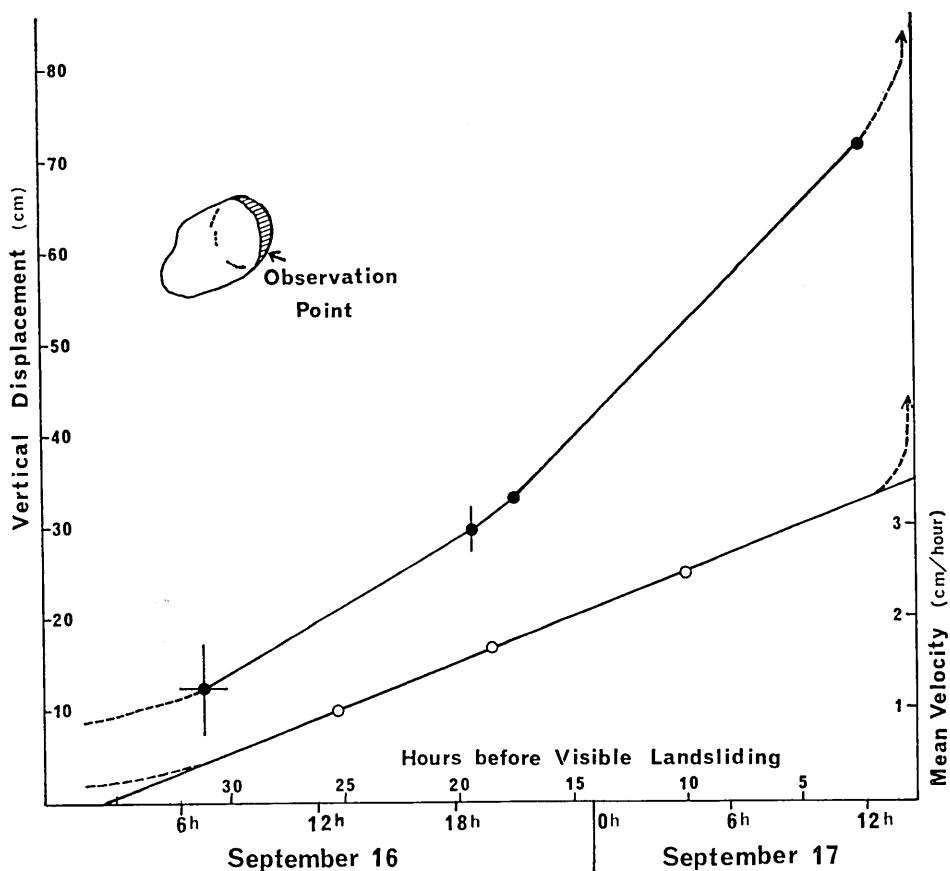
Fig. 9. Vertical components of displacement and mean velocity of the sliding mass prior to visible landslide at Makiuchi, observed at a southeastern margin of the collapsed area.

slide, at least near the observation point, would be divided into three stages; the 1st stage of small but increasing acceleration, 2nd stage of small constant acceleration, and the 3rd one of catastrophe.

The lower curve of the same figure shows *time-mean velocity relation* derived from the upper curve. Three open circles plotted on the lower curve lie on a linear line. This fact means the constant acceleration of observed displacement and the constant resistance against sliding:

During visible landslide, the mean velocity must have been greater than that linearly extrapolated and would have changed something like the dotted curve. This means that the resistance against sliding dropped just before the visible sliding.

If the velocity line is linearly extrapolated into the period before measurements, it becomes zero in the morning of the 16th. Actually, however, cracking started in the morning of the 15th, indicating that the velocity was not zero in the morning of the 16th. This is expressed by another dotted line on the left. In this first stage, resistance against sliding must have been greater but decreasing.

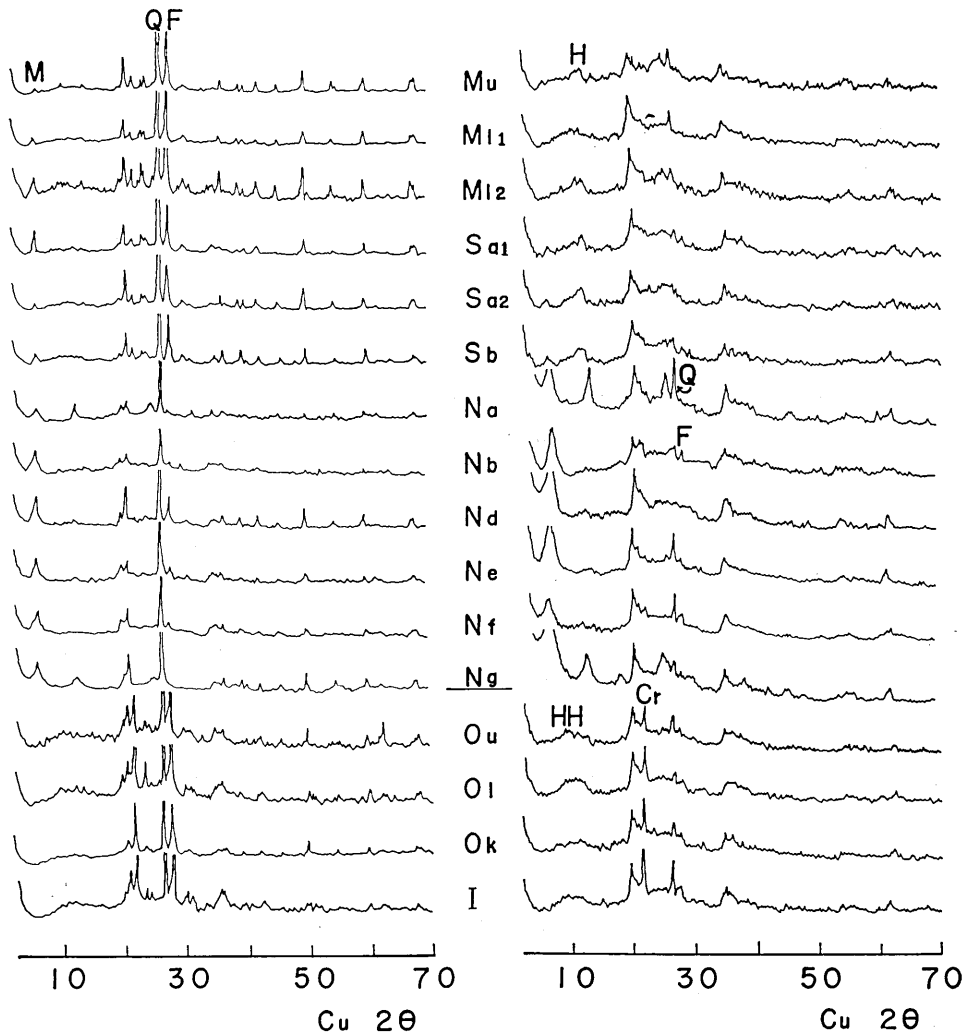
Fig. 11. X-ray diffraction patterns of the specimens collected from slid areas and from alluvial fan deposits. Localities are shown in Fig. 2. The lower four below the line in the centre of the figure are specimens collected from alluvial fan deposits and the rest above the line from slid areas. Refraction patterns of bulk composition and those of decantated finer portion ($<2\mu$) are given on the left- and right-hand respectively.

mass in these slid areas. Formation of montmorillonite is not expected by means of mere weathering process from the surface, but can only be possible in a deeper place where alteration advances without sufficient supply of oxygen¹⁰). This genetic condition of montmorillonite is quite compatible with the occurrence of the present landslides on the slopes of deeply weathered basal rocks.
