23. *On the Damage to Buildings and Other Structures
during the Earthquake of January 23, 1966
in the Vicinity of Matsushiro.*

By Yutaka OSAWA,

Earthquake Research Institute.

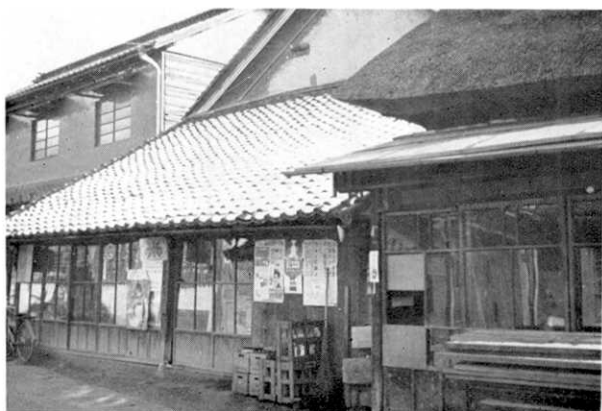
The writer inspected the inclined houses which are the stores located at the shopping center of Matsushiro. It was observed that they inclined at about four degrees in the direction of the main street towards which each house was facing. Figs. 1 and 2 show one of these houses which is a two-story wood frame structure with heavy roof tile and is estimated to be more than 50 years old. The lateral resisting elements of the structure could not be found except a very small amount of stucco wall in the direction parallel to the main street to which the house inclined.

Fig. 1. Front view of a damaged house in Matsushiro.

before the earthquake swarm the house inclined at about one degree and a half. From these results it can be said that this house had an initial inclination before the earthquake swarm started and the amount of inclination increased due to the earthquake swarm having the intensity of IV or III, and then increased again due to the earthquake of January 23. It seems this situation is similar to other damaged houses.

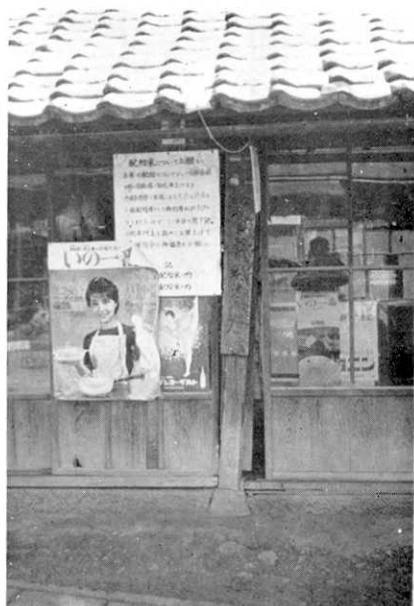
Fig. 2. Close-up of the entrance of the house shown in Fig. 1.
