52. *On the Damage to Window Glass in Reinforced
Concrete Buildings during the Earthquake
of April 20, 1965.*

By Yutaka OSAWA, Toshizo MORISHITA
and Masaya MURAKAMI,

Earthquake Research Institute.

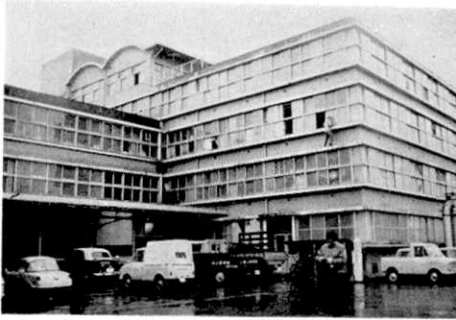
From the estimated deflection and the observation of damage, the cause of damage to window glass in each building will be discussed below.
Shida Hospital—It can be said from the measured period that the frame of this building is not flexible, and twisting would not easily occur because of well balanced wall arrangement. The estimated displacement is only about 0.5 cm and the damage might have been avoided if a small clearance existed between window glass and steel sash. Actually the putty which fixes the glass in the sash was hardened excessively, and this must be the main reason of the glass failure.

Fig. 4. Broken window glass is being repaired in Shida Hospital. (by courtesy of Mr. M. Shibano)

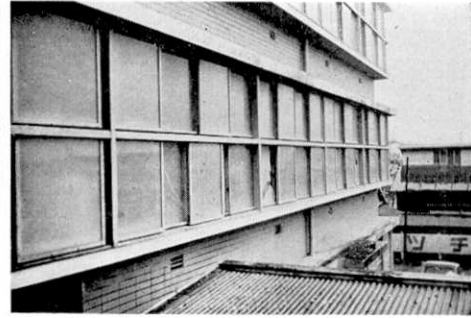
Fig. 5. Close-up of window glass in Shida Hospital. (by courtesy of Mr. M. Shibano)

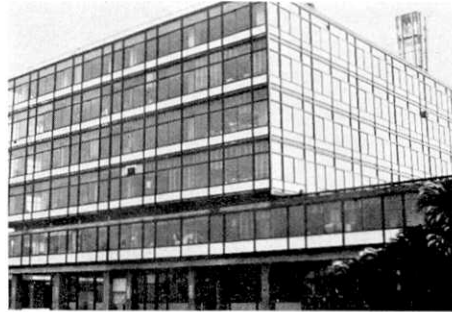
Shimizu City Hall—The estimated displacements in the old building are 1.0 to 2.0 cm. This is larger than that in Shida hospital, but still is not large enough to expect such a large percentage of damage in ordinary glass with some clearance between glass and sash. In the new building the estimated displacements are 1.1 to 2.3 cm which are larger than those in the old building, but there was almost no glass damaged by this earthquake. This difference in the degree of damage must be attributed to the difference in the degree of hardening of the putty, because the putty in the new building was observed to be still soft.

Fig. 6. Outside view of Shimizu City Hall after repairing the broken glass.

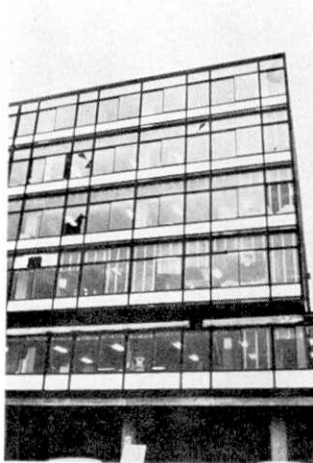
Fig. 7. Front view of old building of Shimizu City Hall. (by courtesy of Mr. M. Shibano)

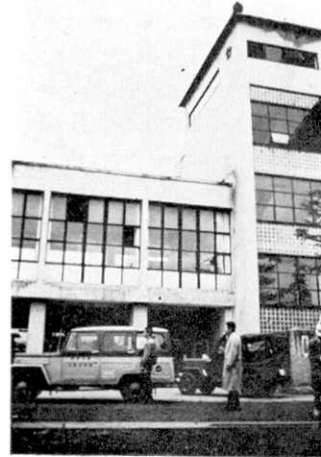
Ihara Middle School—The estimated displacement is almost the same as that in the Shida hospital. The reason of the glass failure is also attributed to the hardening of putty.

Fig. 8. Front view of Ihara Middle School in Shimizu City. (by courtesy of Mr. T. Matsuda)
