### 31. *Field Studies of the Kita Mino Earthquake on August 19, 1961.*

By Fuyuhiko KISHINOUE and Isao ONDA,

Earthquake Research Institute.

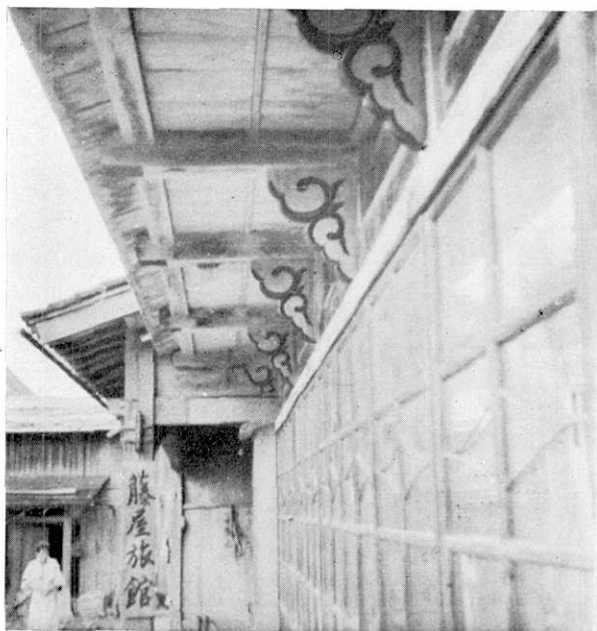
One house completely collapsed under an earth flow at Koike, but many houses in the seismic area are built so rigidly (Fig. 1) that damage to the houses was small. The piteous loss of life was rather more:—8 killed, and 36 injured. The unfortunate loss was due to rock-falls which fell on men as they moved about.

Fig. 1. Rigid structure of a wooden house at Itoshiro.

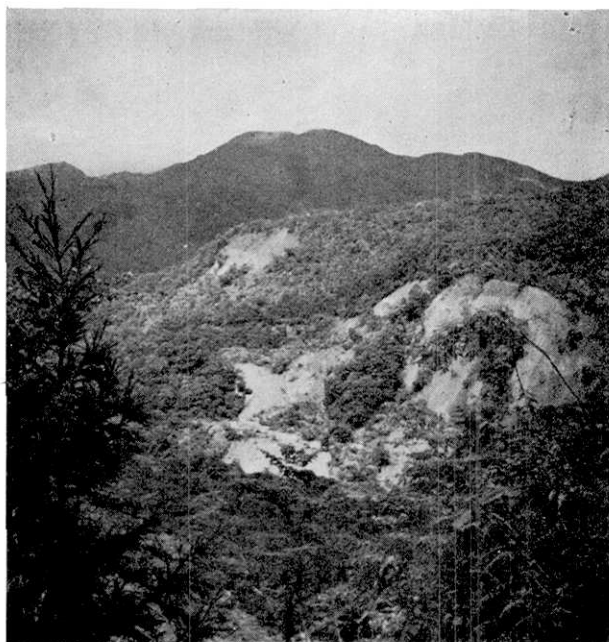
The loss of life in this case was unfortunately caused by rock-falls on mountain climbers, and other damage caused by the earthquake was also mostly due to rock-falls, and landslides, or in this case the sliding down of superficial soils and fragments of rocks (Fig. 3). Places where rock-falls and landslides occurred are shown in Fig. 4.

Thin piled layers of cracked volcanic rock, agglomerate and soil are cut out by the rivers and form such steep cliffs that they overhang locally. In such conditions, rock-falls are liable to take place when earthquake motion is strong. The area of rock-falls was roughly in a circle with the radius of about 10 km. This dimension was nearly equal to the area where there was a shifting of gravestones as mentioned below.

Fig. 3. Landslide and rock-fall at teh western side of Mt. Gankyōji from Koike.

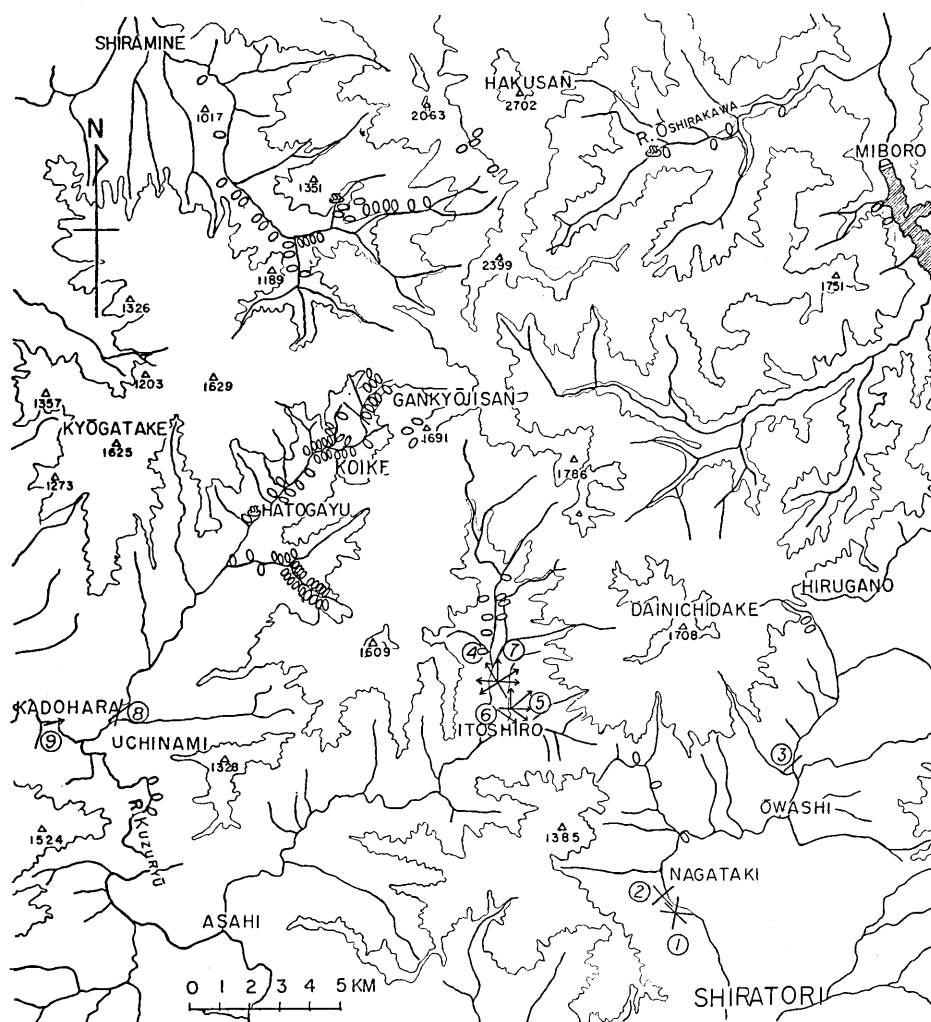
Fig. 4. Rock-falls, landslides (in oblong circle) and displacements of gravestones (in arrow).

第 4 図は筆者らの踏査したもののほか, ほかから聞いたもののうち確定できたものは加えてある。しかし, あまり小さなものは省略してある。この分布を見ると, 約 20 km の直径の円内に入り, 墓石や石碑の移動とはほぼ同じ範囲となつている。地質との関係は別に述べられるであろう。

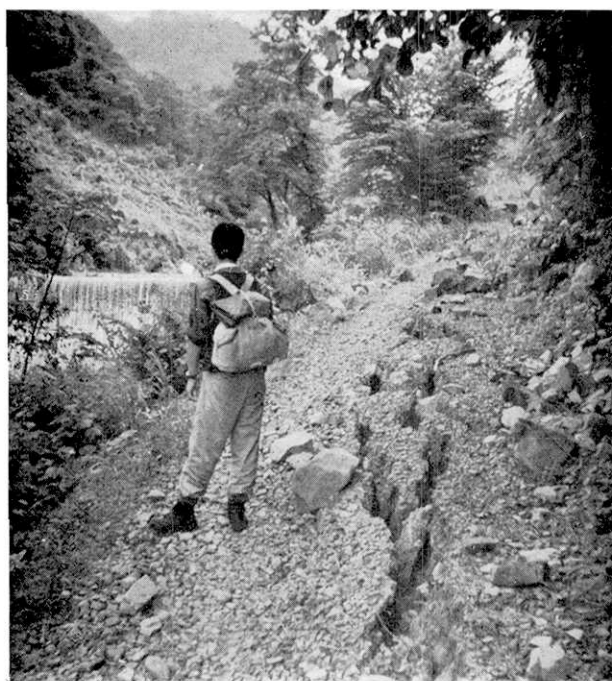
Many roads follow the rivers in this region. The surface of the roads was levelled by cutting into the mountain side in some places and raising the level along the river banks (Fig. 5). In June of this year heavy rains fell in this region, and flood waters tore the earth from the sides of the river banks. Then at many places the roads were unstable when the earthquake took place. The soil fell in at the cuttings

and earth fissures opened parallel to the river.

Fig. 5. Fissure on road and rock-falls on the opposite side of the river between Hatogayu and Koike.

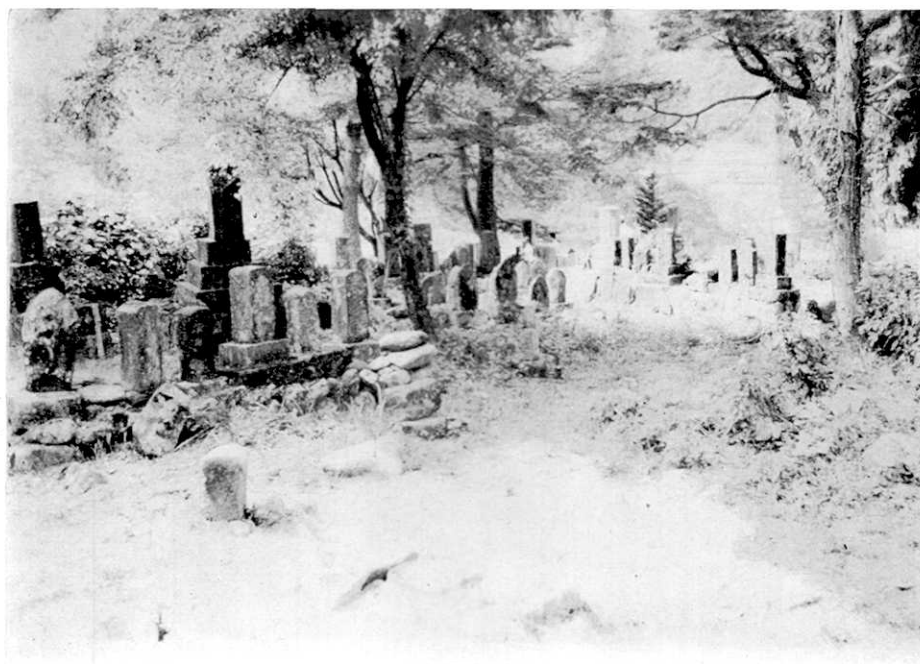
of the earthquake might have been shallow. The rotation of gravestones was thought to be rather more numerous than actual overturning. The writers consider that the ground is hard and the amplitude of the earthquake motion was not sufficiently large to overturn the gravestones but only to rotate them. (Figs. 6 and 7).

Fig. 6. Gravestones at Nagataki, Shiratori.

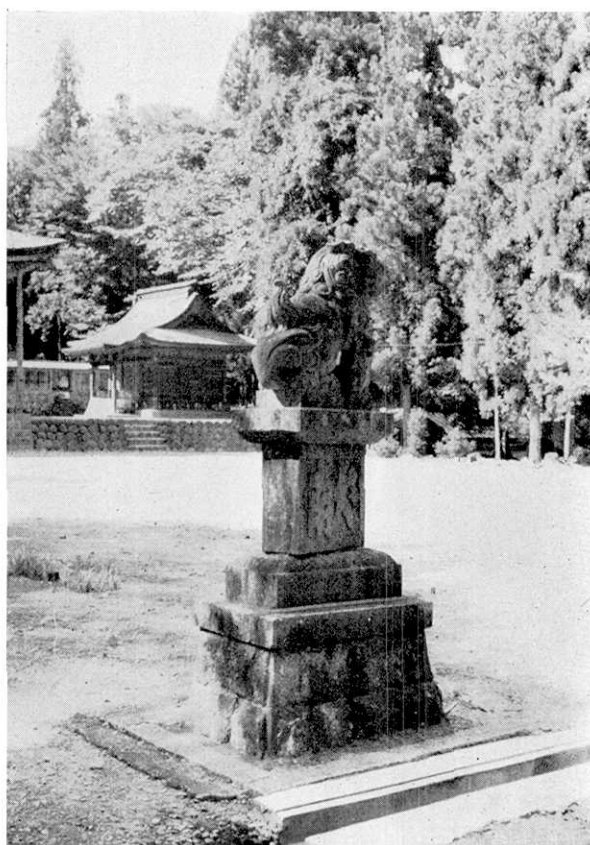
Fig. 7. Rotation of Komainu at Hakusan Shrine, Shiratori.
