## 24. *Vibration Tests of Defective Buildings.*

By Nobuji NASU,

Earthquake Research Institute.

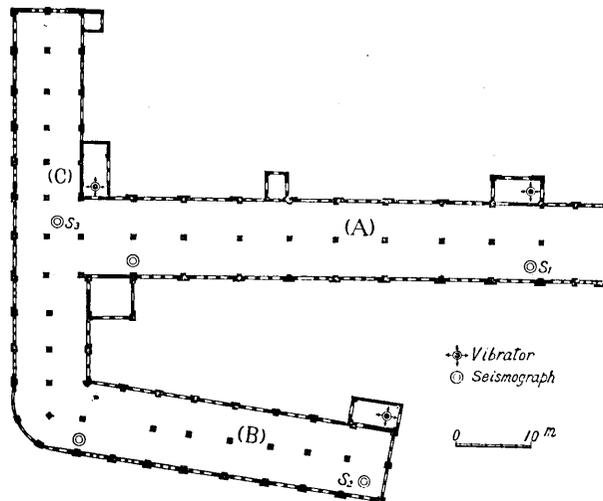
Fig. 1.

(1) A reinforced concrete building of three stories which was reported<sup>1)</sup> to be considerably damaged in the Kwanto earthquake of 1923, was tested (Fig. 1). The vibrator and the seismographs were installed in the places as

shown in this figure. In the transverse direction, three parts of the building (A), (B) and (C) showed a resonance with different periods, that is, 0.41 sec. at  $S_1$ , 0.39 sec. at  $S_2$  and 0.26 sec. at  $S_3$ . In the longitudinal direction, 0.16 sec., 0.30 sec. and 0.22 sec, were the resonance-periods on these points respectively. Thus, we see that the three parts of this building have periods different from each other. The deflections in the transverse and the longitudinal directions are shown in Fig. 2. A noteworthy fact is that the deflection of Part-(B) is particularly large as compared with those of (A) and (C), especially in the transverse direction. The curve in this case is similar to that of the column hinged at the base. This indicates that some of the columns in part-(B) are defective. Actually, the failure of the columns near the end of (B) was found after the 1923 earthquake and these damaged columns were repaired, but this repair-work is not effective at present. For these columns further improvements are being made so as to increase the area of the cross-section and joint the separate footings so as to form of a continuous footing.

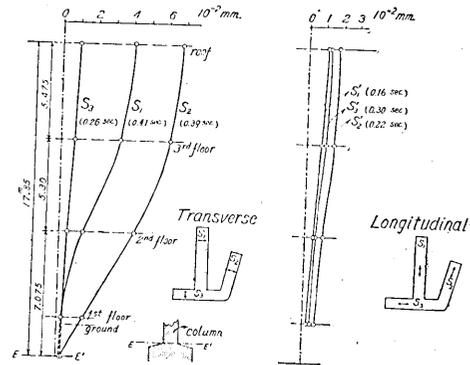
Fig. 2. Deflection.

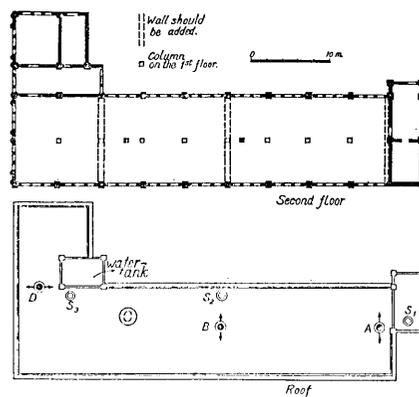
(2) A reinforced two-storeyed building (Fig. 3) which was burnt by fire in 1923 and 1945 was tested. Although the columns and walls on the second floor have been temporarily repaired for the present, they are not strong enough to resist a violent shock, because large cracks are still seen in them. Moreover, no repair-work has been done on the first storey. The plan of this building and the stiffness is not symmetrical; perhaps less stiffer in the middle and strongest near the water tank. The building will rotate about an axis lying near this strongest

a hinged end. This gives a warning against the danger of collapsing in case of an earthquake. All columns and walls must be repaired and at least three partition-walls of reinforced concrete must be added in the positions as shown in Fig. 3.

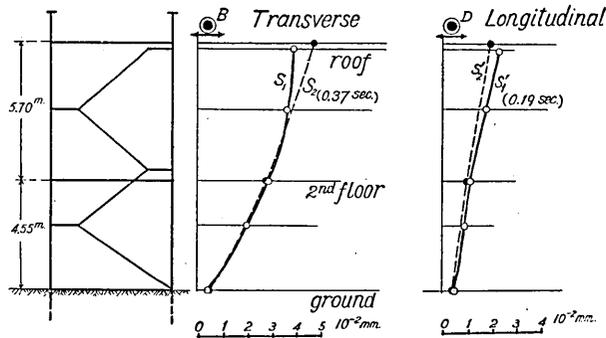
When this building was shaken at B by the vibrator in the transverse direction, a resonance occurred with a period of 0.37 sec. The largest amplitude was naturally in the middle of the roof of the building. As in the previous example, the deflection curves, in Fig. 5 was similar to that of the column with

Fig. 5. Deflections.

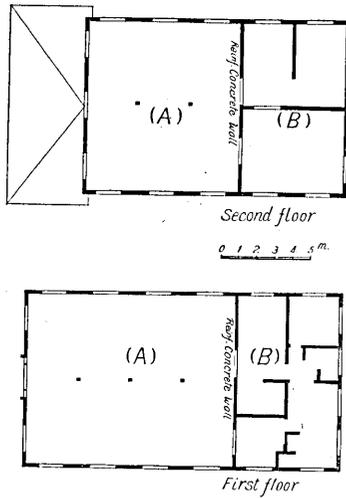
Fig. 6.

(3) The third example is a wooden building of two stories which was recently completed. The plan of this building (Fig. 6) is rectangular, being divided into two parts, (A) and (B), by a reinforced concrete wall. In (A) no partition wall existed, whereas in (B) there were several partitions and the sizes of the room were small. Hence there must be some unbalance of stiffness between (A) and (B).

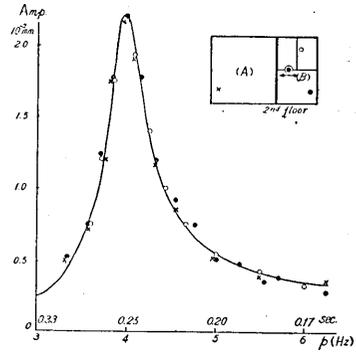
When the building was shaken in a direction perpendicular to the concrete wall, all parts of the second floor moved as a unit. This proves that the wall is effective for the vibration normal to the wall. The response curve is shown

Fig. 7. Response curve,  
 $p$  = frequency,  
 Amp. = amplitude.

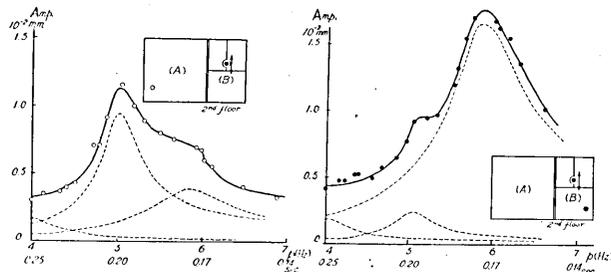
Fig. 8. Response curves of (A) (left) and (B) (right).

left for (A), right for (B)) are not simple in this case, because of the relative motion of (A) and (B). This will cause the failure of the parts near the concrete wall when the shock becomes large. Further, the motion of (A) is restricted on one side by this wall and the amplitude is always larger at the other end than near the wall like a cantilever. A comparison showed that on the second floor the ratio of the amplitudes at 8 m. and 1 m. from the wall was 4.0 : 1. Fig. 9 shows the resonance curve at 1 m. In this case, the vibrator was installed in (A). Thus, the left end of this building vibrates with a larger amplitude than any other parts, and the end must be supported obliquely by

stays extending from the roof down to the ground.

Further, the ends of the beams of (A) and (B) should be jointed rigidly, for example, by means of metal-ties and bolts.

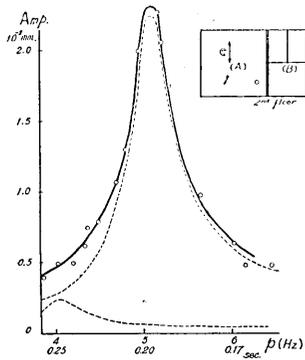
Fig. 9. Response curve of (A).
