41. 昭和14年5月1日男鹿島 地震の地變に就て

地震研究所 { 宮 部 直 巳
武 井 柳 吉

41. *The Deformation of the Earth's Surface that accompanied
the Ogasima Earthquake of May 1, 1939.*

By Naomi MIYABE and Ryukiti TAKEI,

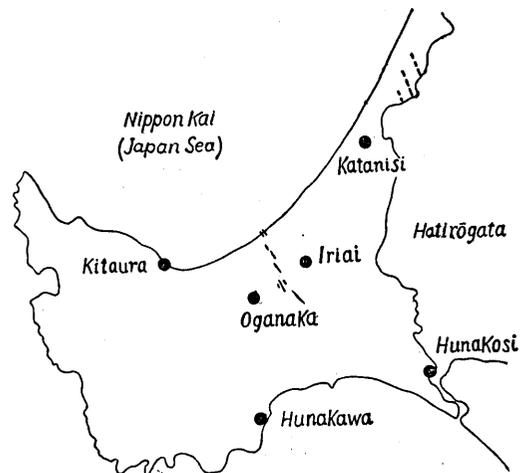
第1圖 昭和13年5月1日男鹿島地震の際の龜裂分布

潟西村における地表面の龜裂は、八郎潟の西北隅で、八郎潟と日本海とを分つ狭長な地域の砂地に生じたものである。その場所は、第1圖に示してある。

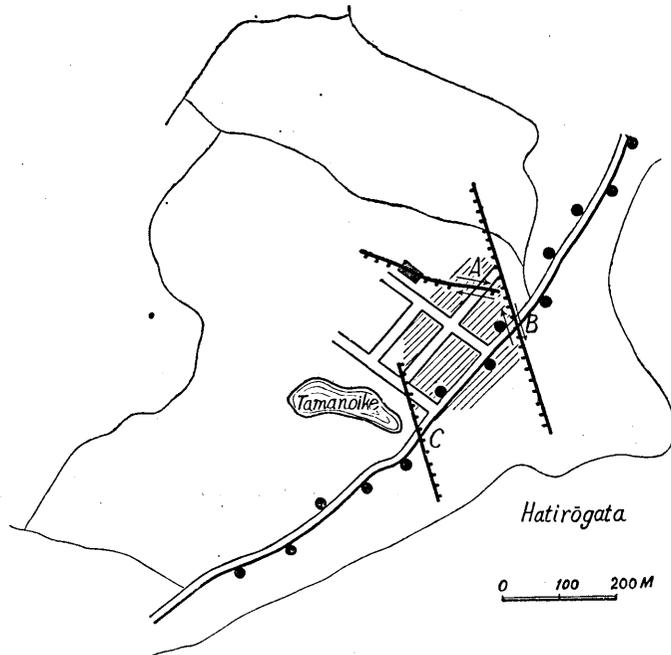
第 2 圖 玉の池附近の龜裂と配置

この潟西村における龜裂分布は更に擴大して第2圖に示した³⁾。

この圖中、龜裂に囲まれた地域で陰影を施した部分は、腐植土を含む地下水や砂を噴出した地域である。

龜裂に沿つて若干の水平方向の喰違を生じたことが看取される。而も第2圖中、A、B、の2個所に於いては之をある程度まで精密に測定することが出来る⁴⁾。即ちA

に於いては、開懇地部落内の直線道路に沿つて建てられた數個の電柱が、地震前に一直線上に並んでゐたものが地震後一直線上にはなくなつたといふことによつて水平移動が認められ、又Bの點に於いて道路の喰違が道路そのものの曲りから見當をつけることが出来る。是等の地點に於いては、變動以前における變動後の地點の位置を大體知ることが出来るので、これに據つて水平移動量を測定することが出来る。測定した相對的水平移動量は、

地點 A に於いて	3.9 m
地點 B に於いて	1.3 m

次に問題となることは如何にして斯様な龜裂が生じたかといふことである。この場所に斷層運動があつたと言つてもよいかもしれないが、併し、この潟西村の龜裂状態や被害状態から推して、從來、丹後、伊豆等の地震の際に認められた斷層運動と同一視することは困難のやうに思はれる。尤も小規模の斷層運動であるとするは必ずしも不可ではないかもしれない。一方から見れば、龜裂にかこまれた——第 2 圖で陰影を施した——部分が幾分か滑落したと考へることも出来る。併し、それも單純な滑落ではないやうである。何故ならば、龜裂を生じた場所は砂地であるが、その表面の傾斜は極めて小さく、些少の震動によつて滑落する様な不安定な状態にあつたとは思はれない。且つ滑落の方向と地表面の傾斜とは必ずしも一致しないやうである。

是等の事實から見て、第 2 圖上で陰影を施した部分は、以前には玉の池に續く沼地又は少くとも濕地であつたのではないであらうか。而して其處に生ひ茂つてゐた草が砂に埋められて現在の平地が出来てゐるとすれば、砂層の下部に炭化した植物のあること、地下水位の高いこと等容易に諒解し得る。又若しさうだとすれば、震動によつて表面砂層の下部が流動性を帯びることが豫想され、従つて下部の流動性物質の移動に伴つて地表面に不規則的な變形を生ずる可能性も考へられる。さうでなければ、單一な滑落現象としては、第一に水平方向の相對的移動の向きが説明し得ない。

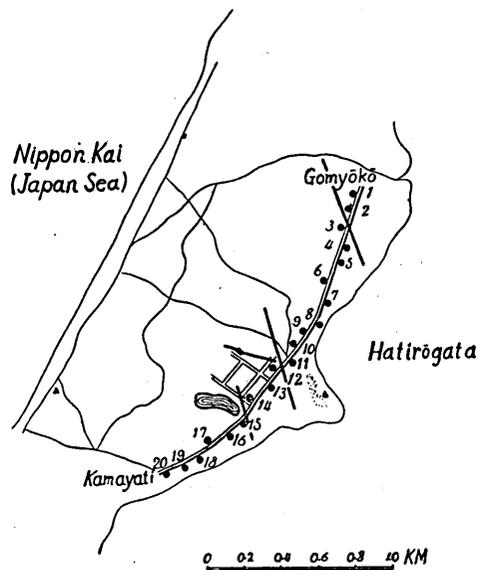
第 5 圖 五明光—釜谷地間水準點の分布 (數字は水準點番號)

そこで、吾々は、五明光、釜谷地間約3kmの間に精密水準測量を施行することにした。先づ、この區間に20個の水準點を埋設した。水準點は、約4寸角、長さ1尺位のコンクリートのブロックで、頂部に鐵リベットを埋めてある。是等の水準點の間隔は100m乃至200mである。その配置は、第5圖に示してある。

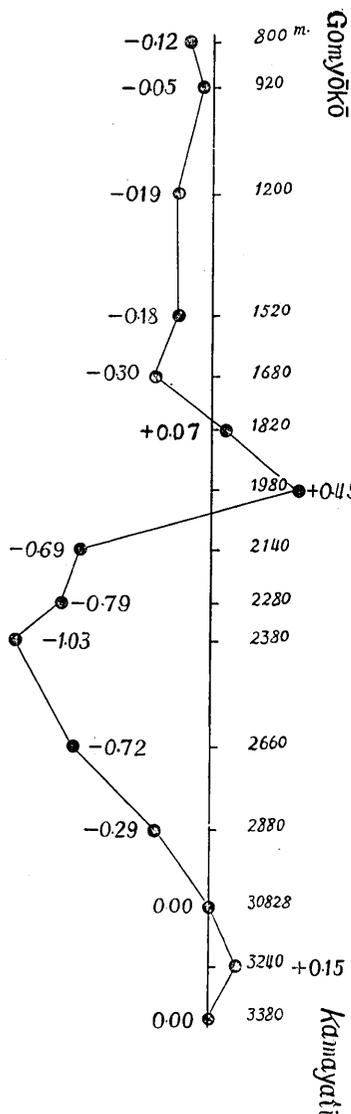
第 6 圖 五明光一釜谷地間縣道沿線の垂直變動 (符號の付いた數字は變動量を示す、單位は m) (The numerals with signs denote the amounts of vertical displacements and the numerals without signs denote the horizontal distances.)

斯様にして測定された縣道に沿うての變動の有様は第6圖に示されてゐる。但し、この變動量は、釜谷地附近における地盤高は地震前後で變化しないといふ假定の下に算出されたものである。

この程度の誤差を考慮しつゝ再び第 6 圖を見れば、釜谷地附近の變動を 0 とした時玉の池附近で著しく下り、之を越えた處で一度稍々上昇した後、五明光附近では又大略元に戻つてゐる。このことは、變動が、極めて狭い地域に限られてゐることゝ、前後 2 回の高さの測定値が 10 cm 内外の精度で相當信頼し得ることを示すものと思はれる。尙、吾々の測量における往復の差異は 5.0 mm であつて、測量部規定の一等水準測量の精度よりは稍々悪い程度である。

この測量の結果は第 6 圖に示されてゐる通り、玉の池附近の B, C の 2 個の龜裂に圍まれた地域の沈下が著しく、その量は最大約 1 m に及んでゐる。又この場所では、地下から土砂と、黒く濁り且惡臭を持つた水とが噴出したことは前述の通りである。

以上の通り、この地震の際に地下から土砂と水とを噴出した現象は、その地域が周圍に比して著しく沈下したといふ事と關聯してゐるといふ事實が、相當程度の明瞭さを以て言へる。

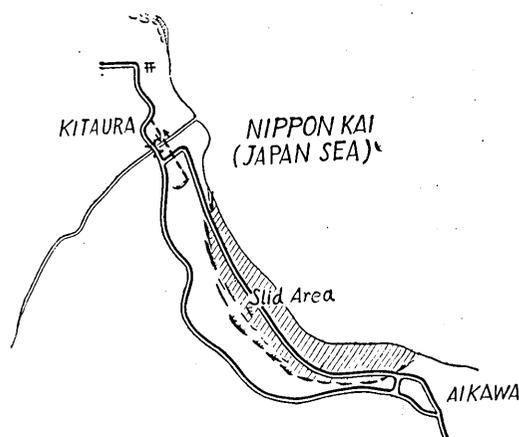
第 8 圖 北浦町附近地氾地域略圖

地辻地域の大略の圖は第8圖に示してあるが、茲に一寸注意されるのは、同圖に點線で示した線である。この線上にある家屋は何れも多少損害を被つてゐる。そして尙この線が北浦町を略東西に流れる小川を過るところでは、川の兩岸に明瞭な龜裂があり、且つこの龜裂に沿うて水平の相對的移動がある。その移動量は約30 cmである。而して東側が北へ移動してゐる。垂直方向の變動は認められない。併し、この裂線は地辻地域の北端から3~400 mの間追跡されるに過ぎない。第9圖の寫眞は、第8圖に點線で示した裂線が小川を過る處で、その兩岸に現はれた龜裂を示したものである。

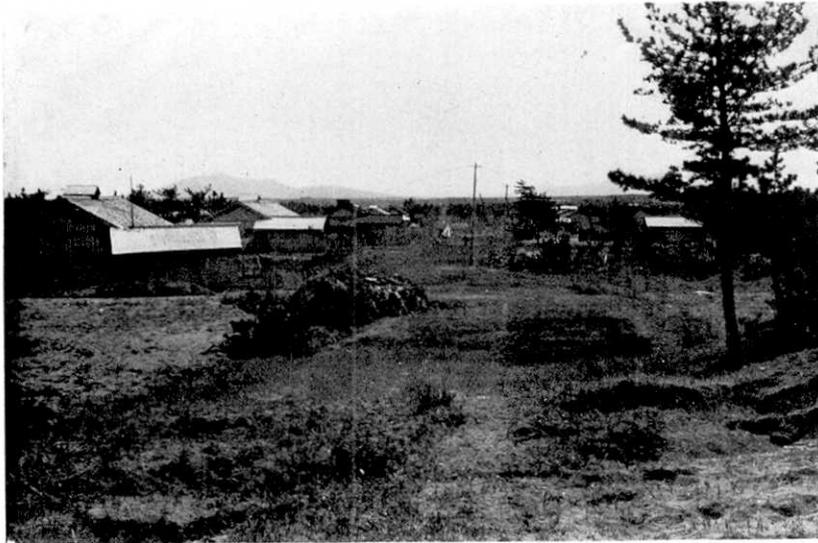
第 3 圖 潟西村に於ける地變 (地震前眞直であつた道路の曲り)

Along the cracks, horizontal dislocations were noticed. At a point denoted by A in Fig. 2, the horizontal displacement was indicated by the displacement of a pole. At another point B in Fig. 2, the horizontal displacement was indicated by a new curve in a previously straight prefectural road.

Fig. 3. Deformation in Katanisi-mura,
(The road was strait before the earthquake.)

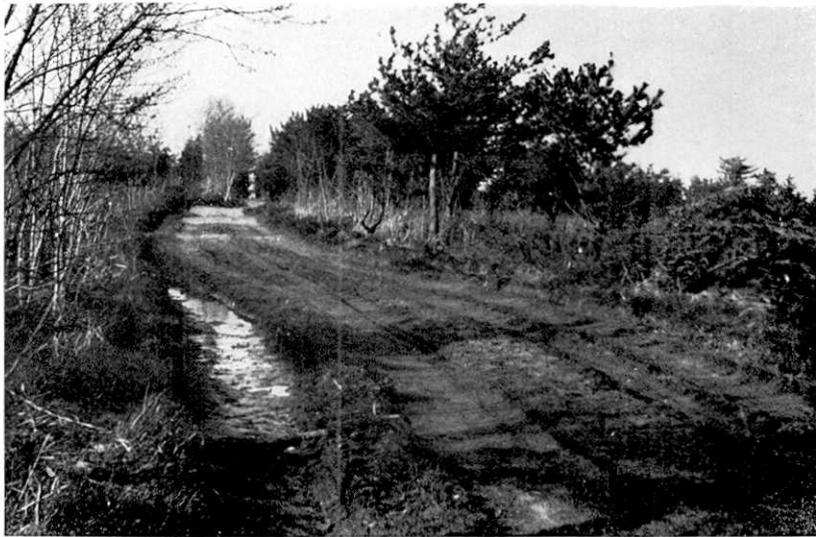
第 4 圖 潟西村に於ける地變 (地震前眞直であつた道路の曲り)

Fig. 4. Deformation in Katanisi-mura,
(The road was strait before the earthquake.)

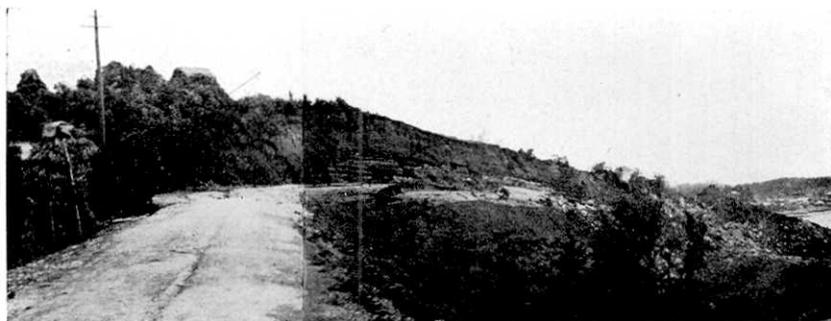
北浦町に於いては、既述の如き地氾があつた。この地氾地域の邊縁は延長 1 km に及んでゐる。地氾地域の有様の一部は第 7 圖の寫眞に示してある。

この地氾を生じた地域の、全體として滑り面に沿うて移動した量は比較的小さい様である。地氾地域の邊縁部で、その移動量と思はれる、氾つた土地と氾らない土地との間に生じてゐる喰違ひは數十種乃至 1 m 程度に過ぎない。但し、氾つた地域内では、多數の裂隙を生じて無數のブロックに分裂し、その各々のブロックが勝手な運動をして居る。又ある場所では更に微少な岩屑となつて海上に流出したものもある。又ある場合では隣接してゐるブロックが

水平に移動若しくは著しく傾斜し、空隙を生じて、その空隙に陥没したブロックもある。それ故、一見した所では、甚しく滑落したかに見える箇所もあるけれども、上述の様に、實際、全體として移動した量は比較的小さいのではないかと思はれる。北浦町における倒潰家屋は全部が、この地辻を生じた地域にあるので、地震動のみによつて破壊されたと明かに認められる家屋は全く無い様である。即ちその全潰家屋のすべてが地震に伴つた地辻によつて生じたものであると認められる。

第 7 圖 北浦町の地這 (南側より)
Fig. 7. Landslide at Kitaura-mati. (Photo from S.)
