Example of a Simple Brick Structure damaged by Earthquake.

F. OMORI, Sc. D.,

Member of the Imperial Earthquake Investigation Committee.

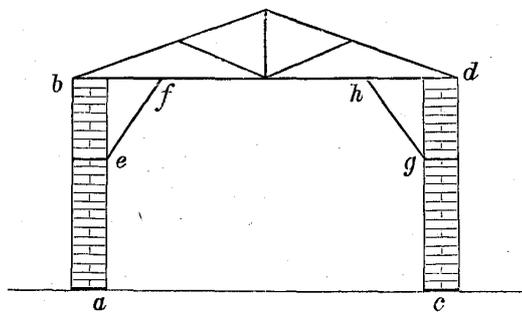
with wooden truss supported by 20 brick posts (*ab*, *cd* in the accompanying figure.) The building covered an area of 100 *tsubo*, and was 20 *ken* in length and 5 *ken* in width, the longer axis being parallel to the N-S

The seismic stability of the Ensuiko market-house, whose construction has been sketched above, is indicated by the acceleration (=a) of the earthquake motion, which is capable of fracturing the supporting columns at their weakest position, namely, the base. This can be calculated by the formula

The value of the acceleration *a* is found to be only 497 mm/sec². Such an intensity of motion is by no means that of what may

be called a "great destructive shock," but is not much different from the maximum acceleration at Hongo on the occasion of the semi-destructive Tokyo earthquake of June 20, 1894. Thus the seismic stability of the market-house under consideration will be seen to be very low. In order to make a structure in Formosa practically earthquake proof, we must raise its seismic stability to an acceleration of about 2,000 mm/sec².

As is to be easily imagined, all the posts of the market-house were fractured by the earthquake of Kagi of 1904 at their bases, each being also broken at or near the foot of the timber diagonal support (*ef* and *gh* in the figure.) It is hereby to be remarked that great care must be taken in the use of trusses and ties. The existence of even an apparently insignificant discontinuity, in the form and dimension, the rigidity, or the material, invariably produces a fracture or mutual destruction at the joints.
