25. *The Imaichi Earthquake of December 26th, 1949. General Description.*

By HIROSI KAWASUMI.

Earthquake Research Institute.

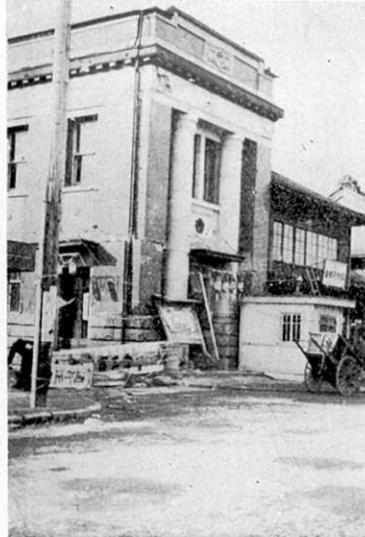
Fig. 4. Damage of houses at Imaichi Town.

b. Police station.

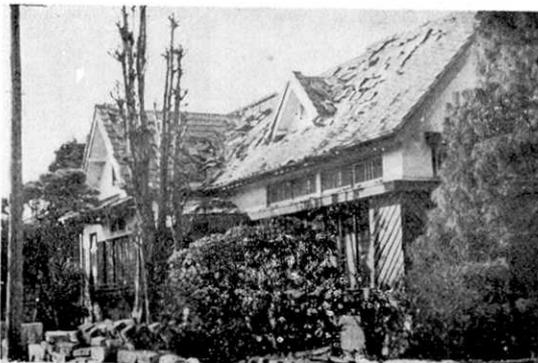
d. Wooden dwelling house.

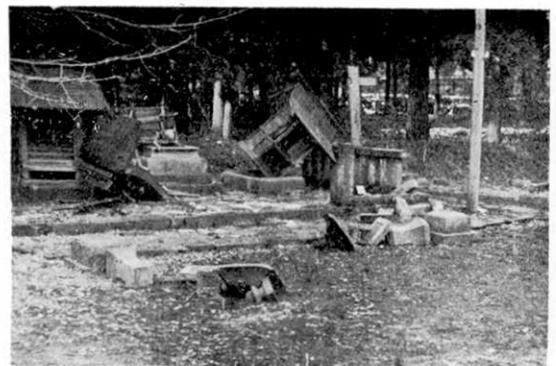
e. Subversion of smaller constructions at the Takinowo Shrine.

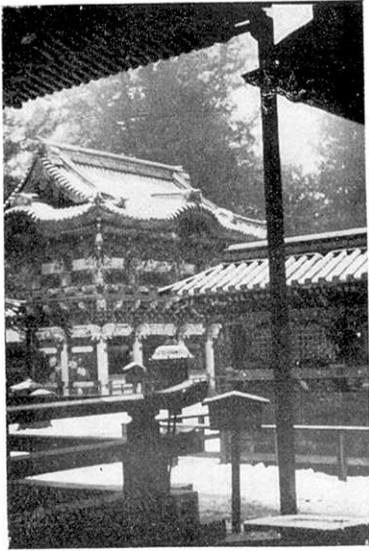
Fig. 5. Effect of Earthquake at Nikko. Wooden buildings suffered almost no damage.

a. The Yōmeimon (gate).

A word on the damage at Nikko may also be added for the sake of comparison with those of historical earthquakes. According to the authorities of the Tōshōgu and Futarasan shrines and the Rinnōji temple, the stone walls (520 sq. m.), stone fences (550 m.) and 2 stone stairs were badly shaken or shattered and 40 stone or bronze lanterns (tōrōs) were overturned, while the buildings in the shrines and the temple were scarcely damaged, although masonry buildings in the Town was badly shaken. It is also to be remarked that at the copper refinery plant at Kiyotaki, about 5 km. SW of Nikko, a brick chimney was broken down and a concrete chimney cracked badly.

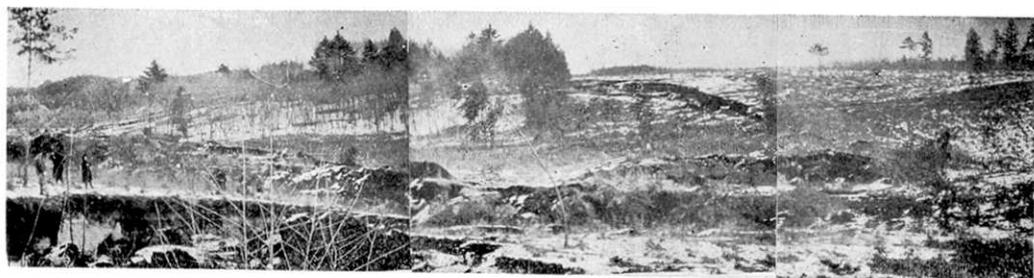
Fig. 6.

a. Low angle landslide at Tsuchizawa, Imaichi Town. Land before the crack fissure in the central part slid bodily with forest almost undisturbed. The ridge in the foreground is the result of upthrust at the margin of the slid land.

It is, therefore, no wonder that the fissures in the ground and landslides in the mountainous region within the disaster area were so severe as will be seen in the map to be presented by the writer and R. Morimoto in the following. But the writer, who had learned the landslides accompanied with the Calabrian earthquake of 1783 from Lyell's *Principle of Geology*, could really understand the severity of the landslides in Italy when he saw the large landslides at places where the slopes before the earthquake were as low as 7 or 8 degrees in the present earthquake district. (See Figs. 6, 7 & 8.)

The landslides in the present disaster area were greatly facilitated, on the other hand, by the existence of a very slippery stratum of much weathered white pumice which was ejected from the Nantai Volcano.

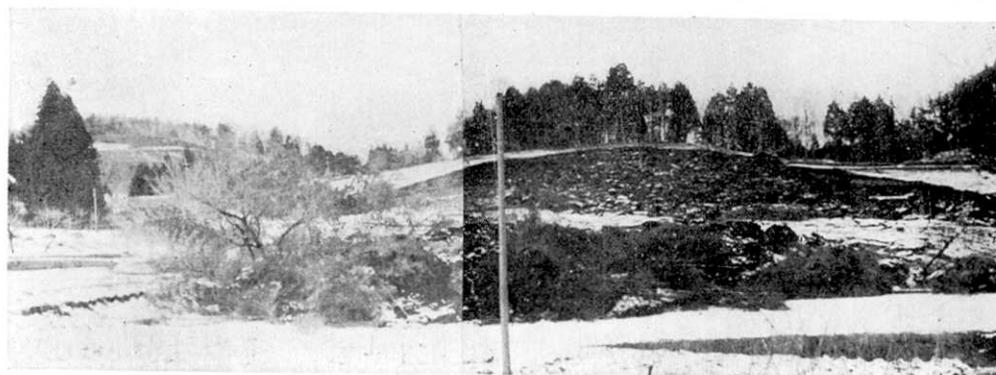
b. Low angle land slide at Numachi, Nikko Town (above), c. with temporary pond at the right margin. (left).

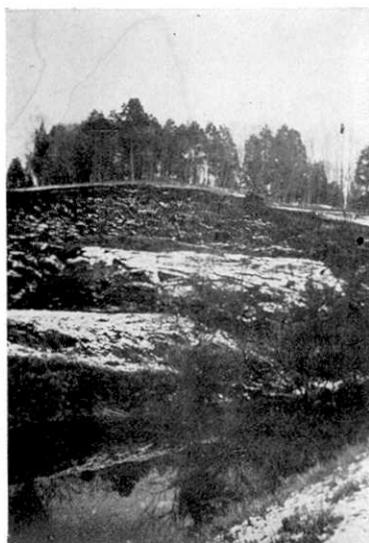
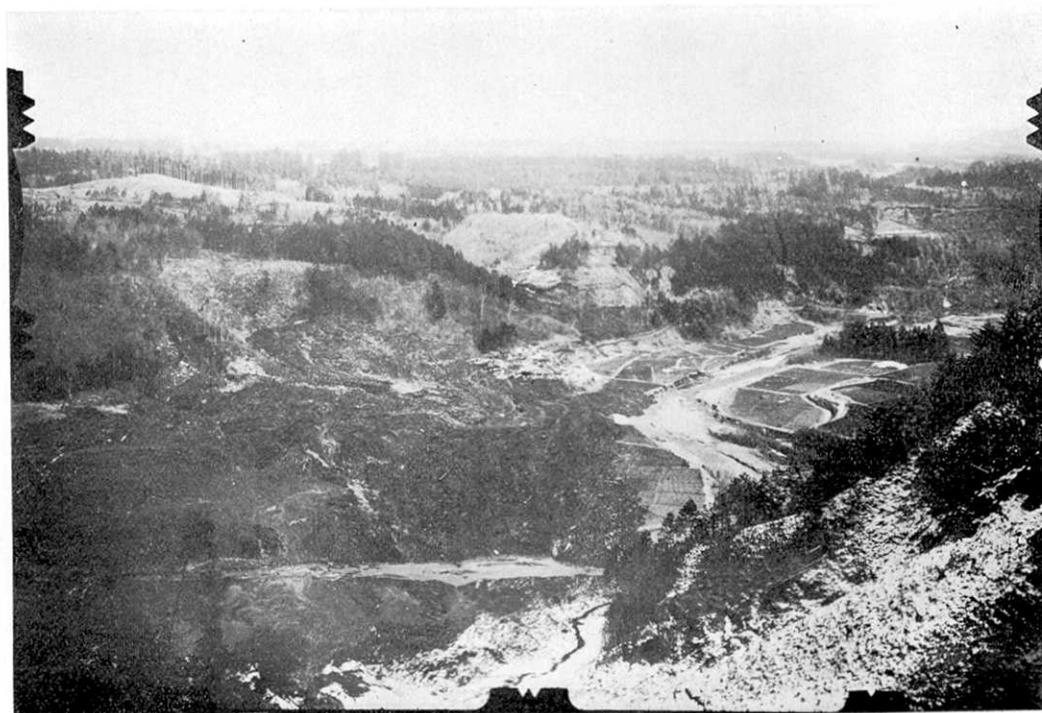
Fig. 7. a.

High angle landslide (a) and the debris flowed down from it and buried 2 houses and 4 men and 1 horse (b). Murose-Namekawa, Imaichi Town.

It is also to be remarked that even in the southern part of the epicentre where the slippery pumice layer was lacking, the landslides were also conspicuous at steep mountain sides, and at many places they turned into mud avalanches and destroyed houses and buried several persons to death at

several places. Indeed, most of lives lost and missing in the present earthquake were the result of these landslides. (cf. Figs. 7, 8.)

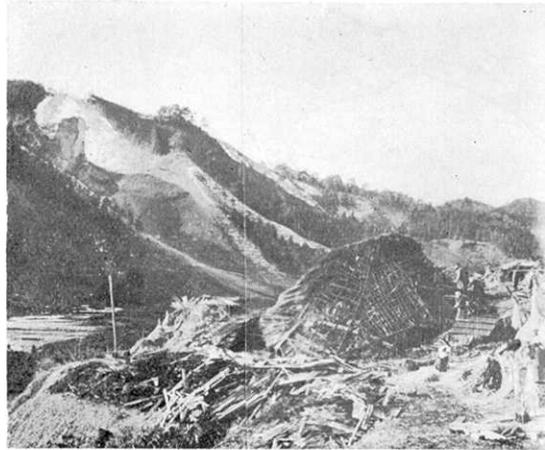
Fig. 7. c. The house pushed down and half buried by the mud flow. A horse was buried to death under the house. Stream line of the mud-avalanche is seen on the slope of the valley side in the background.

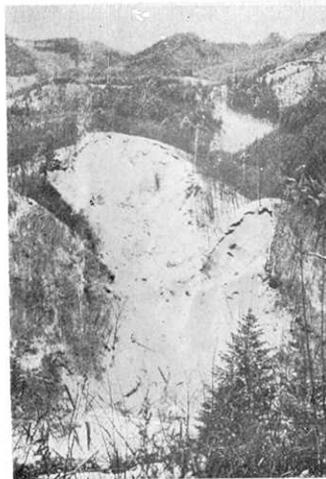
Fig. 8. a. High-angle landslide at Matsunokiuchi, Nikko Town.

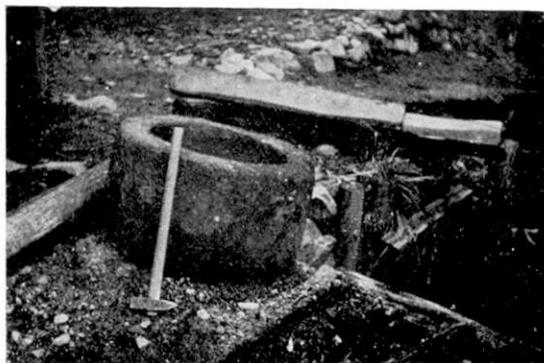
Fig. 9.

a. An "ishiusu", a stone implements for making rice cake, which was tossed some 20 cm several times like bounding rubber ball by the earthquake motion. At Nagahata, Ochiai Village.

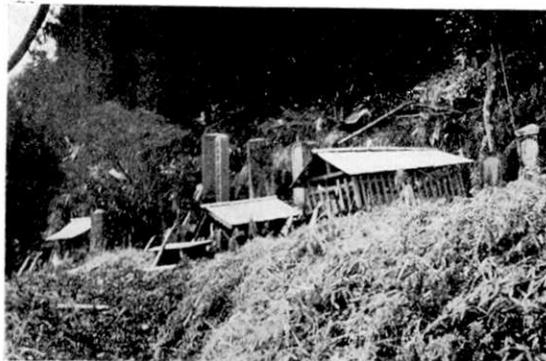
b. The tomb stone in the vicinity was disturbed but slightly.

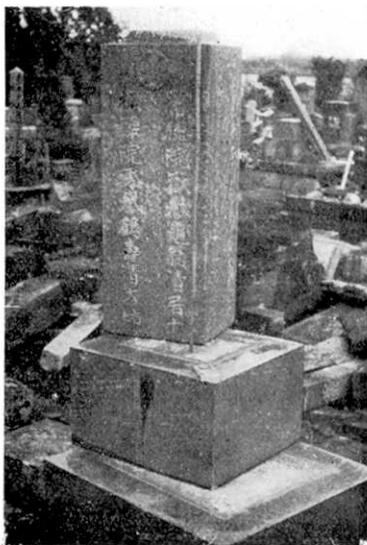
c. The tomb at the Imaichi Town was much disturbed and only very few tomb stones remains standing.

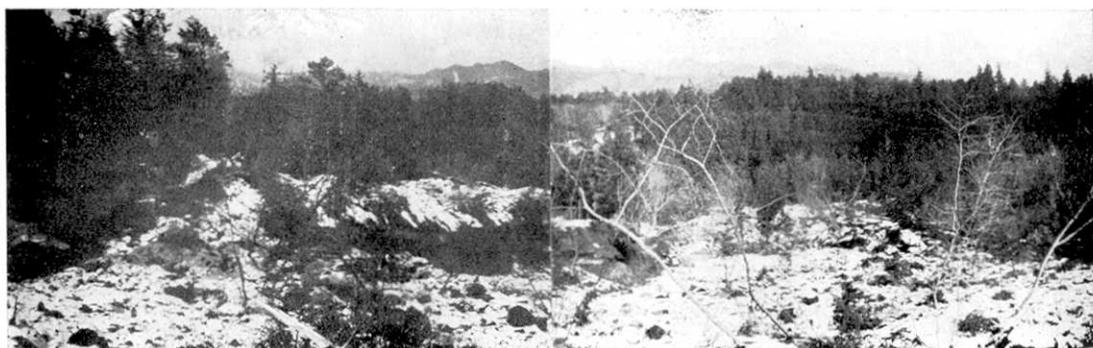
Fig. 10.

a. Devastation of a forrest at Yamakubo, Nikko Town.
