Changes in Modal Parameters and Performance of a Prestressed Concrete Bridge under Step-by-step Loading

Abstract: This study discusses a bridge collapse test under static loading on a real prestressed concrete (PSC) bridge. In the static loading test, step-by-step loading until failure were considered. Forced vibration test was also carried out along with the static loading test to investigate how changes in performance of the PSC bridge affect modal properties of the bridge. The structural performance feature that makes use of the potential energy and energy dissipation in each load step is calculated from load-displacement relation and is adopted to estimate the structural performance of the PC bridge. Observations showed that the 1st bending frequency was little connection to the structural performance feature. On the other hand, strong relationships between the 2nd bending modal frequency and the level of structural performance was observed. This demonstrates the usefulness of the 2nd bending mode in vibration-based bridge health monitoring for the PSC bridge.

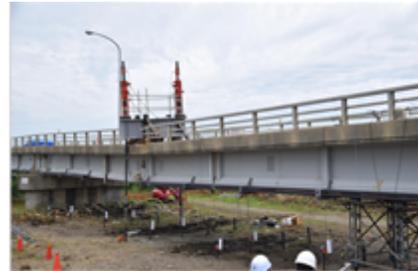
Figure 1. Target bridge.

The target bridge and static loading device are shown in Figs. 1 and 2. The bridge is a five-span simply supported PSC bridge with four main PSC girders. The length of each span is 35.6m and the width is 7.2m. 12 pairs of steel strand ($12\phi*7$) were utilized as a PS tendon for each girder. The bridge is about 170m away from the coast line and had been operated more than 50 years since its construction. Therefore, chloride attack to the main girder was significant, and cracks of the main girder caused by corrosion of the internal steel rebar and spalling of the concrete were observed by visual inspection. Figure 3 shows the damage location map of the bridge obtained from the periodic inspection before the experiment. Damage was distributed throughout the span, and exposure of the reinforcing bar due to concrete peeling was observed at three locations. Considering the inspection result, reduced load carrying capacity was expected.

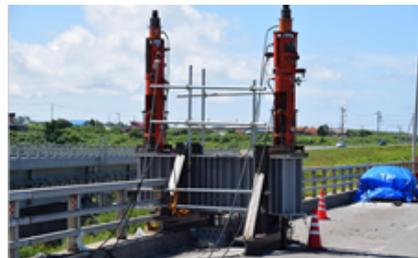
Figure 2. Loading device.

The static load test was carried out utilizing two 3000kN center hole type hydraulic jacks installed on the loading beam with a loading block. Fig. 2 shows the loading device installed on the PSC bridge. The load was applied statically and monotonously. As a reaction device for the static loading, two tendons having a loading capacity of 2500kN for each are anchored to the underground sandstone layer. The applying load was monitored by the load cell and the jack stroke was monitored during loading. The loading point was set at the span center of the G1 girder (see Fig. 2 and Fig. 4). Sensor deployment map is shown in Fig. 4. The vertical displacement of each observation point was measured by displacement transducers installed under the girder. Moreover, the longitudinal displacements at both ends of the G1 girder were also measured.

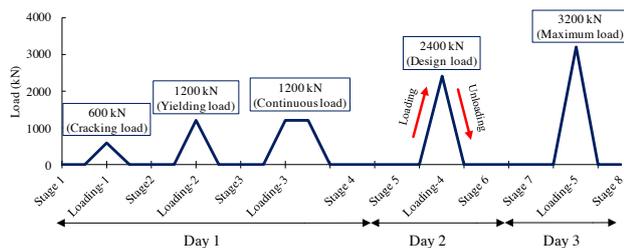
Figure 5. Static loading process and vibration test stages.

The static loading progress and vibration test stage are shown in Fig. 5 in which “Stage n ” indicates the time of the vibration test. The static loading and vibration tests were conducted over three days. Five stages of the static loading test (Loading-1 to Loading-5) until fracture of the guard rail were considered. Loading-1 is the scenario loaded up to 600kN which induces bending cracks to the main girder. Loading-2 is the scenario loaded up to 1200kN which is the yield load of the reinforcing bar (hereafter, rebar). In Loading-3, as with Loading-2, static load of 1200kN was applied again but the loading was kept for about two hours. Loading-4 is the scenario loaded up to 2400kN which is the failure load predicted in a preliminary structural analysis. Loading-5 is loaded up to

3200kN which leads to fracture of the guiderail. It is noted that the load resisting capacity of the PSC bridge was about 1.3 times larger than the analytical ones. The static loading test demonstrated that the damages and deterioration during the service period have hardly affected bending performance of the bridge.

An impact test utilizing a hammer was conducted under unloaded situation after each static loading (see Fig. 5) to examine changes in the dynamic properties of the bridge with different health conditions. As can be seen in Fig. 5, Stage 1 is the initial state before the static load test. Stage 2 is the unloaded state after Loading-1 (600kN), and Stage 3 is the unloaded state after Loading-2 (1200kN). Stage 4 is the unloaded state after Loading-3 which is the state of being loaded by 1200kN for about 2 hours. Stage 5 indicates the state that the bridge was left overnight after

Stage 4. Stage 6 is the unloaded state after Loading-4 (2400kN), and Stage 7 is the state when the bridge is left overnight after Stage 6. Finally, Stage 8 is the unloaded state of Loading-5 (3200kN).

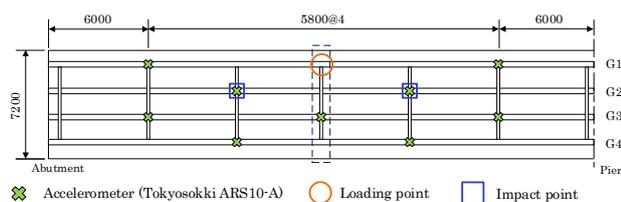
Figure 6. Location of impact points and accelerometers (Unit: mm).

The vibrations induced by the impact were measured utilizing strain gauge type accelerometers (ARS10-A, Tokyo Sokki). The location of accelerometers and hitting points are shown in Fig. 6. The total hitting times was 40 times per each stage.

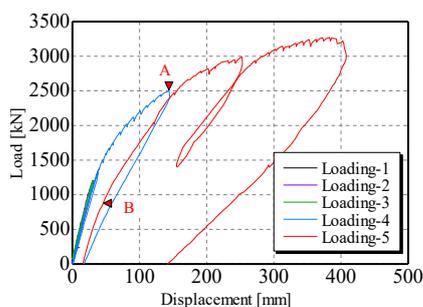
Figure 7. Load-vertical displacement curve (span center of G1 girder).

The load-vertical displacement curve observed at the span center of the G1 girder is shown in Fig. 7, in which no clear residual displacement is observed until Loading-3. It indicates that the bridge behavior was elastic until Loading-3. At Loading-4, the bridge was loaded up to 2500kN (designed failure load) and unloaded, this loading step resulted in the residual displacement of around 16mm. When the bridge is reloaded (Loading-5), the load-vertical displacement curve traces the unloading points (point A in Fig. 7), which indicates enough restoration performance. The gradient of reloading under Loading-5 is almost the same as that of the Loading-1 to Loading-4 until the tensile stress occurs at the lower edge of the PSC girder (point B in Fig. 7). This indicates that the prestressing force remains and makes the entire section keep effective. Therefore, it can be said that the vibration characteristics would be hardly changed as the initial stiffness keeps almost constant through Stage 1 to Stage 5. Relationships between structural performance and vibration characteristics are discussed in Section 4.4.

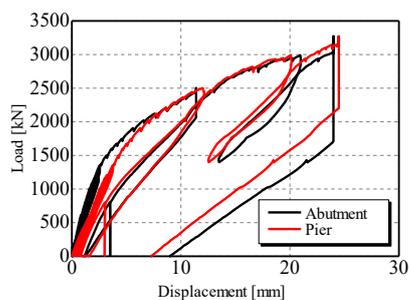
Figure 8. Load-longitudinal displacement curve (on pier and abutment of G1 girder).

The load-longitudinal displacement curves observed at the supports of the G1 girder are shown in Fig. 8. It shows that the longitudinal displacements at both sides differ at the lower loading level (smaller than 1500kN). While the displacements reached same level at the higher load level (greater than 2000kN). This indicates that the behaviours of supports vary according to the load level.

The horizontal springs were introduced to the bearings as the field test showed that both sides of the G1 girder moved in the longitudinal direction. The spring constants were estimated utilizing the measured longitudinal displacements. The bilinear horizontal springs and rotational spring were modeled in the FE model following the bi-linear behaviour of the longitudinal displacements. The spring constant of the rotational spring was decided 1.0×10^9 N/rad by a sensitivity analysis.

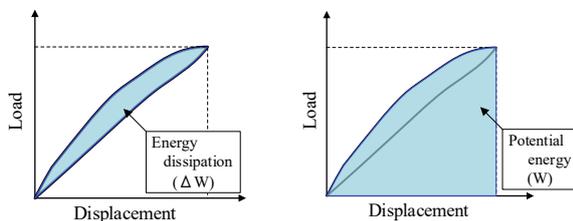
A structural performance feature is introduced to normalize bending performance of the PSC bridge. The structural performance feature is estimated utilizing the potential energy and energy dissipation in each load step of the static loading test. Eq. (1) shows the structural performance feature (hereafter, performance feature) at loading- n ($n = 1, 2, \dots, 5$) with function of the energy dissipation (ΔW) and the potential energy (W). The energy dissipation (ΔW) and the potential energy (W) are explained in Fig. 9.

$$Z = \left(1 - \frac{\Delta W}{W}\right) \times 100 (\%) \quad (1)$$

(a) Energy dissipation (b) Potential energy
 Figure 9. Energy dissipation and potential energy.

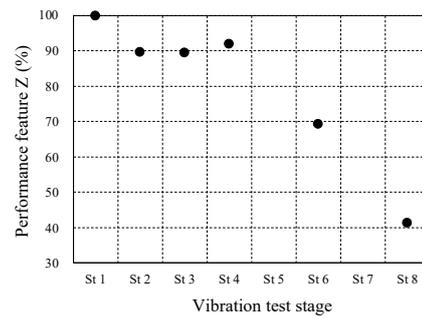
Figure 10. Change in performance feature.

When the PSC bridge behaves elastically and no damage occurs, the energy dissipation would be zero and the performance remains in 100%. On the contrary, if damage is introduced or the beam reaches its plastic range, the energy dissipation occurs, and the performance feature would show lower value than 100%. Fig. 10 shows the change in the performance with respect to each stage. It

can be seen that the performance feature Z has been drastically decreased when the static load reached cracking load (compare Z under st.1 and st. 2 in Fig. 10), design load (compare Z under st.4 and st. 6 in Fig. 10) and maximum load (compare Z under st.6 and st. 8 in Fig. 10).

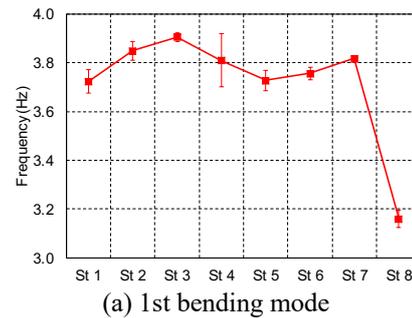
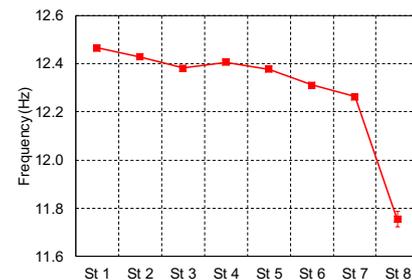
This study thus focuses on the identified frequency as a representative dynamic property. Changes in identified frequencies for the 1st and 2nd bending modes are plotted in Fig. 11, which shows that the frequency for the 2nd bending mode resulted in stronger relationship with structural integrity. Similar observations are reported in (Luna Vera et al. 2020). Changes in mode shapes are shown in Fig. 12, but it was hard to observe a pattern. Moreover, the change in MAC values are too small to be utilized in damage detection except for the failure state.

Figure 11. Change in bending modal frequency.

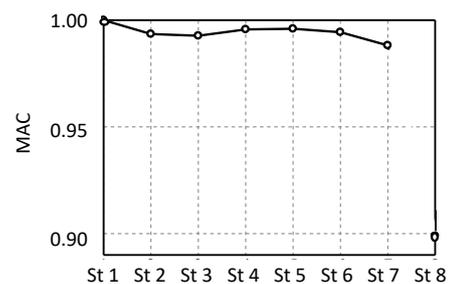
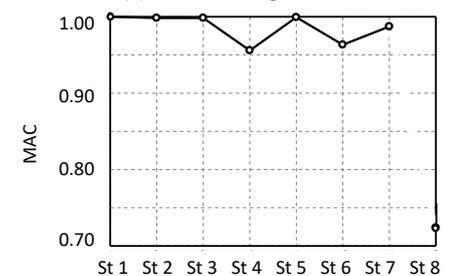
Figure 12. Change in MAC values.

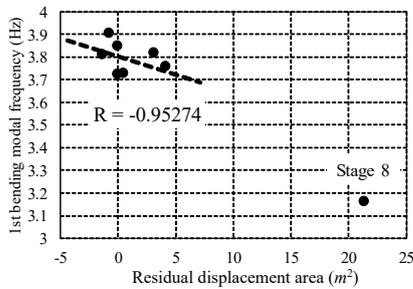
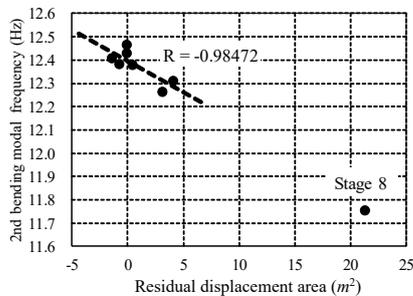
The relationship between residual displacement and bending frequency are investigated utilizing residual displacement area shown in Fig.13(a). It is observed that a strong correlation exists between changes in residual displacement area and changes in bending frequencies as shown in Fig. 13(b) and (c). Therefore, changes in the performance feature Z and bending frequencies are investigated, and are shown in Fig. 14. The dotted line shows a linear regression between frequency and performance feature from Stage 1 to Stage 7. Stage 8 was not considered to the regression since Stage 8 is close to the ultimate condition which rarely occurs in real bridge monitoring. From the linear regression curve, a strong correlation was observed between the 2nd bending modal frequency and the performance feature.

Figure 13. Residual displacement area vs. Normalized frequency.

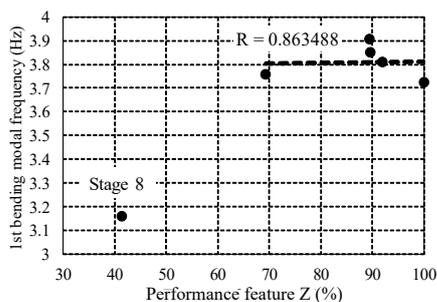
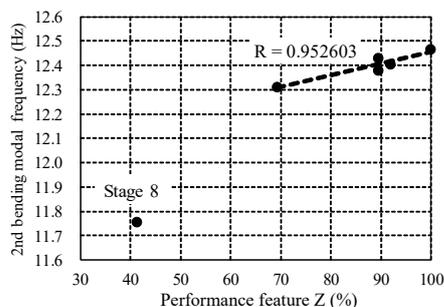
Figure 14. Performance feature vs. frequency.

The similar loading step as in the experiment is considered in FEA, and the relationship between the performance feature and the normalized frequency is investigated. The normalized frequency is calculated by dividing the observed frequency at each vibration test stage by the frequency before the static loading test. When the bridge is unloaded after each loading step, eigenvalue analysis is conducted to obtain analytical natural frequencies of the bridge. Fig. 17 shows the comparison between performance feature and normalized frequency obtained from the analysis. It shows that changes in the energy and frequency obtained from the experiment for the 1st bending mode was not well simulated in comparison with Fig.14(a). While the 2nd bending mode showed a similar trend with experiment.

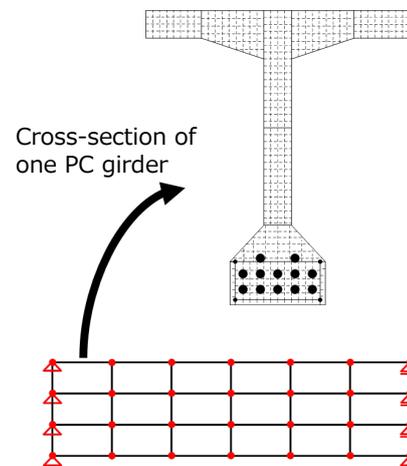
Figure 15. FE model of the target bridge with mesh for fiber model.

Finite element (FE) analysis was conducted to discuss the relationship between structural performance and modal properties of the PSC bridge in detail. The FE model for the target bridge is constructed by the fibre model which is a kind of beam models and can easily grasp the nonlinear behaviour of members. Fig. 15 shows the FE model of the target bridge. Concrete deck, main girders and guiderail were modelled with the fibre model. Cross beams were modelled with elastic beam and the pavement were modelled with shell element. All elements were rigidly connected. Based on the periodic inspection documents, Young's modulus of steel and concrete were assumed as 200 GPa and 40 GPa, respectively.

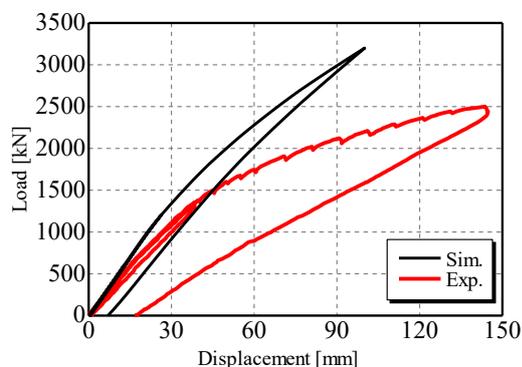
Fig. 16. Load vs. displacement curve.

In order to discuss the non-linear behavior of the model, the pushover analysis was conducted up to the same displacement as the Loading-4. Fig.16 shows the load-displacement curves from the experiment and FEA. From Fig.16, there is a large difference in the degree of the plasticity although the eigen frequencies were comparable with the experimental ones.
