五條川橋震害圖及改造橋脚圖

ELEVATION AND PLAN

OF

GOJOGAWA BRIDGE.

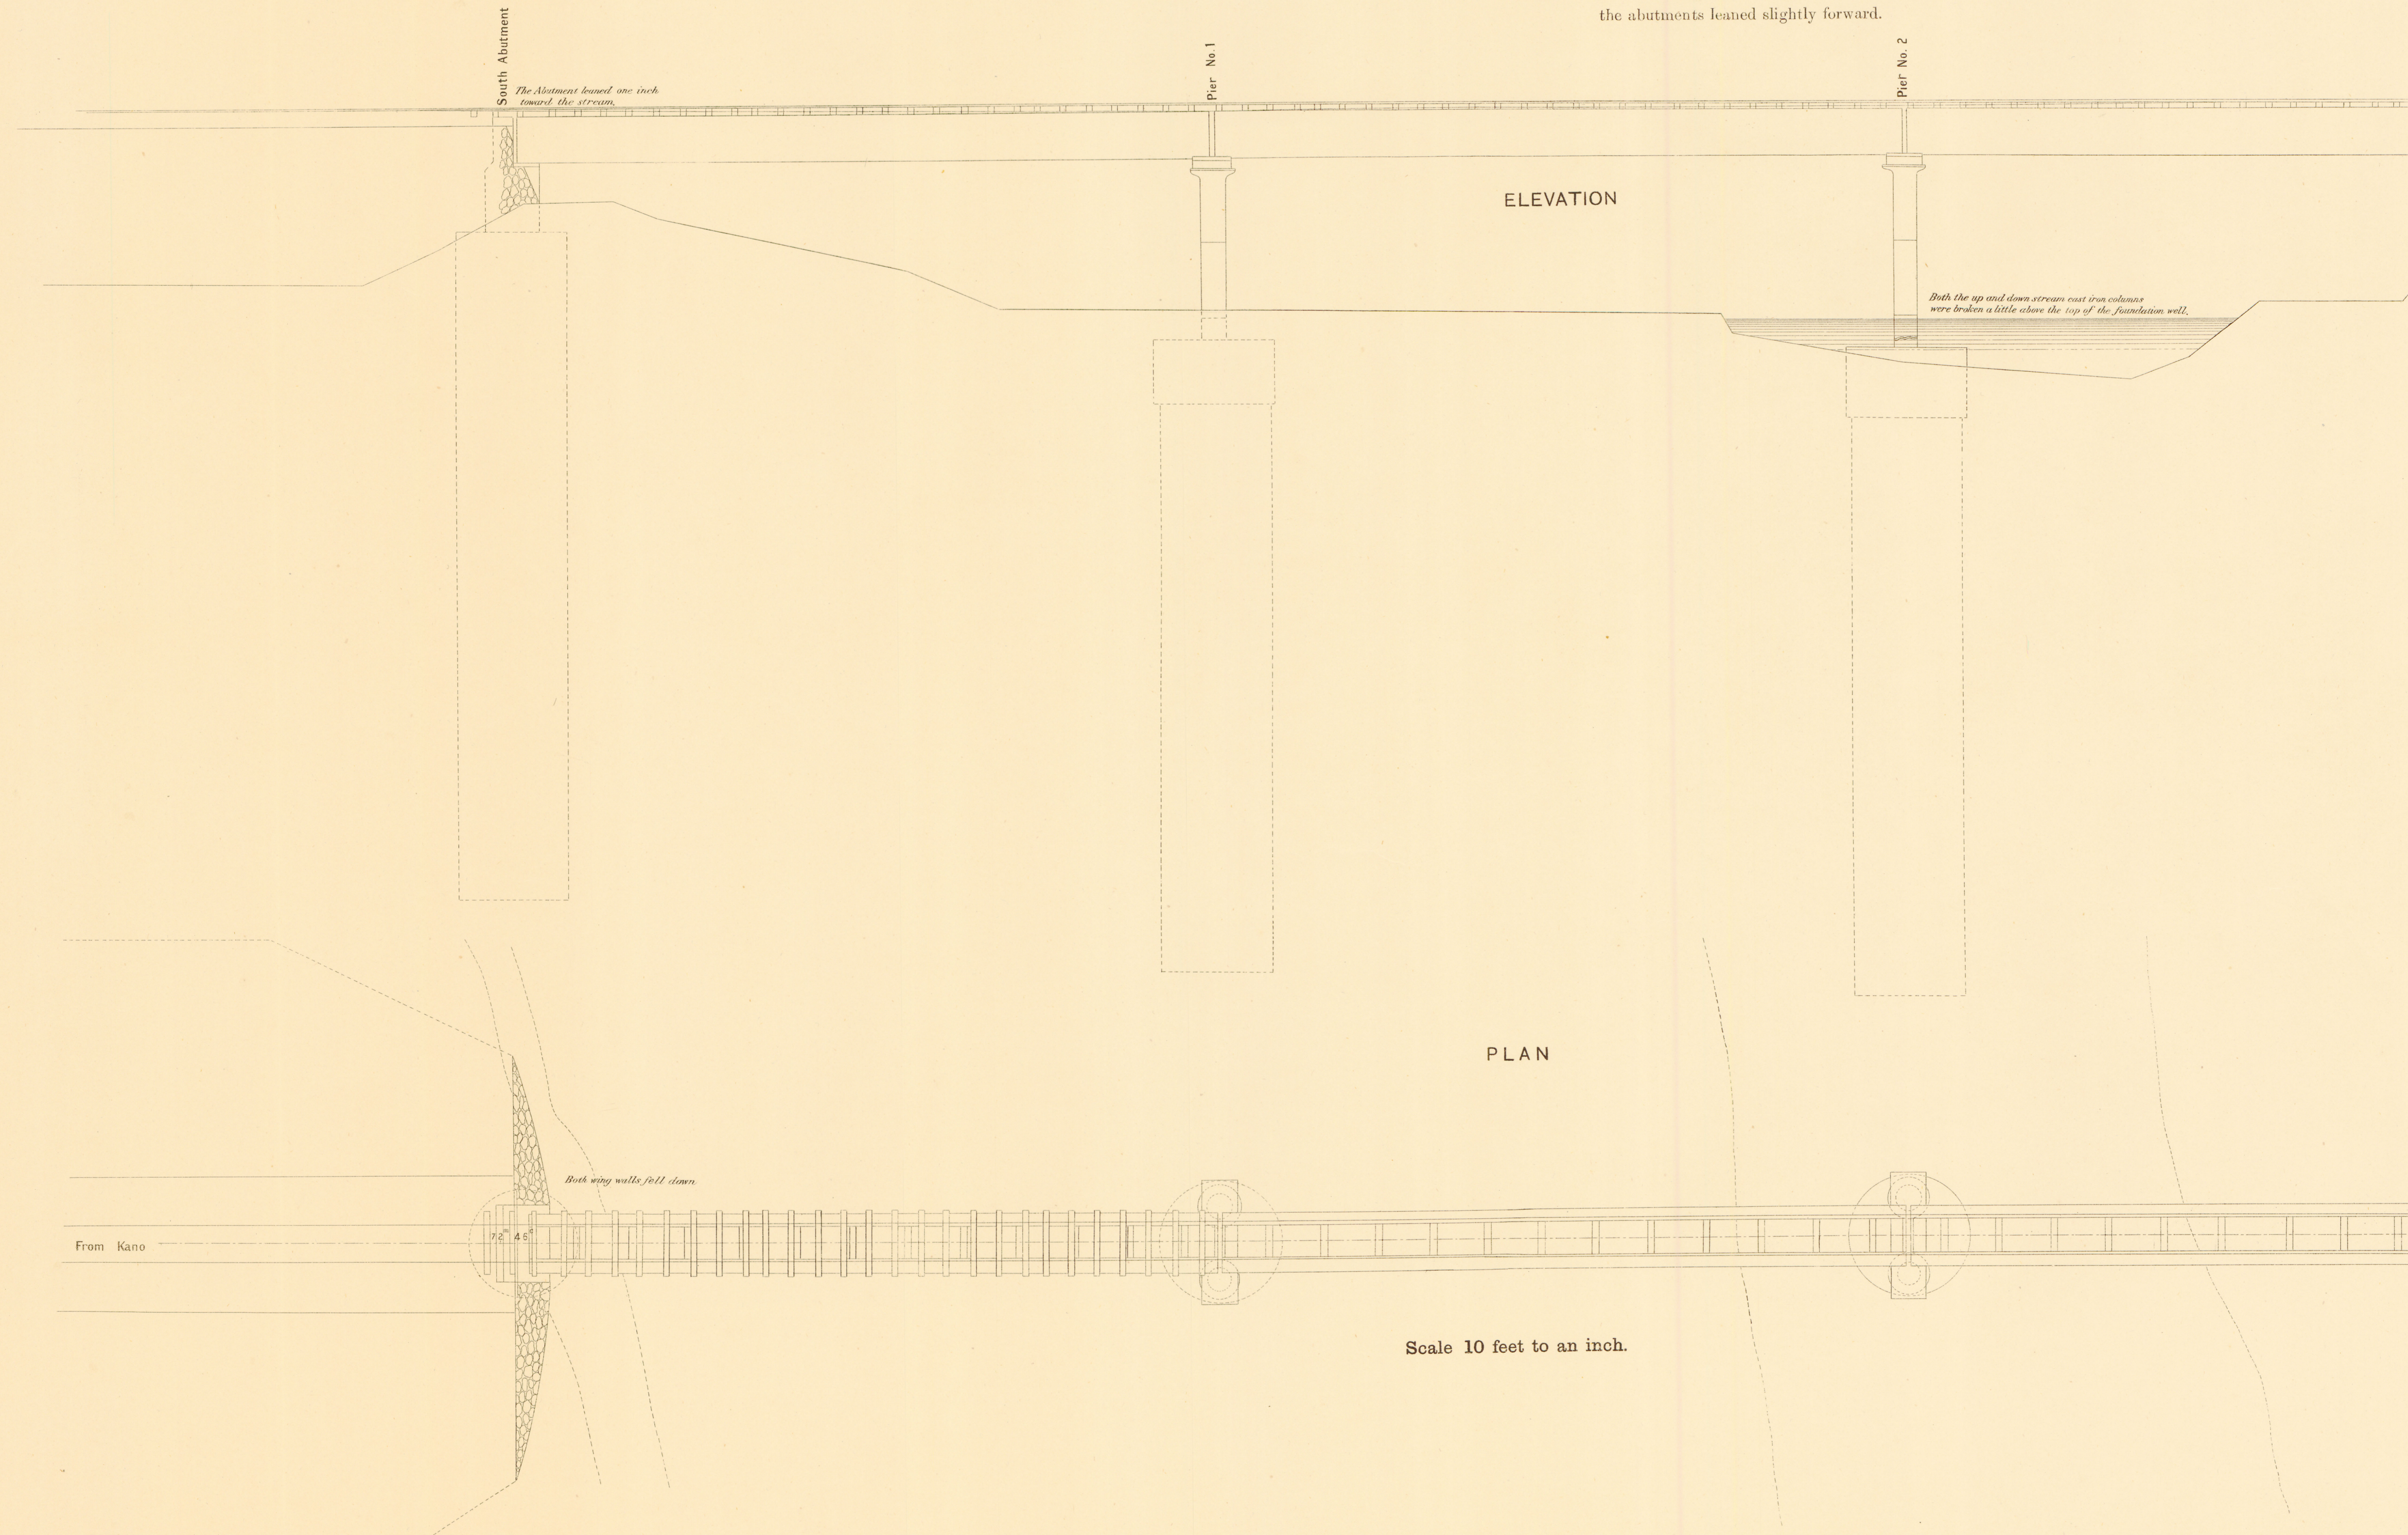
五條川橋震害圖及改造橋脚圖 (其一)

Showing the condition after the great earthquake of Oct. 28th, 1891.

Pier No. 2, consisting of the same pattern as used in Shinkawa Bridge broken at a few feet above the top of the foundation well and one of the abutments leaned slightly forward.

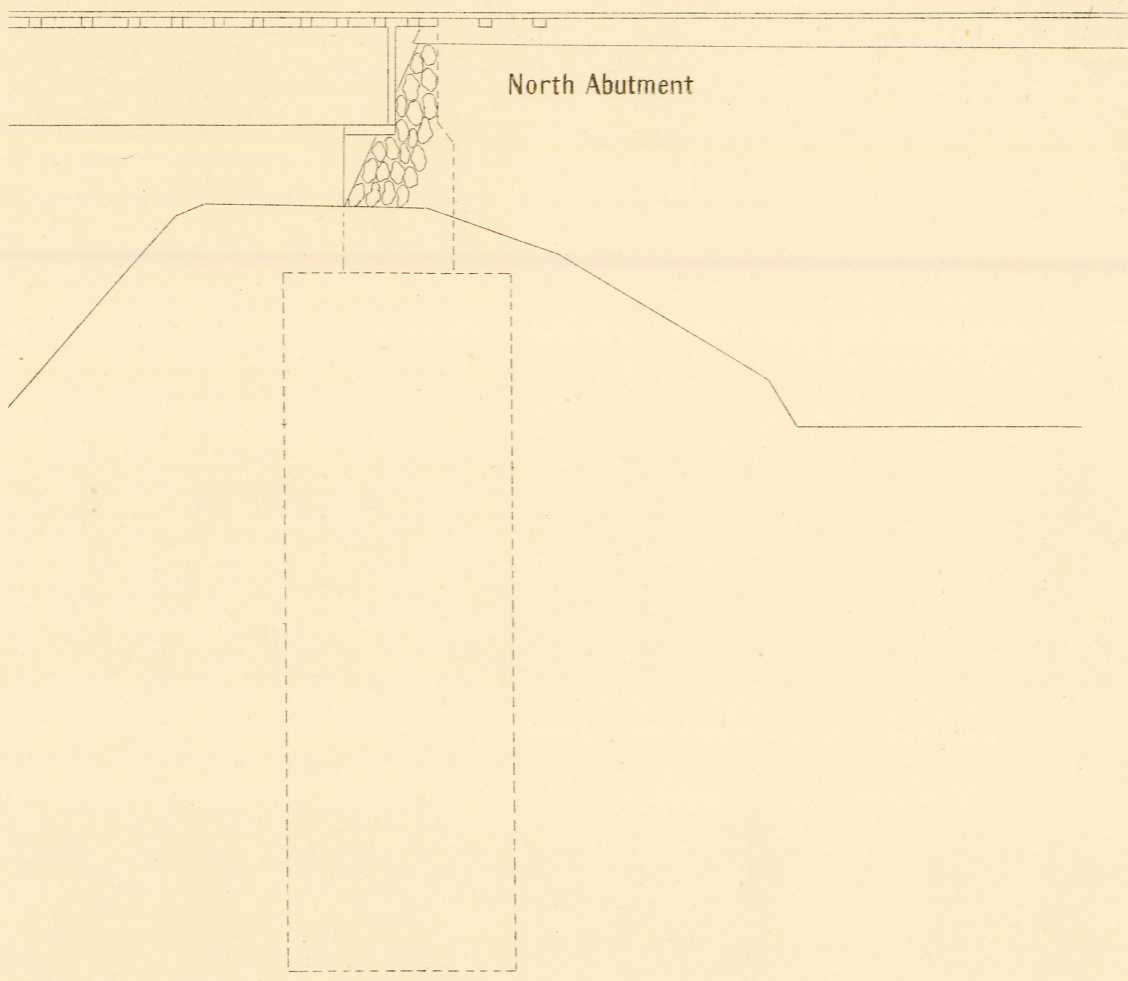
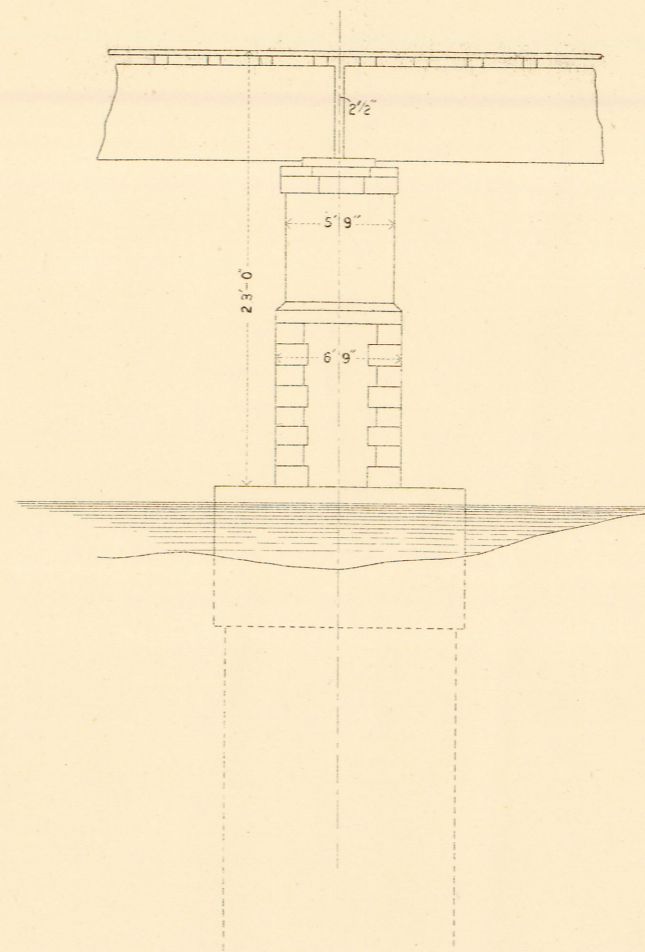
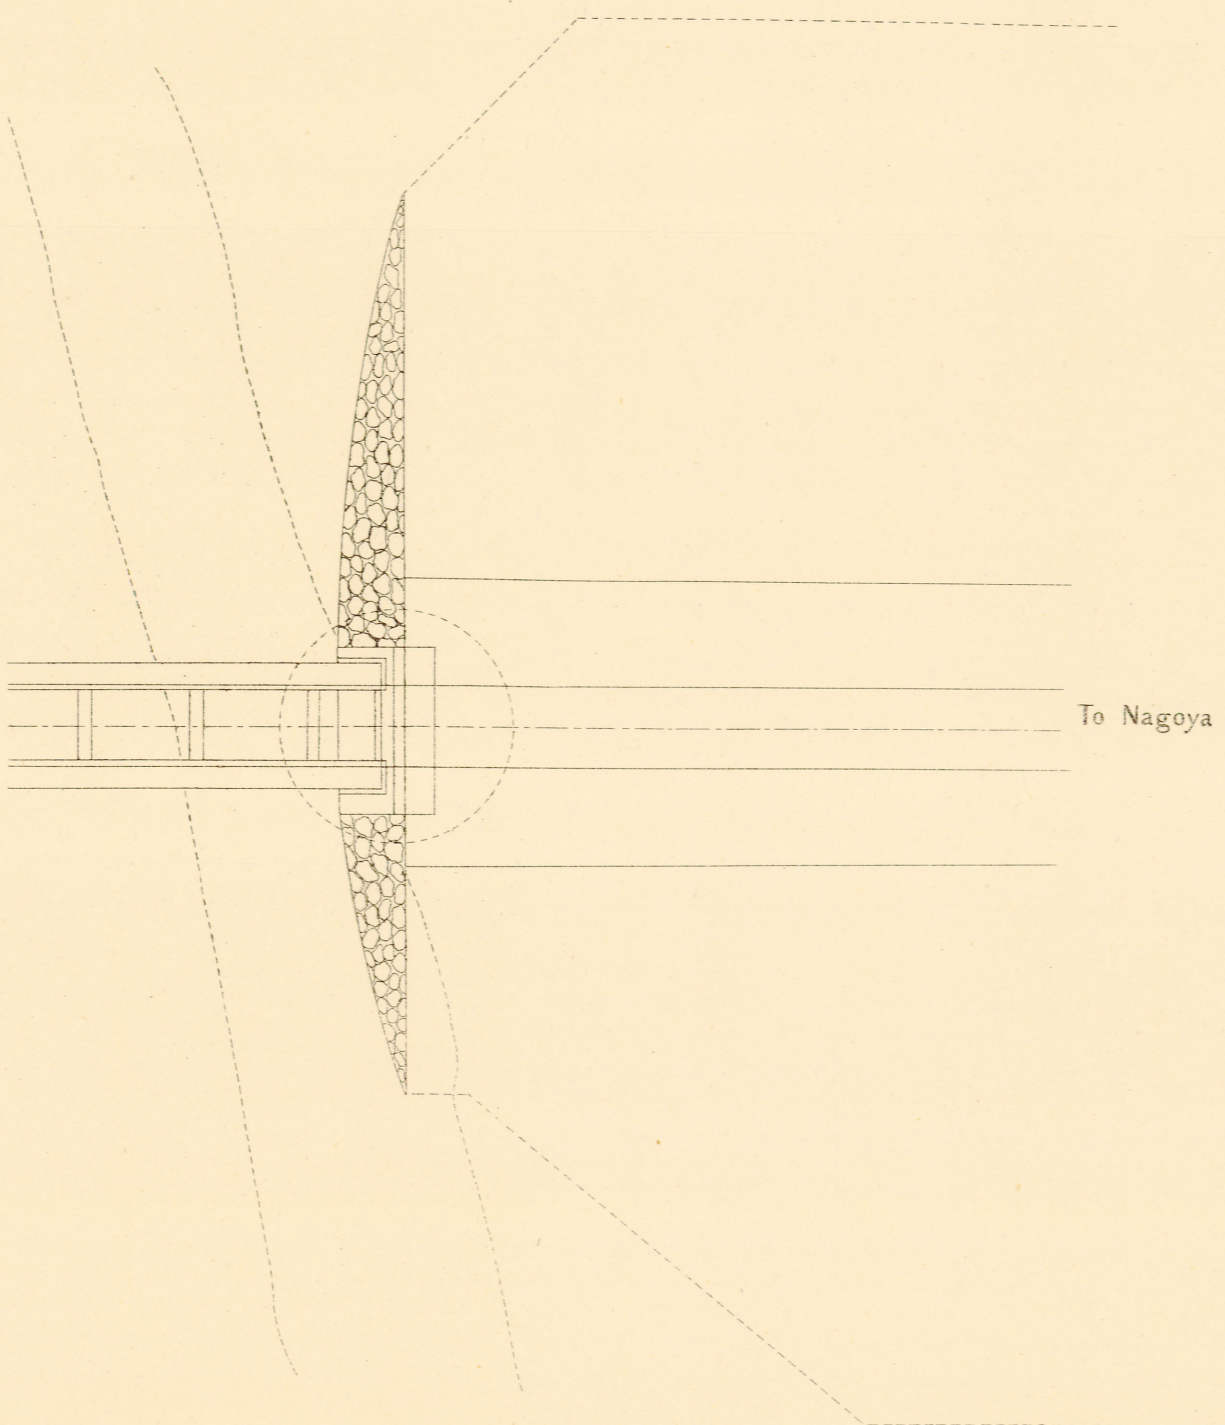
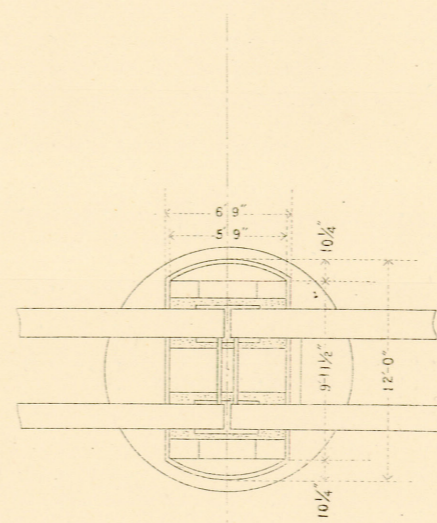
ELEVATION AND PLAN OF PIER

as reconstructed after the Earthquake.
