圖 害 震 橋

SIDE AND FR OF KISOGAWA

BRIDGE.

quake disaster of Oct. 28th, 1891.

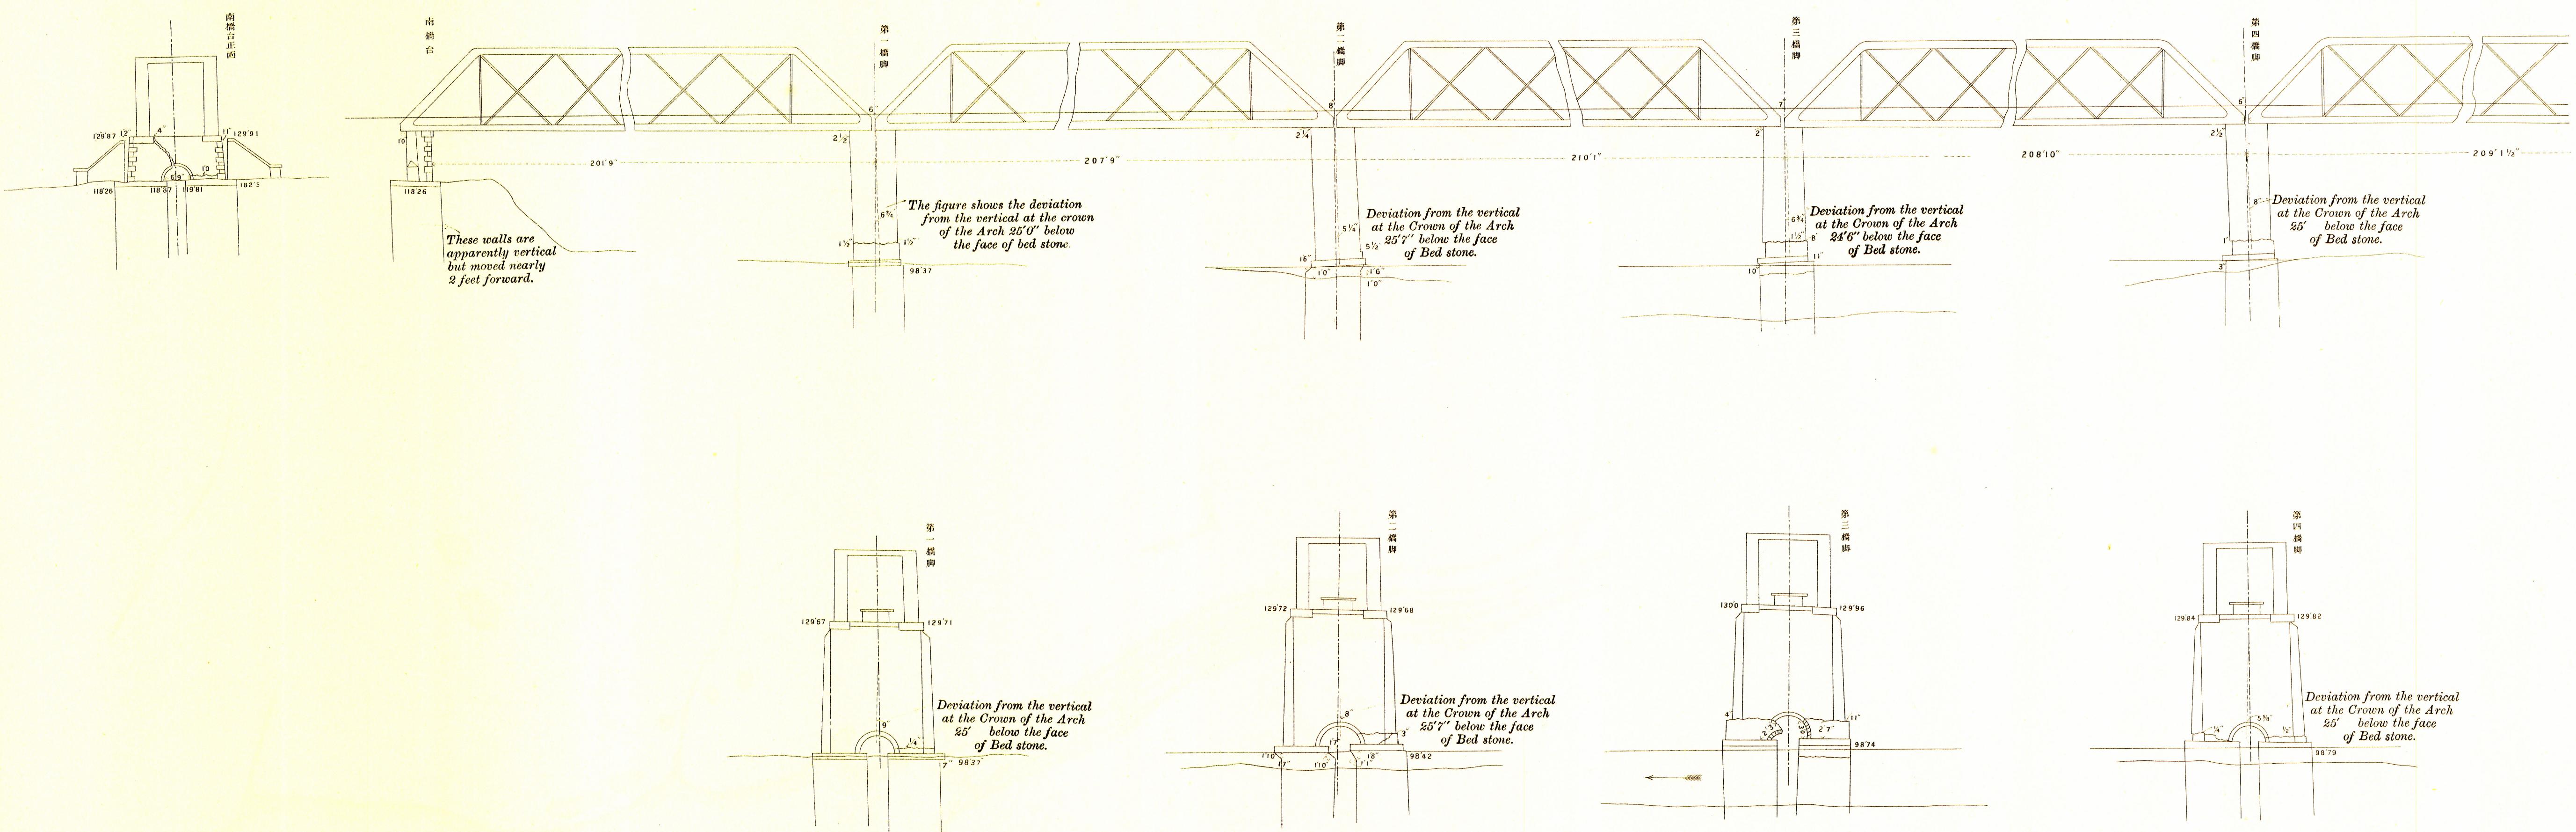
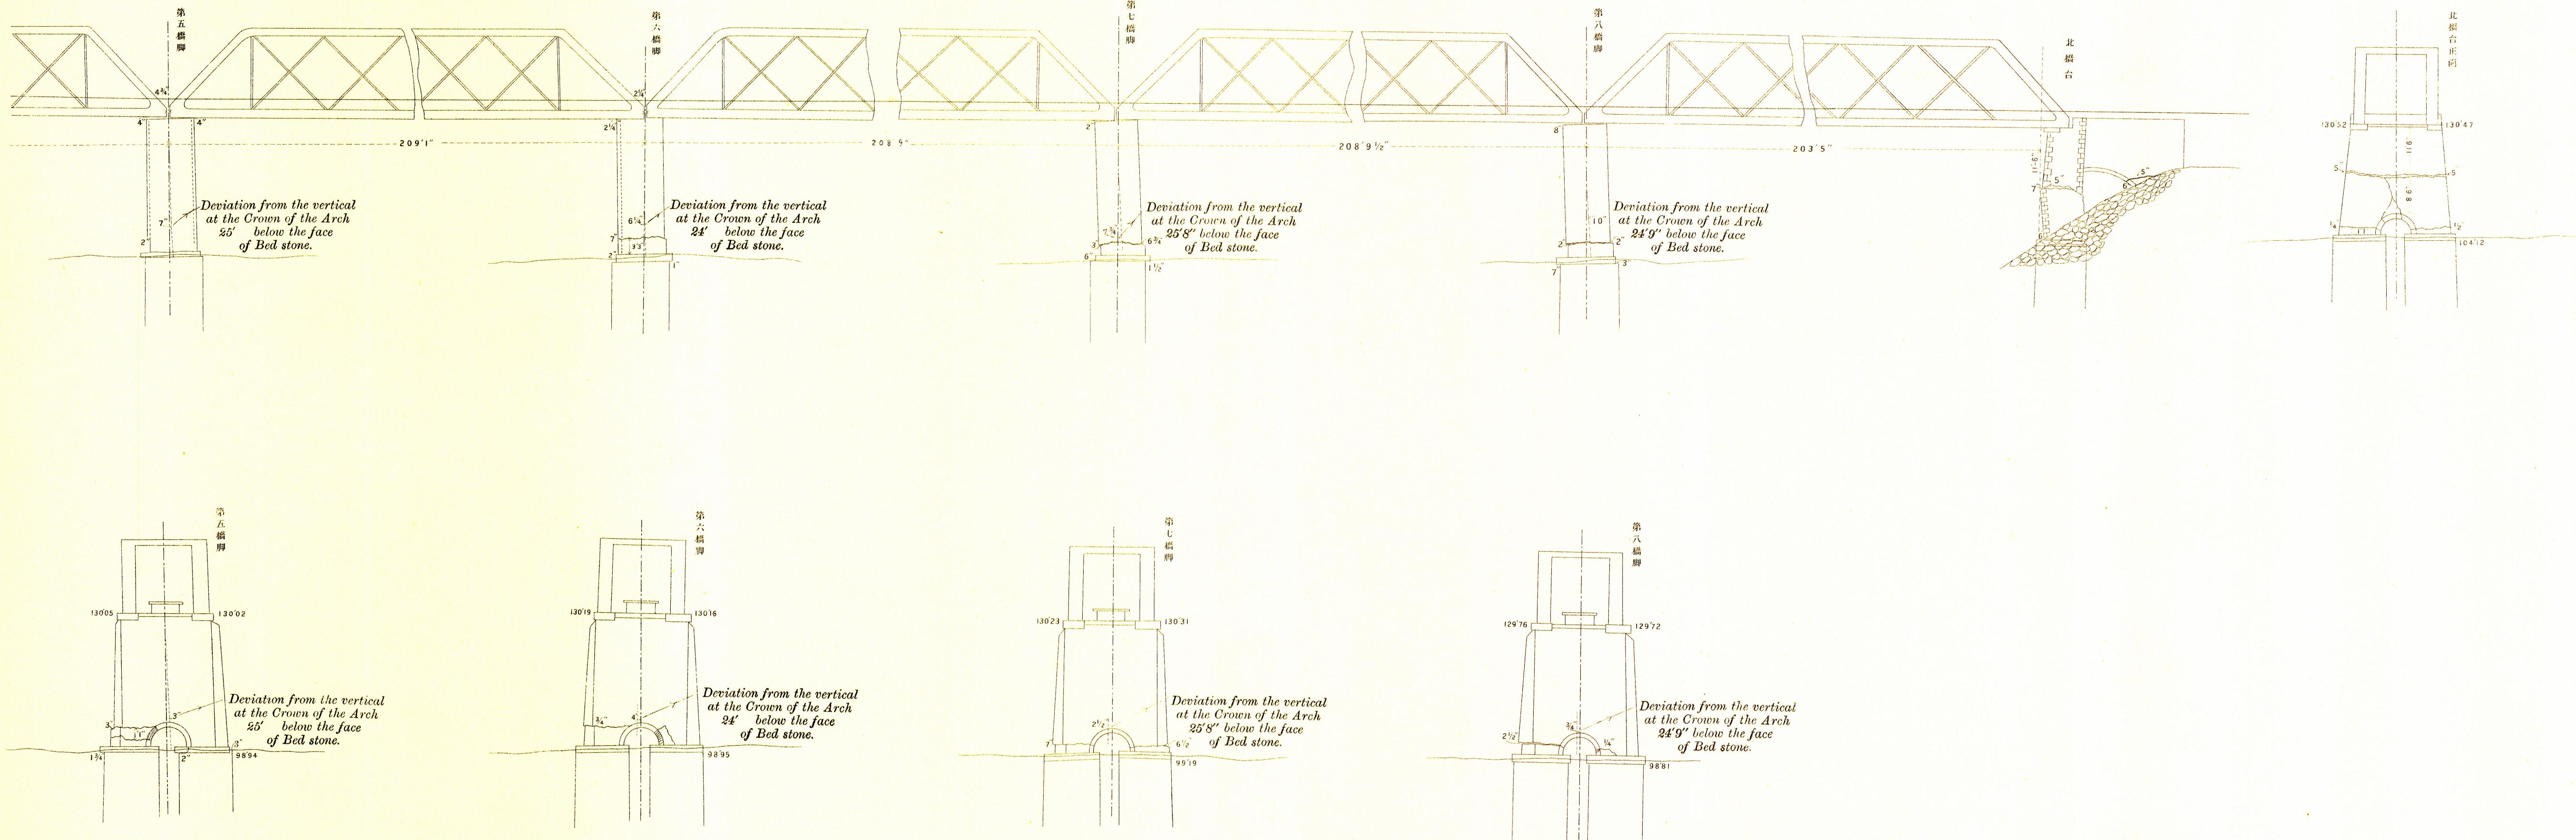
Showing the condition after the earth
All piers and abutments cracked at a few feet ab
less displaced in var
Scale : 20 ft. to

ove the top of foundation wells and more or
ious directions.
