ELEVATION AND PLAN

OF

NAGARAGAWA BRIDGE PIERS.

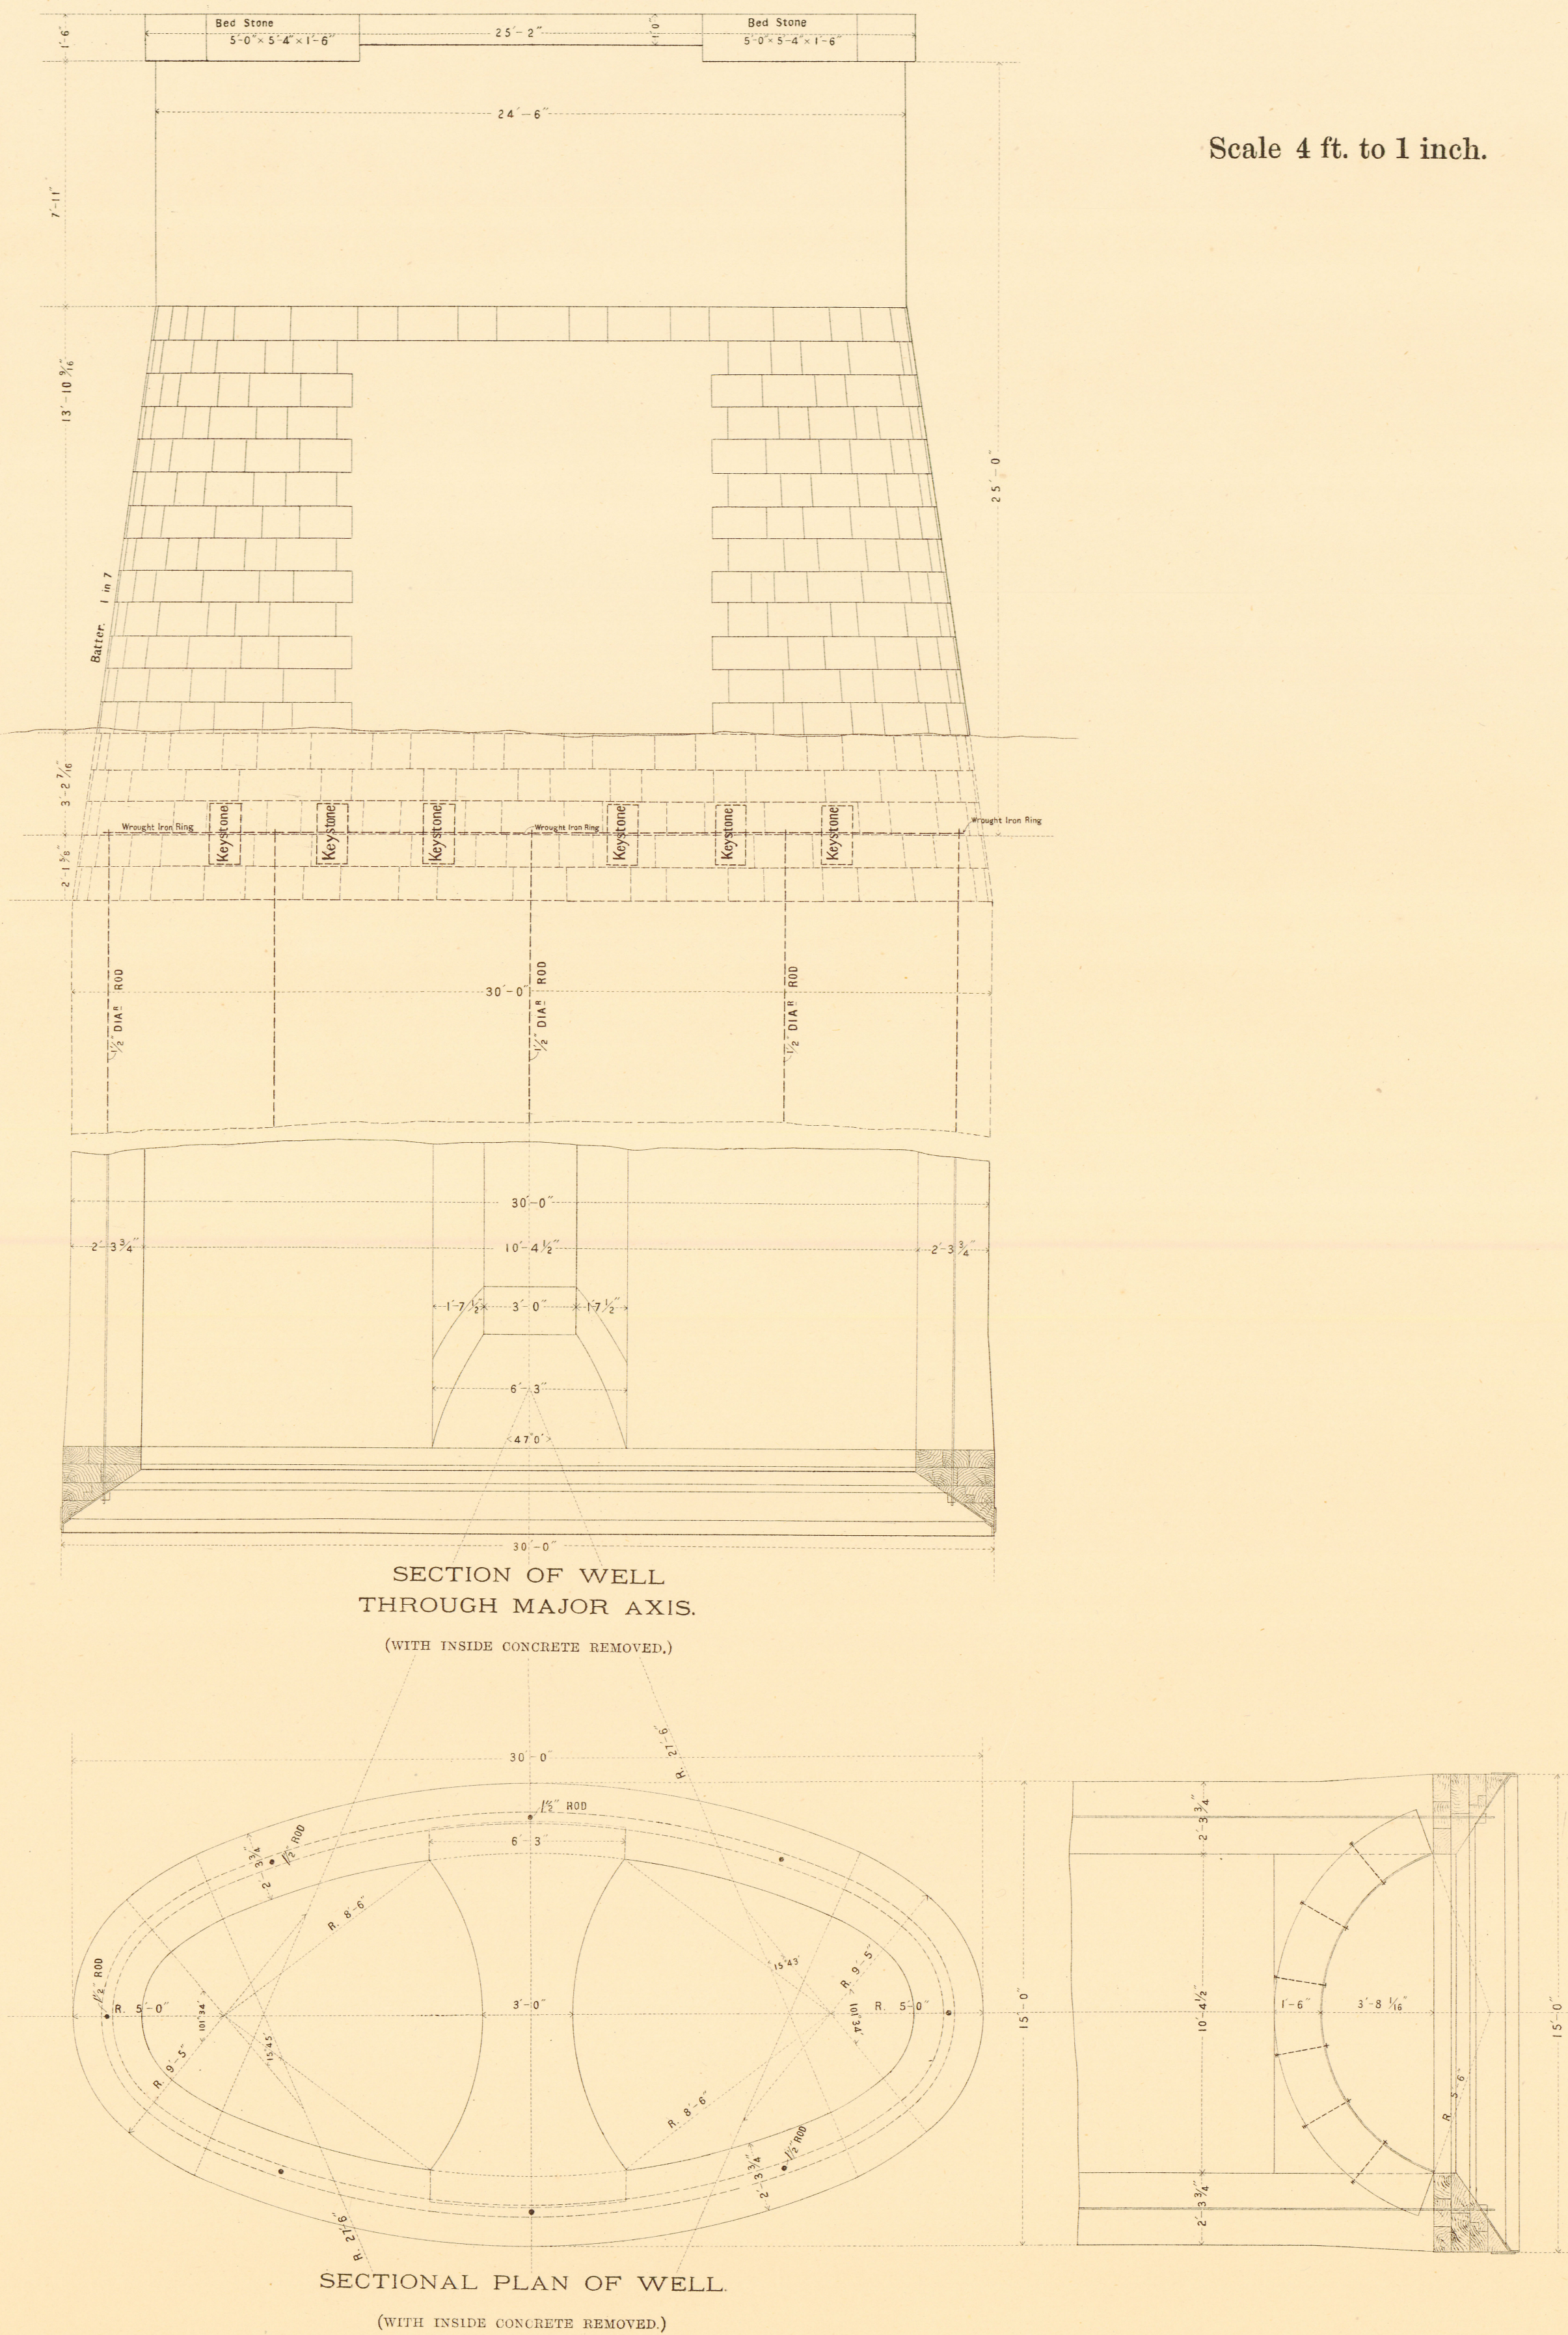
As reconstructed after the earthquake disaster of Oct. 28th, 1891, by using elliptical foundation brick well and building in several keystone at the portion near the ground surface and the structure built up as shown, with object to increase the sectional area of the pier near the river bed, which has been proved to be most likely attacked portion by earthquake.

SIDE VIEW

FOR

PIERS Nos. 4, 5, 6, 7 & 8.
