長良川橋震害略圖

ELEVATION AND PLAN

NAGARAGAWA BRIDGE.

Showing the condition after the earthquake disaster of Oct. 28th, 1891.

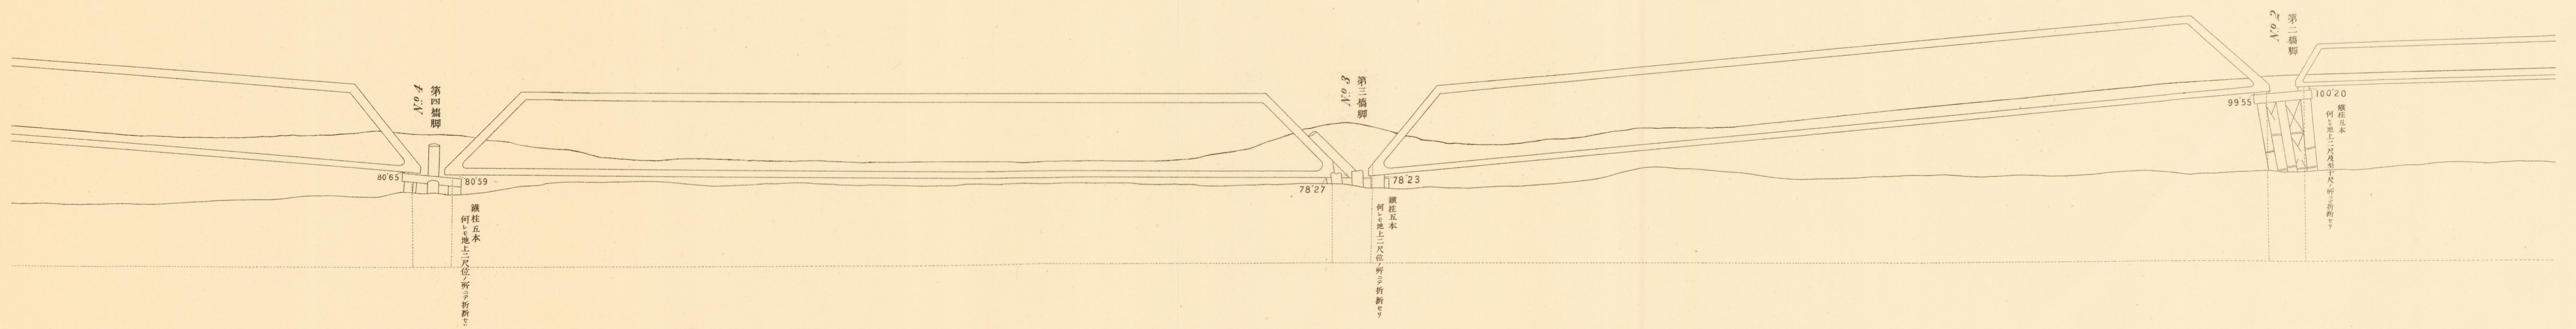
側 面

All piers broken and two piers No. 3 and No. 4 entirely failing. The girders fall down as shown.
