境川橋震害圖

ELEVATION & PLAN OF SAKAIGAWA

境川橋震害圖(其一)

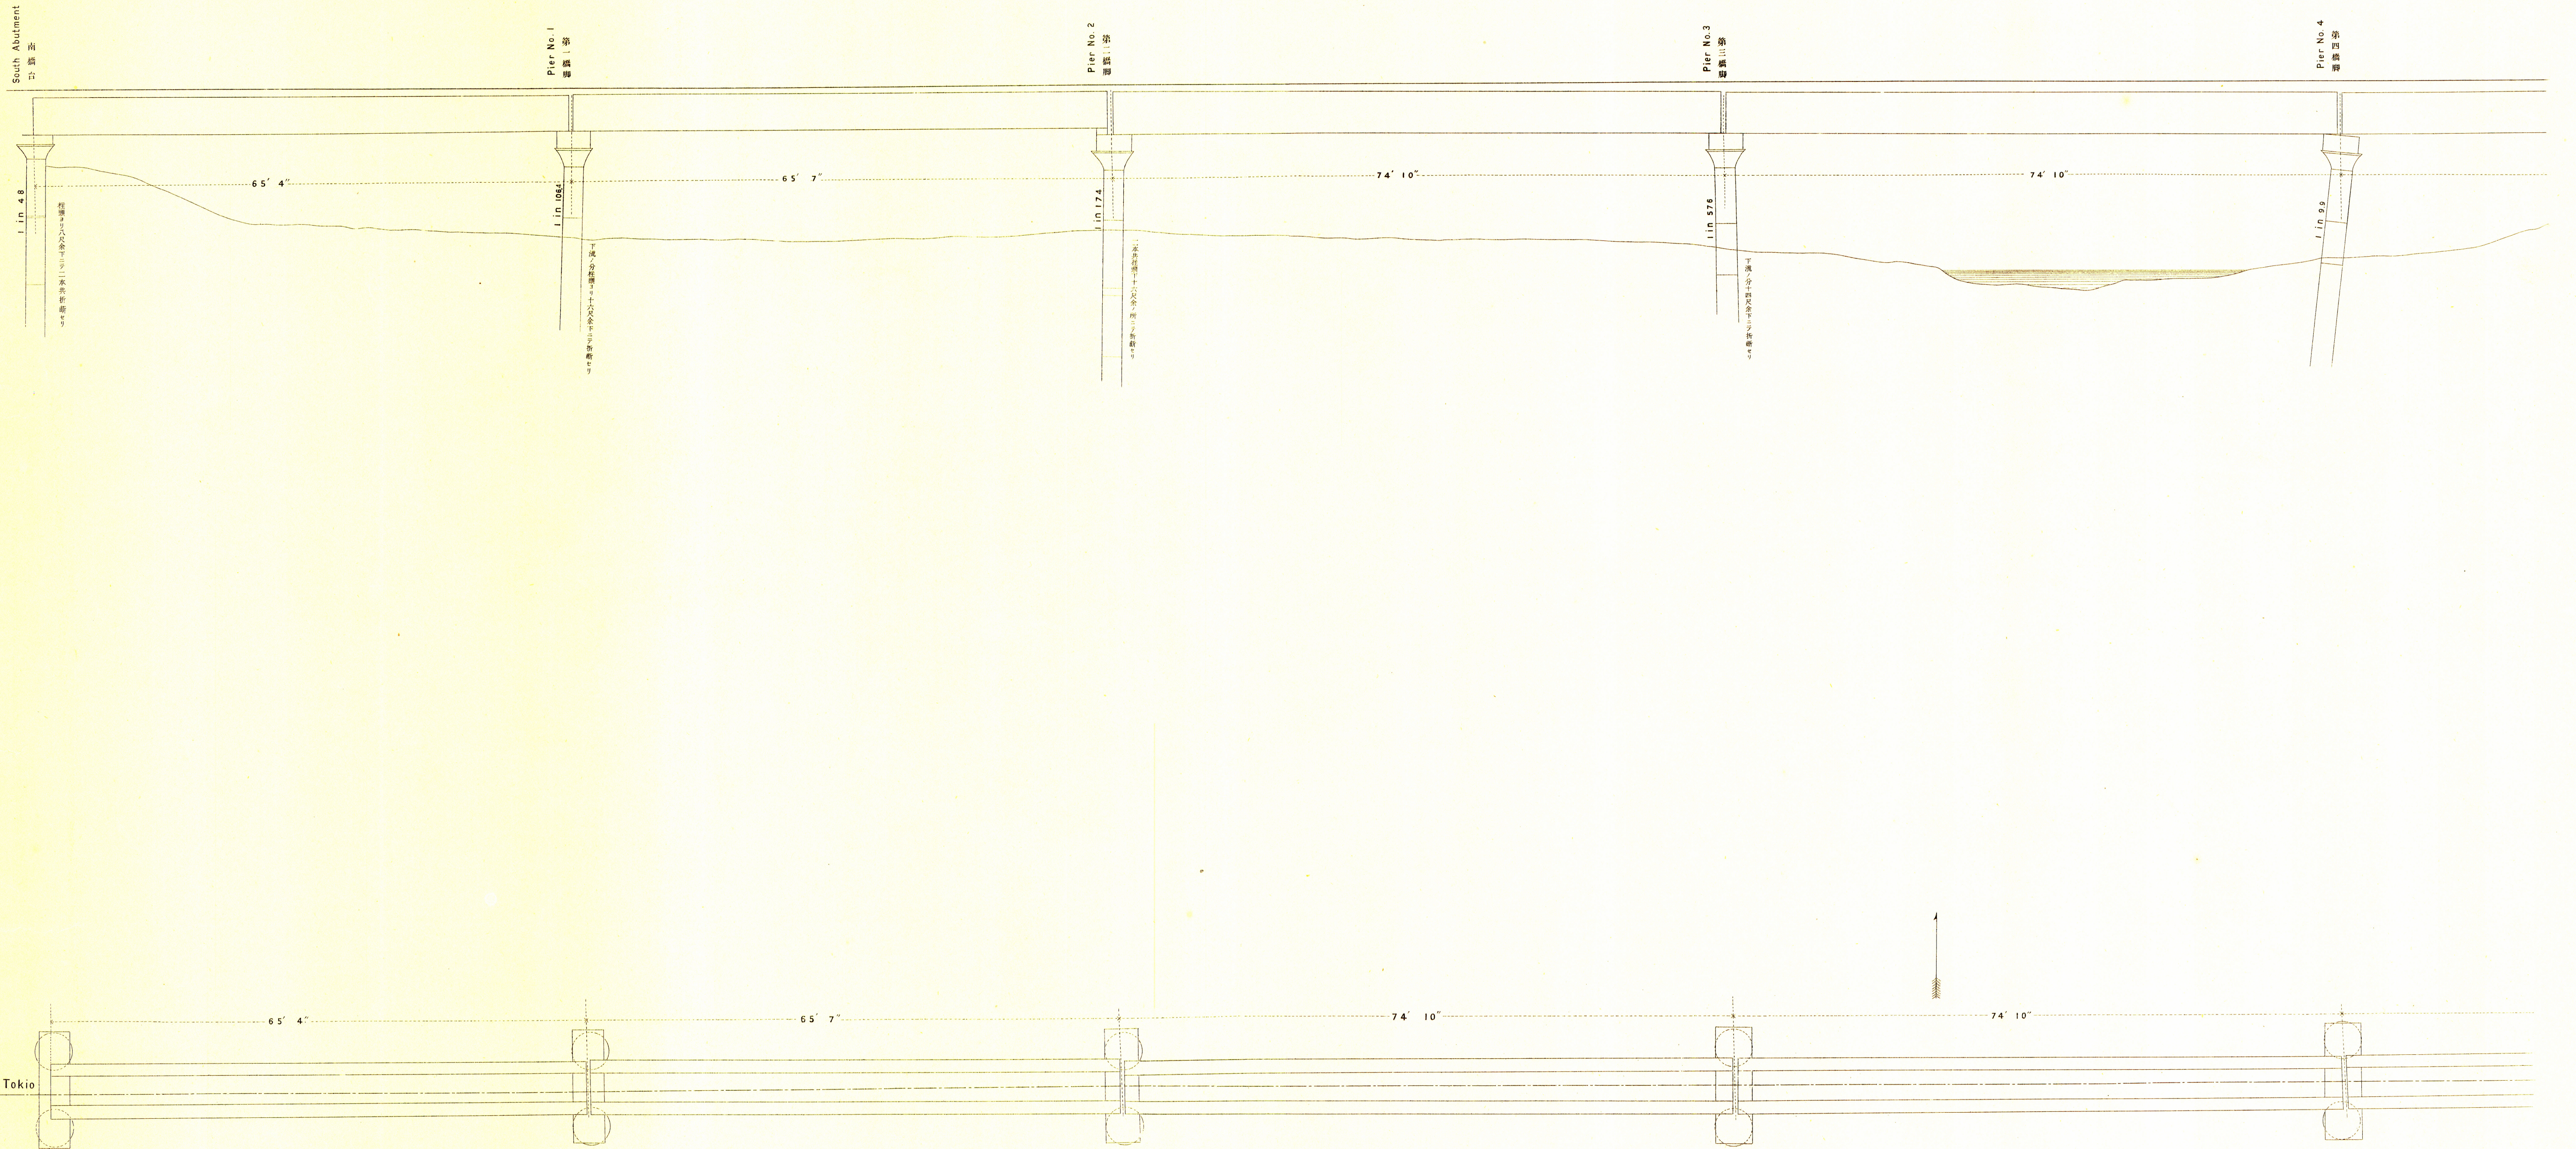
Showing the condition after the earthquake disaster of Oct. 28th,
All the piers, each consisting of a couple of cast iron screw piles, 2'6" in diameter and filled with concrete, broken

near the surface or underneath the ground.
