圖脚橋造改及圖害震橋川新

ELEVATION AND PLAN

SHINKAWA BRIDGE.

Showing the condition after the great earthquake of Oct. 28th, 1891.

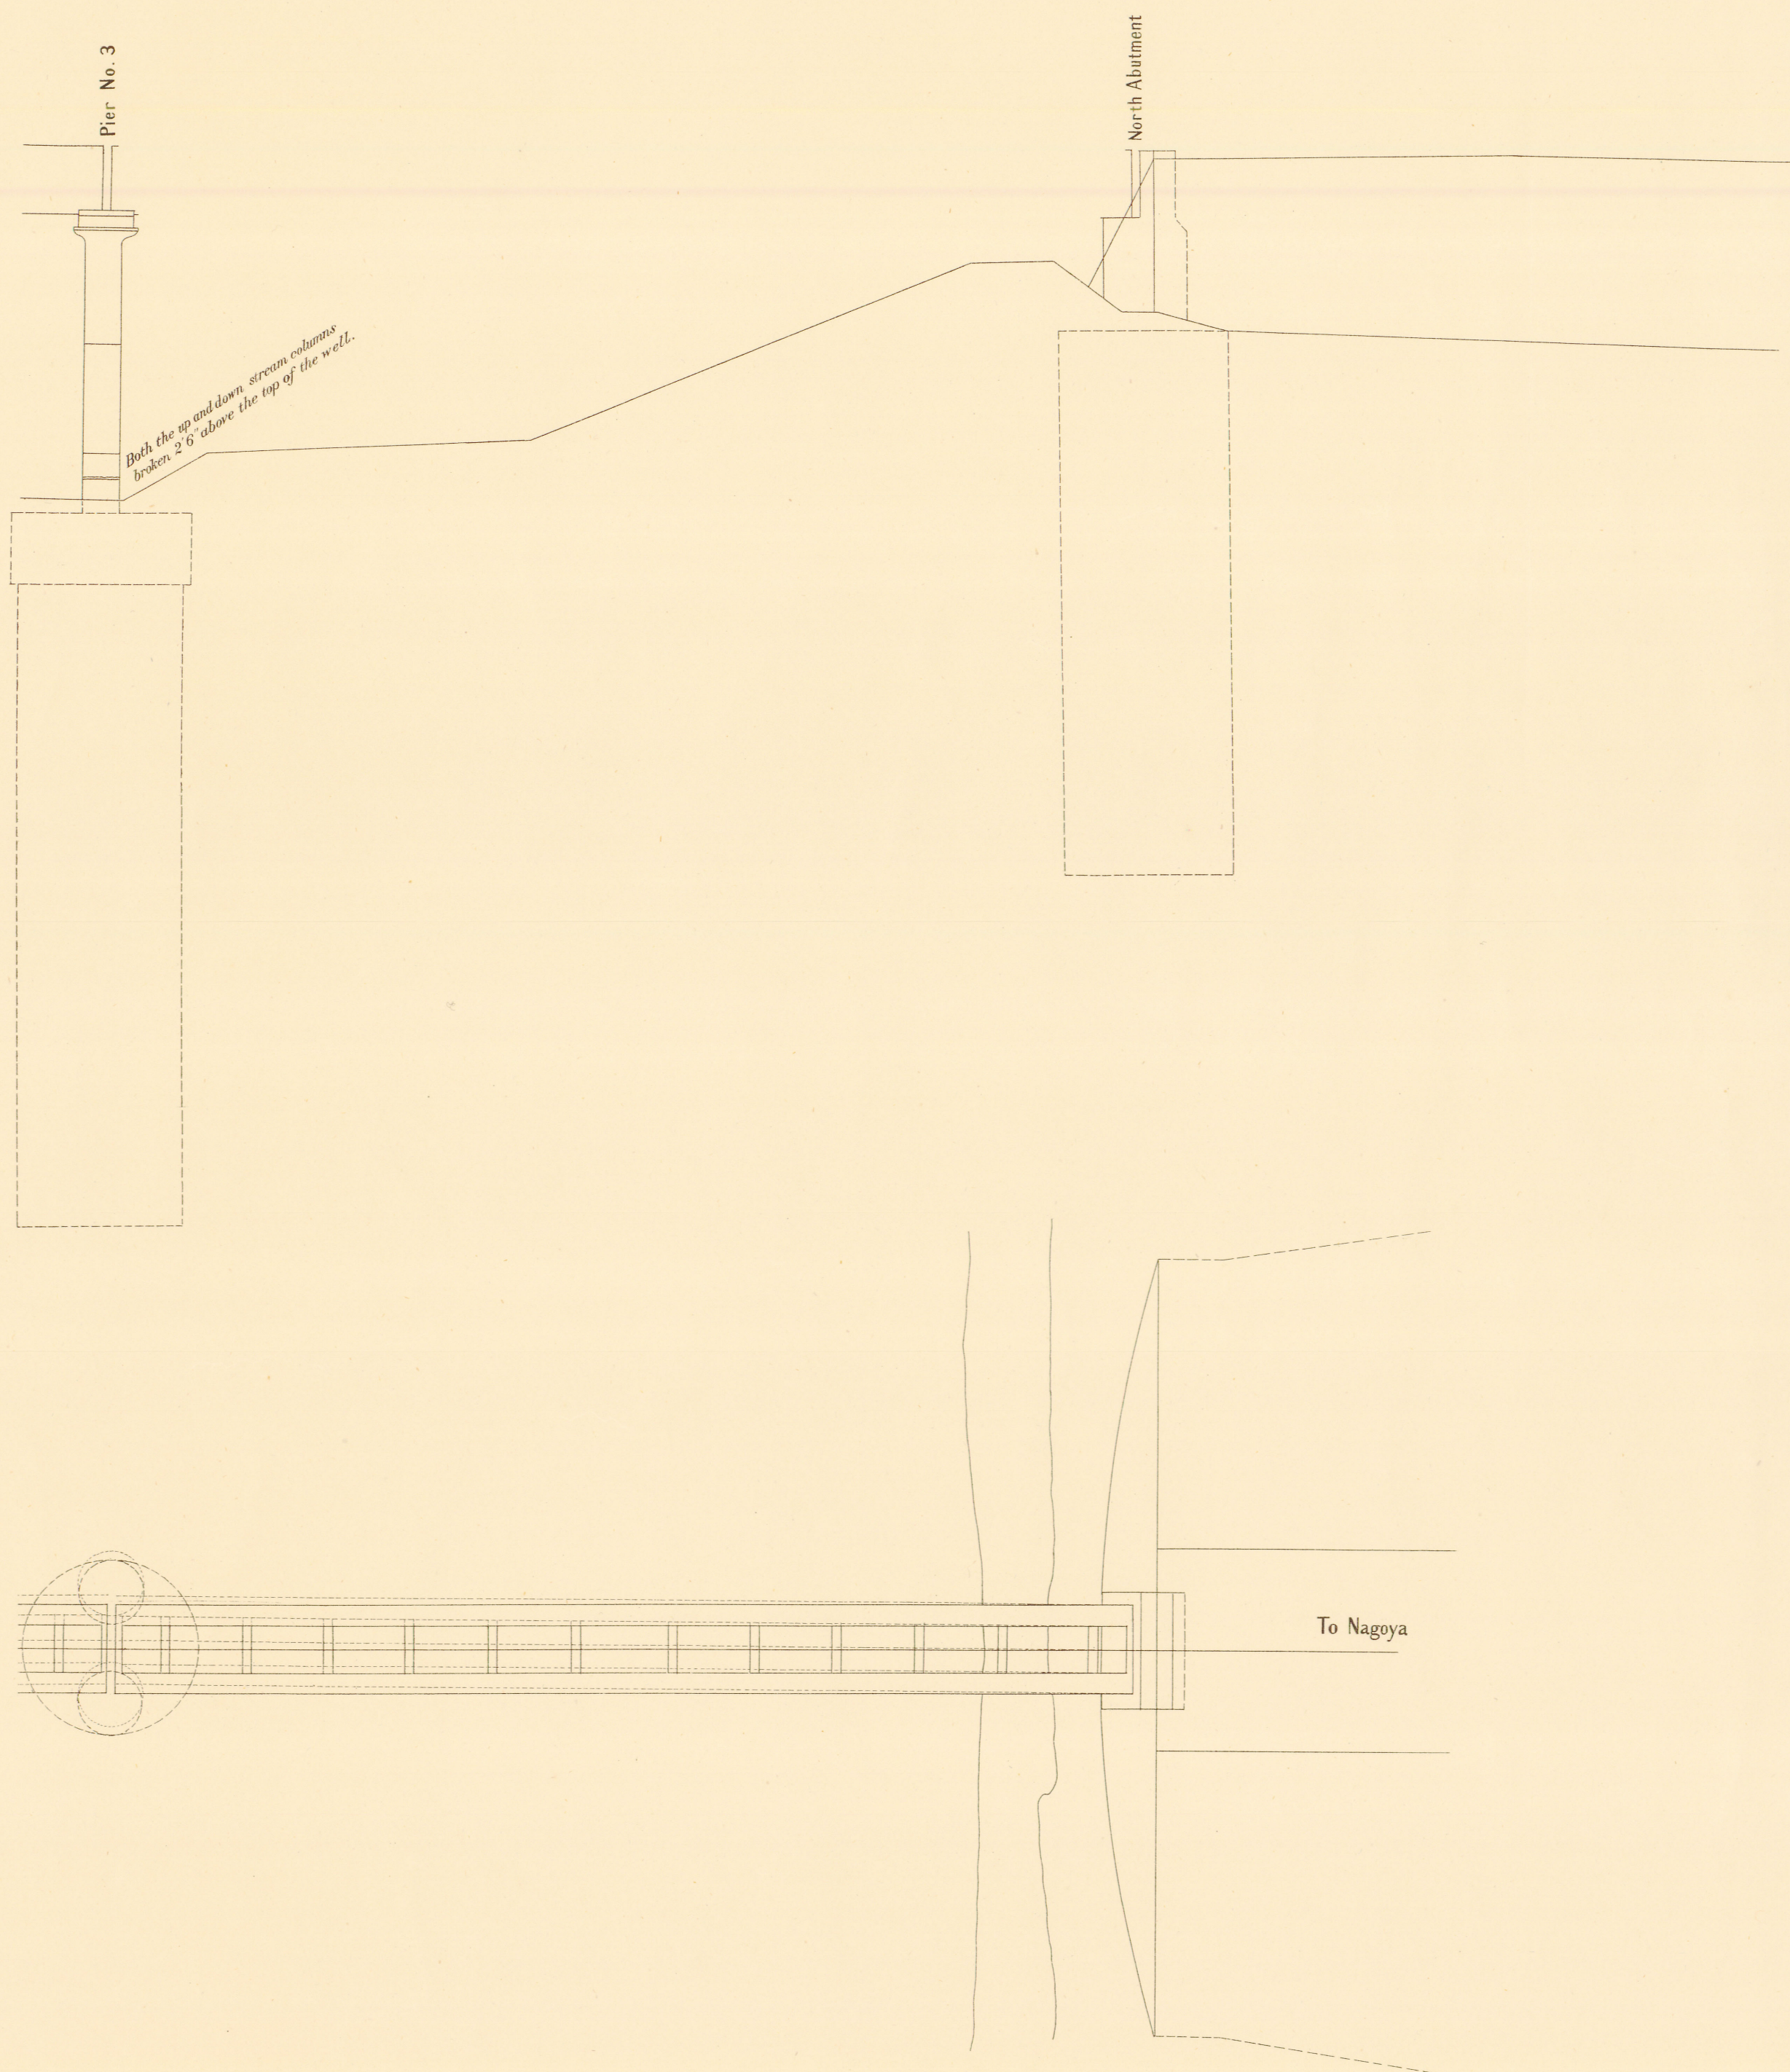
ELEVATION AND PLAN

PIER

as reconstructed after the earthquake.
