Spectral Analysis of Optical Remote Sensing Images for the Detection of Damage due to The 1999 Kocaeli, Turkey Earthquake

Miguel ESTRADA*, Masashi MATSUOKA** and Fumio YAMAZAKI*

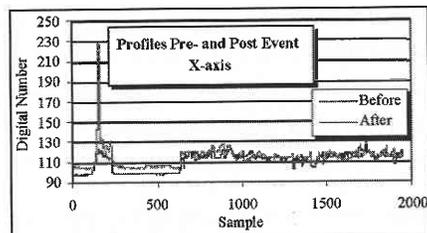
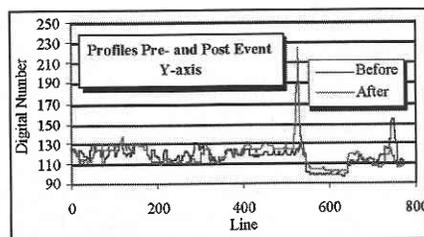
Fig. 3 Profiles of the pre-and post-event images of the band 6. Notice the peak values that represent the area around Tüpras refinery.

(a) Profile along X-axis.

(b) Profile along Y-axis.

To identify the areas affected by fire we compare the profiles of the pre-and post-event images. The profile represents the distribution of the digital number (DN) of certain band along a strip of the image. This strip can be taken over the X-axis or Y-axis. For this comparison the band 5 (mid infrared), band 6 (far infrared or thermal band) and band 7 (mid infrared) have been used. Figure 3 shows the profiles of the DN of band 6 along the X-axis and Y-axis.

It can be observed (Figure 3) that there is a pattern in the profile before the earthquake as well in the after one. But in the region between sample 100 and sample 200, in the X-axis, and between the line 500 and 600, in the Y-axis, there are peak values, which represent the high temperature. Since the coordinates of this area are known, we can identify it in the image. This area corresponds to the Tüpras refinery, which suffered from a very large fire. Figure 4 shows the composite color image (752) of the area around of the refinery.

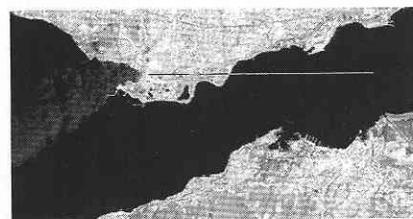
Fig. 4 Color composite (752) images around Tüpras refinery.

(b)Post-event

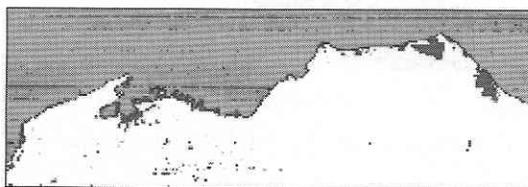
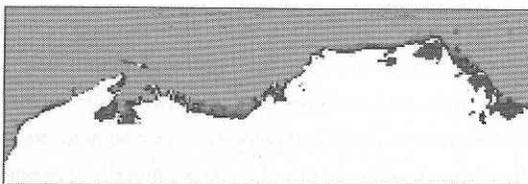
(a) Pre-event

(b) Post-event

Fig. 6 The coastline in Gölcük, after matching the histograms. The intense red in (b) shows the sunken areas.

two images, it can be seen that in the image of the post-event (Fig. 6 (b)) there are some areas that differ from those in the pre-event image. These differences represent the inundated area. Also it is possible to calculate the extension of the flooding, by counting the number of pixels that differ between these two images. In order to count the number of pixels that belong to water body we have used the 2-D scatter diagram. In this diagram we plot the distribution of reflectance of two bands, in this case band 4 vs. band 5. We define threshold values for the reflectance of the water, based on the values of training areas of water. Finally with the threshold values we make

the selection in the 2-D scatter diagram. Finally we count the number of pixels that fall into this 2-D range. The number of pixels that belong to water: Before: 8430 pixels, after: 9413 pixels, difference = 983 pixels. Total affected area (flooding)= 983 × 30 × 30 = 884,700 m², that correspond to red areas in the Figure 6 (b).

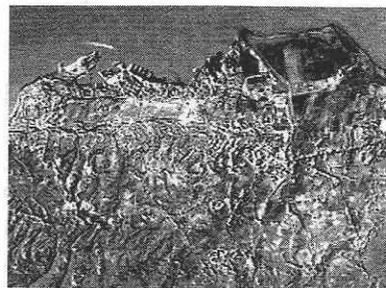
Fig. 7 Ratio (after/before) of the average of the first three visible bands.

where: $BB_k(i, j)$ is the digital number of the pixel (i, j) of the band k of the pre-event image. $BR_{avg}(i, j)$ is the averaged value of the pixel (i, j) of the pre-event image. This same formula is also applied to the post-event image. Then, we calculate the ratio between these two averaged images by Equation 2, where AR represents the averaged image after the event and R the ratio. Figure 7 shows the image obtained from this equation.

In the center of this image, the damaged area appears brighter and also the sunken area can be distinguished (in dark tones). This image is then compared with the ground truth data (AIJ, 1999) shown in Figure 8.

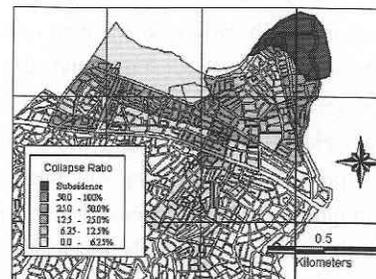
Fig. 8 Damage distribution in Gölcük city by AIJ (1999).

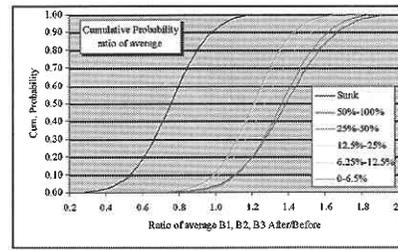
Fig. 9 Cumulative probability of the ratio (after/before) of the averaged images.

As a result of this comparison we obtain the distribution of DN for the different levels of damage. Figure 9 shows 4 different sections: the sunken area (blue), low level damaged (green and turquoise) the section for level of damage 12.5 % – 25 % (yellow) and the section for high level of damage (red and orange)

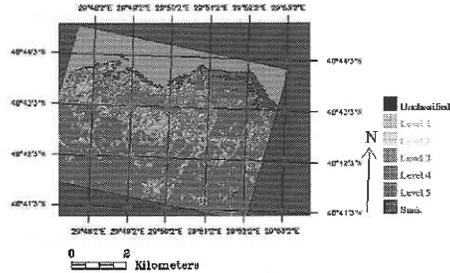
Fig. 10 Spatial distribution of damage using the maximum likelihood classifier for Gölçük.
