Saiko High Water: A preliminary report

西湖増水調査速報

S. HERATH*, Kimiro MEGURO*, Taikan OKI** and Kazuhiko MIURA**

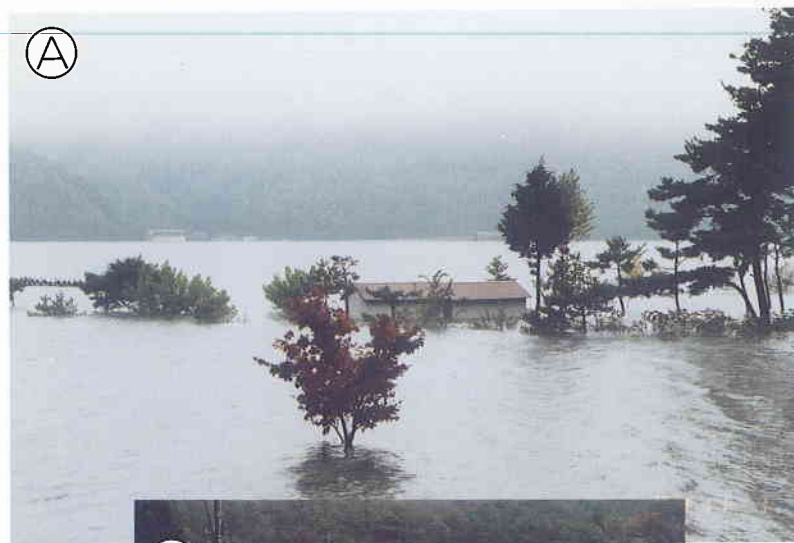
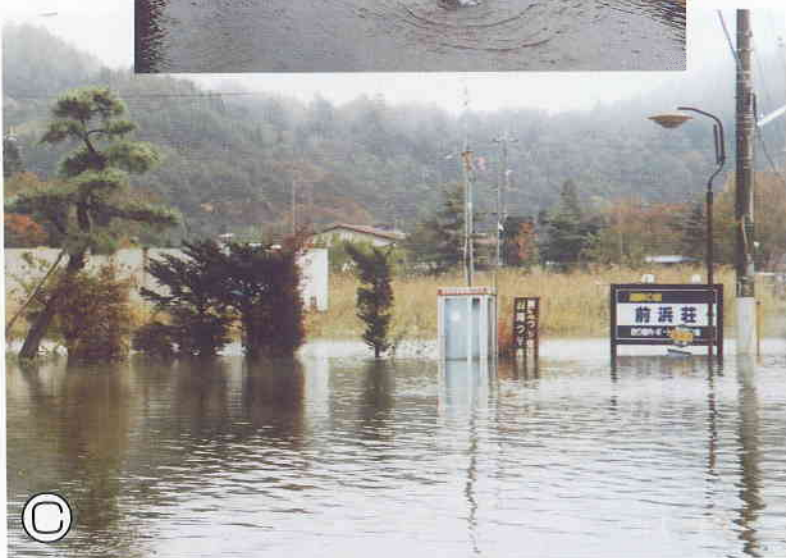
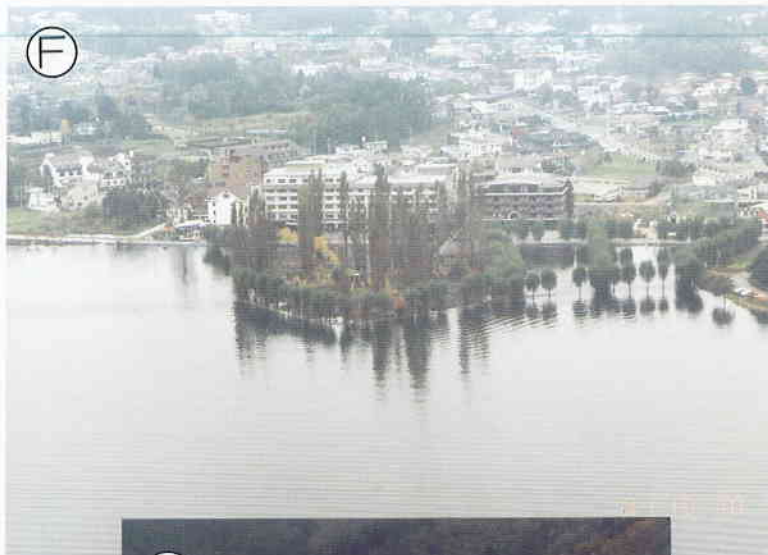
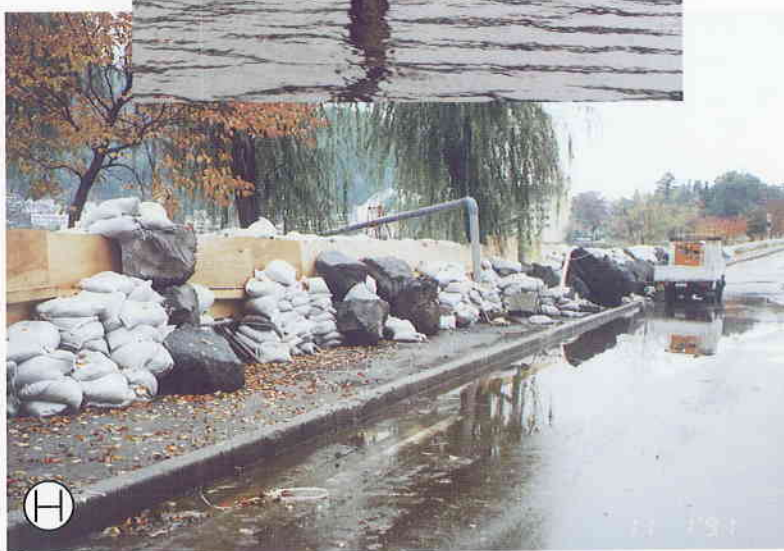
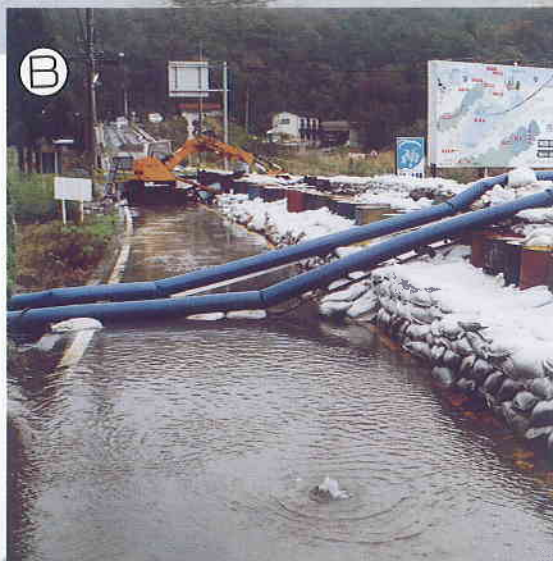
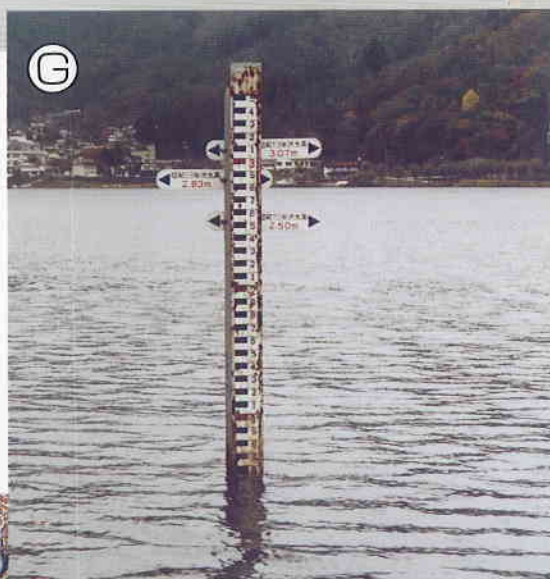
Fig.1 Layout of the Lakes and floods in 1991

Lake Saiko is one of the five lakes round Mt. Fuji formed by volcanic activities. The details of the lakes are given in the table 1. Fig. 1 shows the layout of 4 of these lakes. Due to the volcanic origins, there are no natural outlets from these lakes. Rainfall falling on the surrounding catchments are transported by natural rivers and ground water movement in to them, and the lake water levels rise according to the rainfall received. In recent history, several diversions have been constructed to utilize the lake storages for power generation, as well as to control the water levels. The only outlet from the lake Saiko with a capacity of 4 m³/s discharges in to Kawaguchi

Kawaguchi lake area suffered serious damage from rising water in August 1983. After this flooding, lake Kawaguchi was declared as a major river, thus enabling the government agencies to take part in its water storage planning. Fig. 1 (G) shows the levels of previous floods at Kawaguchi Lake, against 1991 water levels.

The ring road around Saiko lake was not usable since the middle of September. In some parts, the road was completely under the water (fig. 1, E) while in some other parts water seeping through drainage systems inundated the roads (fig. 1, B).

The Kawaguchi lake water too was at a critical level thus making it impossible to receive excess water from the upstream Saiko (fig. 1 F). In a few places around the lake Kawaguchi, road running around the lake was at a lower elevation than the

lake water level, protected by sand bags and pumps operating around the clock (fig. 1 H).

Almost all of the buildings affected near Saiko were leisure related (fig. 1(D, E)), while the permanent housing of the residents were located in high areas. No deaths or serious injuries have been reported. Although the damage assessment has not been completed, major losses are expected to be the loss of income from visitors for vacation and sightseeing and the cost of renovation of roads.
