博士論文

**Prediction for shallow landslides based on time history
of tilting of slope surface**

By
Jiren Xie

Department of Civil Engineering
The University of Tokyo

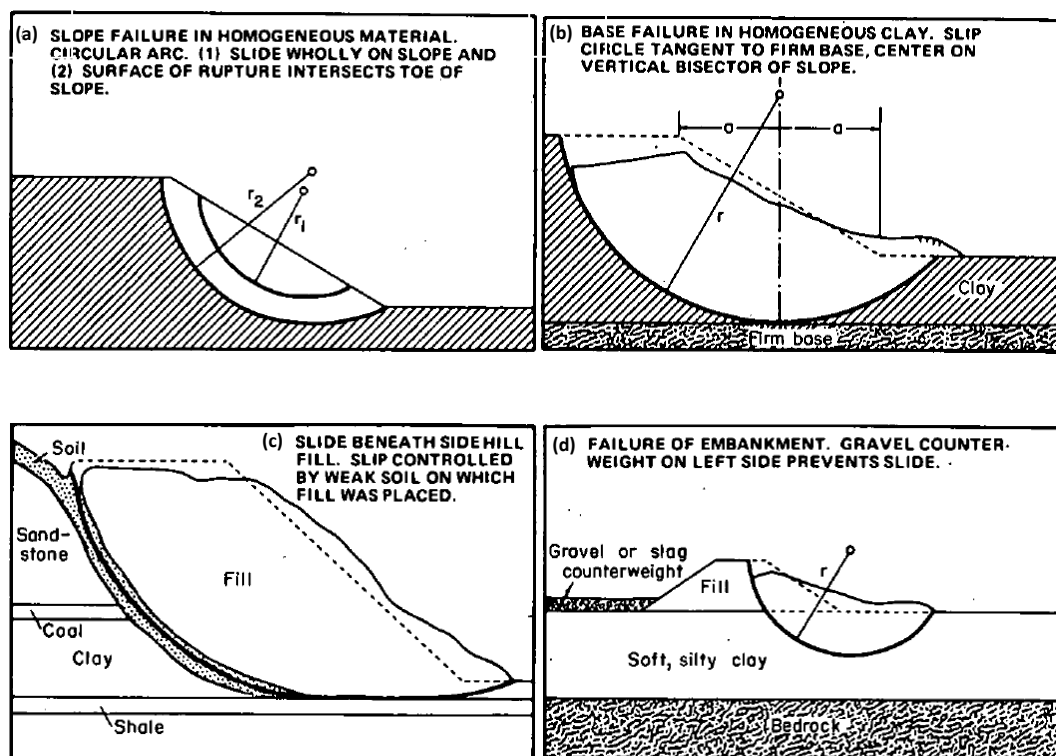
Fig. 2-3 Rotational landslides in homogeneous materials (after David, 1958)

The rotational landslips occur most frequently in fairly homogeneous materials, such as homogeneous slopes, constructed embankments as well as fills (Fig. 2-3).

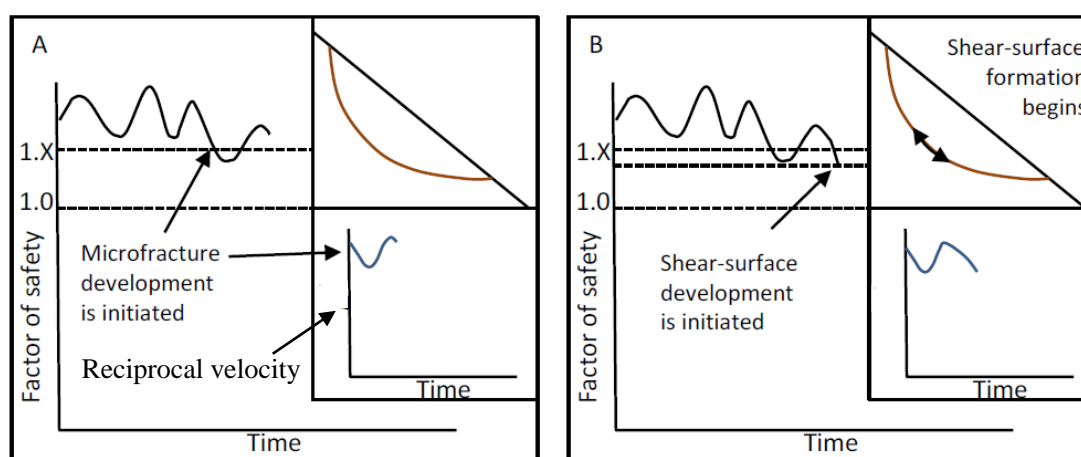
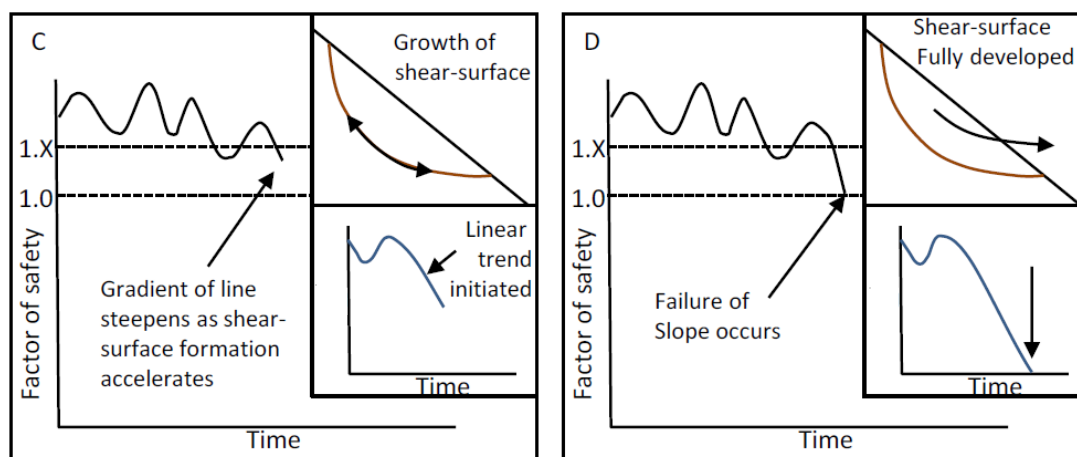
Fig. 2-5 Definition of slope failure considering the change in factor of safety (after Petley et al., 2005)

Petley also proposed a concept to define the slope failure based on the variation of the factor of safety in a slope, as shown in Fig. 2-5.

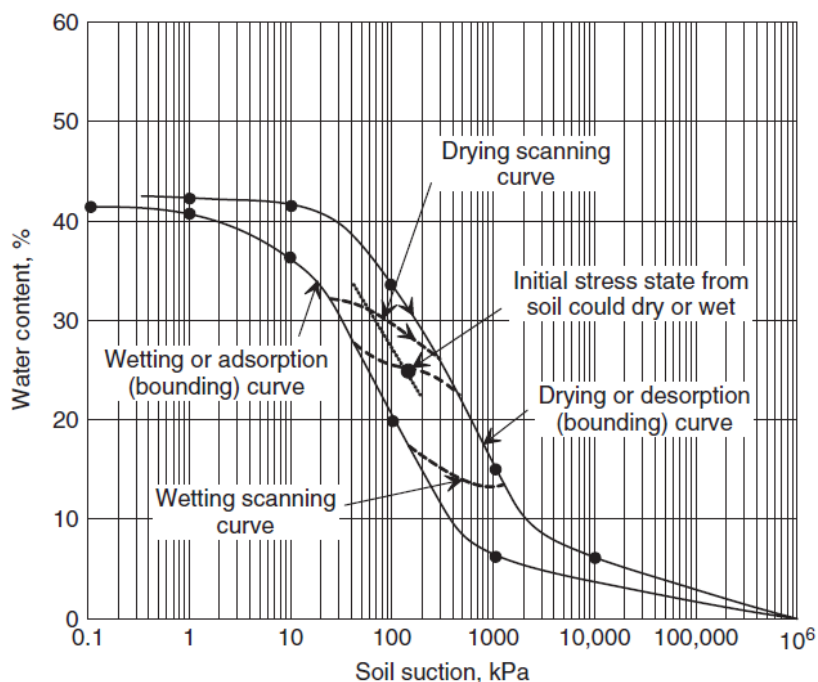
Fig. 2-7 Soil-Water characteristic curve (after Fredlund, 2003)

With a review of published research works related to the mechanism of rainfall-induced slope failure (Anderson et al., 1995; Farooq, et al., 2004; Brand, 1981), it is widely assumed that the slope failure induced by rainfall is because of reduction of matric suction with the water content of soil increasing during the rainwater infiltrating. The relationship between water content and matric suction is usually described by the soil-water characteristic curve(Fig. 2-7).

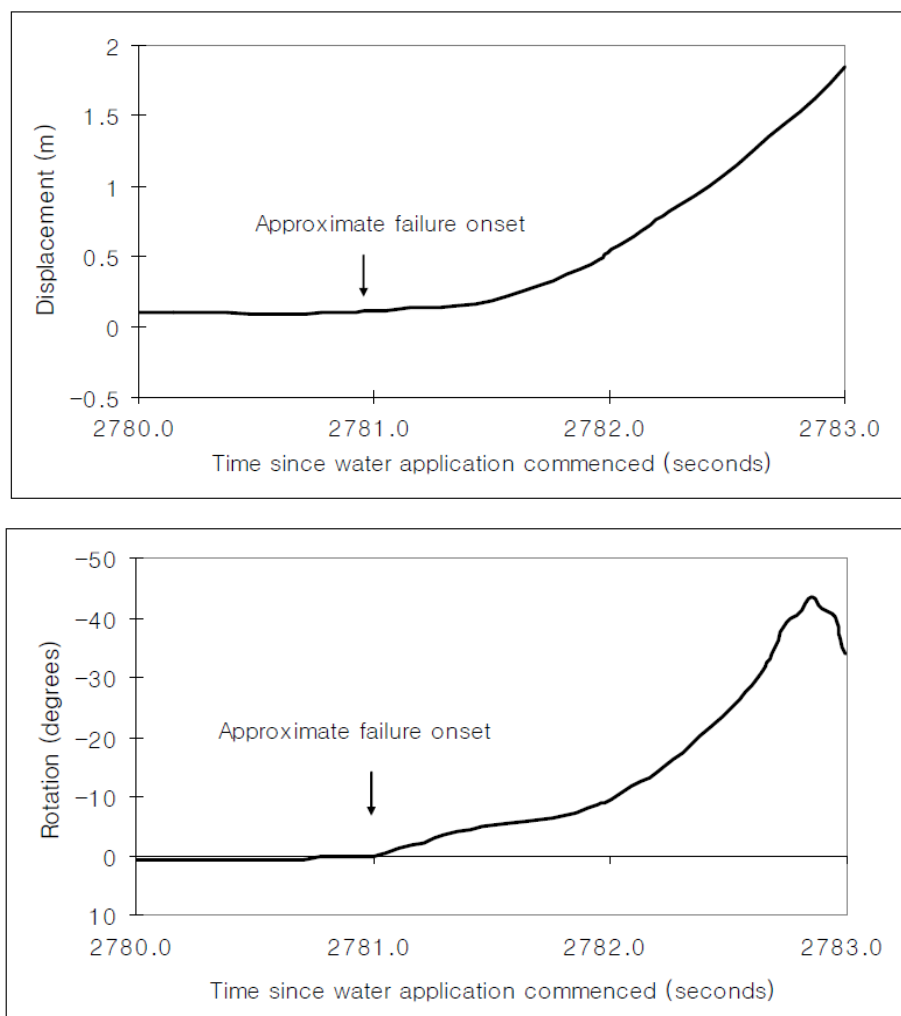
Fig. 2-16 Displacement and tilting angle against time (after Iverson et al., 2000)

and also indicate that, tilt movement could be used as an indication of a landslide failure.

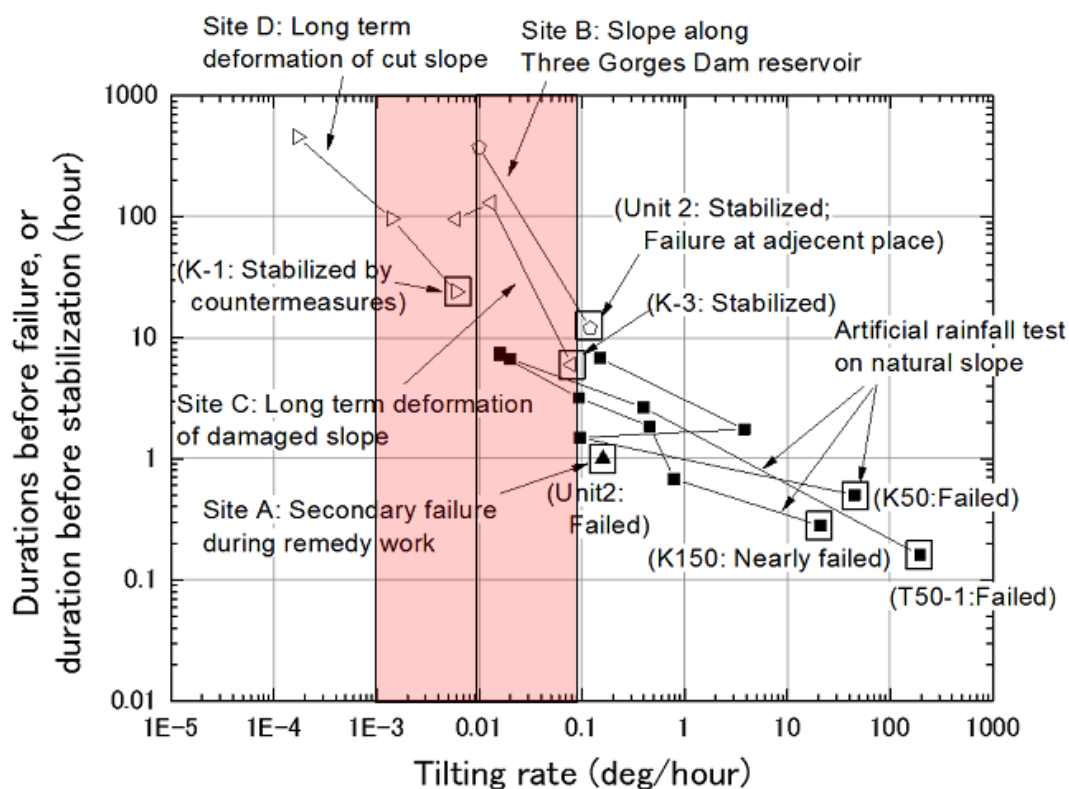
Fig. 2-20 Data of tilting angle rate against durations before failure and stability(after Uchimura,2015)

By imitating the method developed by Saito, in which the relationship between surface displacement rate and remaining time before failure was proposed for slope failure time prediction, the data of the tilting rates and the duration before slope failure or stability was presented in Fig. 2-20. The criterion value of tilting rates for precaution and warning was determined to be 0.01 degrees per hour and 0.1 degrees per hour respectively, for a conservative decision (Uchimura T. et al. 2015).

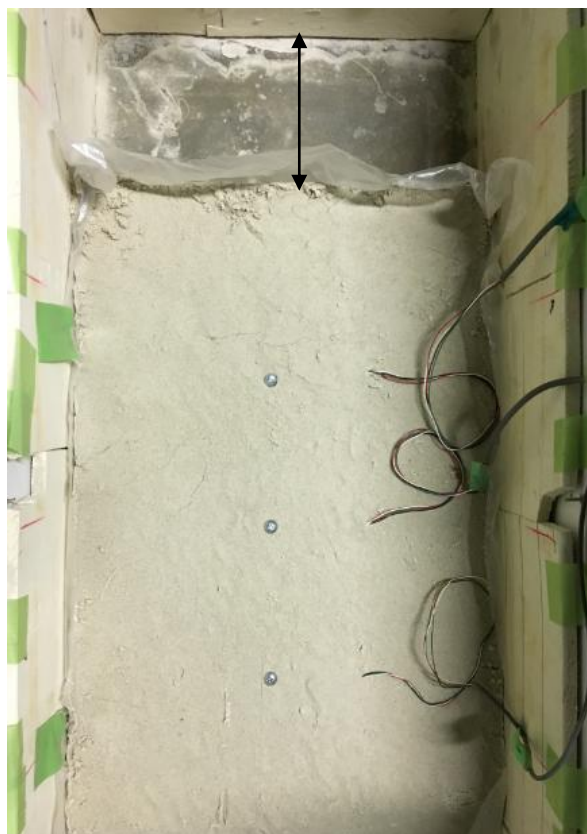
Fig. 5-24 The image of slope failure in Test 10

displacement (Fig. 5-24).

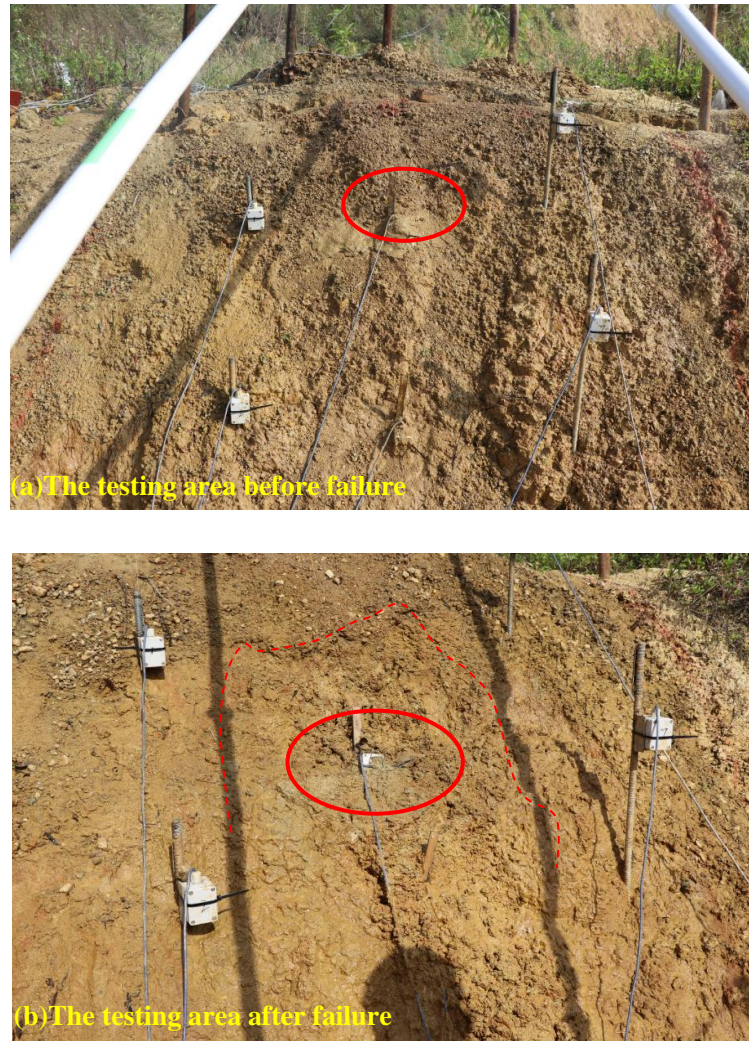
Fig. 5-44 Images of the testing area before and after the slope failure

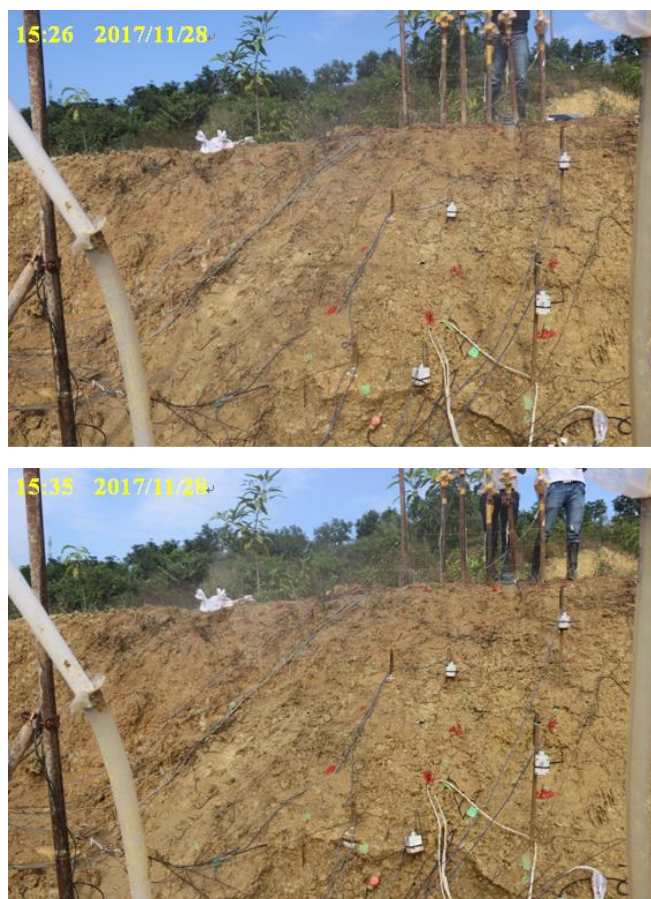
Fig. 5-48 Erossion occurred in lower part and caused the tilt sensors failed

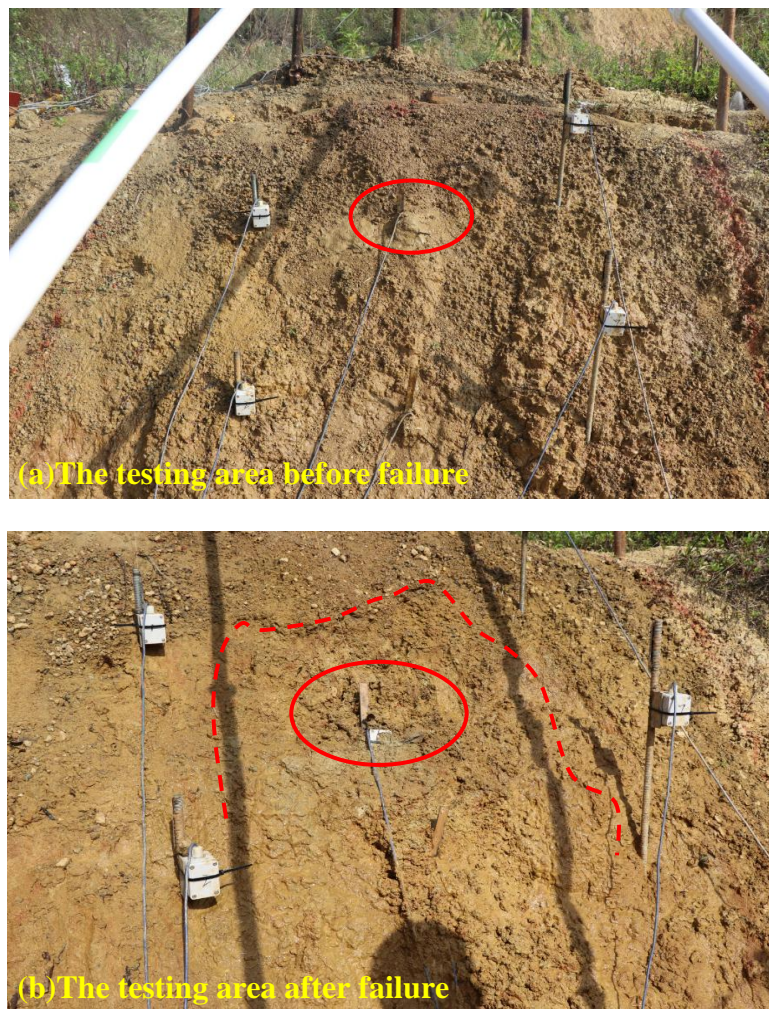
Fig. 6-92 Images of the testing area before and after the slope failure

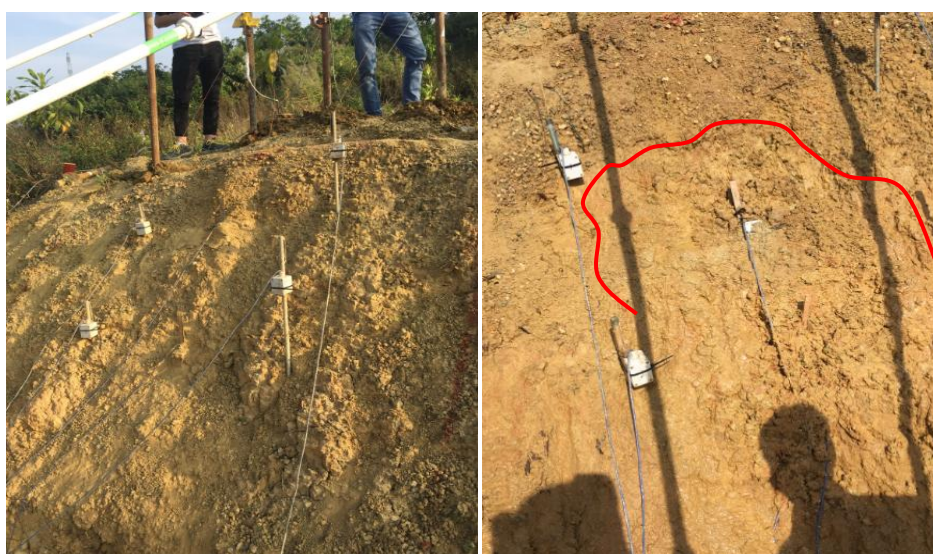
Fig. 7-9 The image before and after the slope failure in Test 3

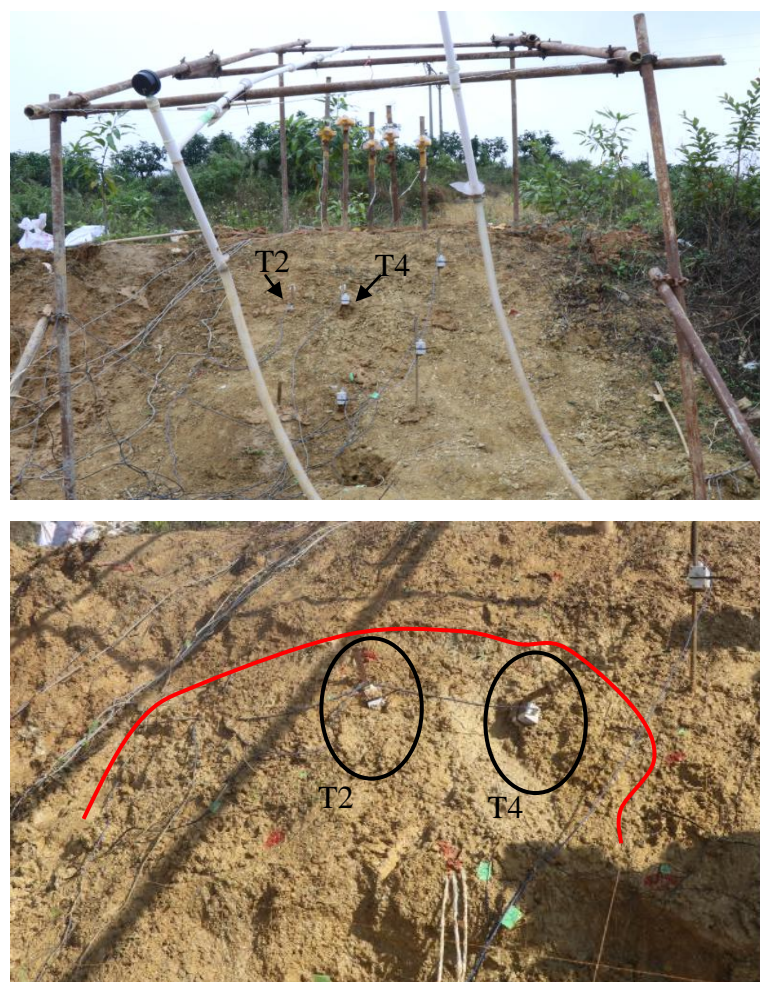
Fig. 7-12 The image before and after the slope failure in Test 4

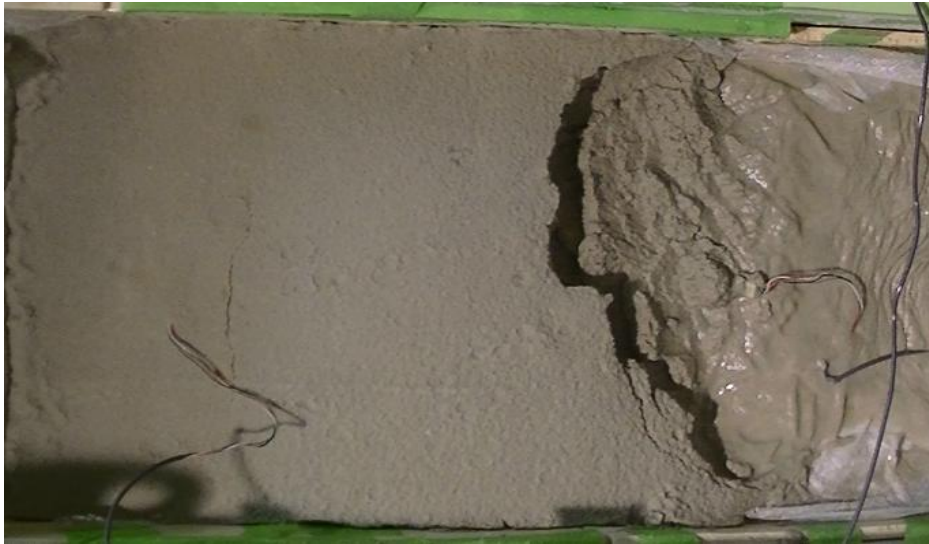
Fig. 7-24 The image of T2 damaged by erosion
