THE SEVERE JAPAN EARTHQUAKE OF THE 15TH OF JANUARY, 1887.*

BY S. SEKIVA.

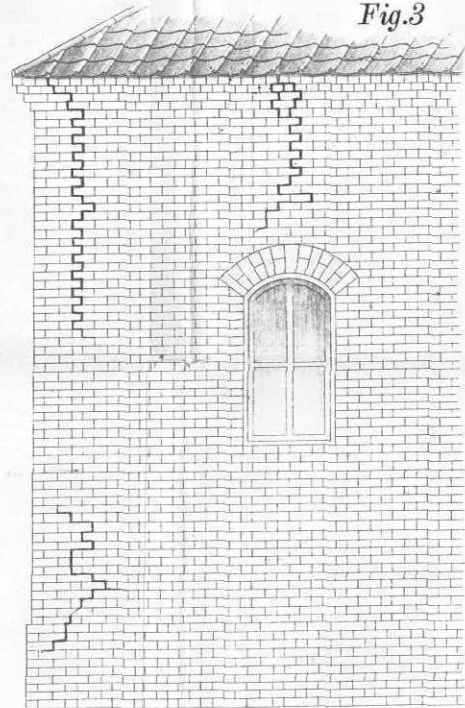
Fig.3

Two brick structures received serious damage (Plate II. Fig. 3), cracks having been formed, as usual, at the corners of the buildings and over the windows. The seismic vibrations, however, left no traces on the Town Hall, the Custom House, Prefectural Office, and other well-built structures of brick or stone.

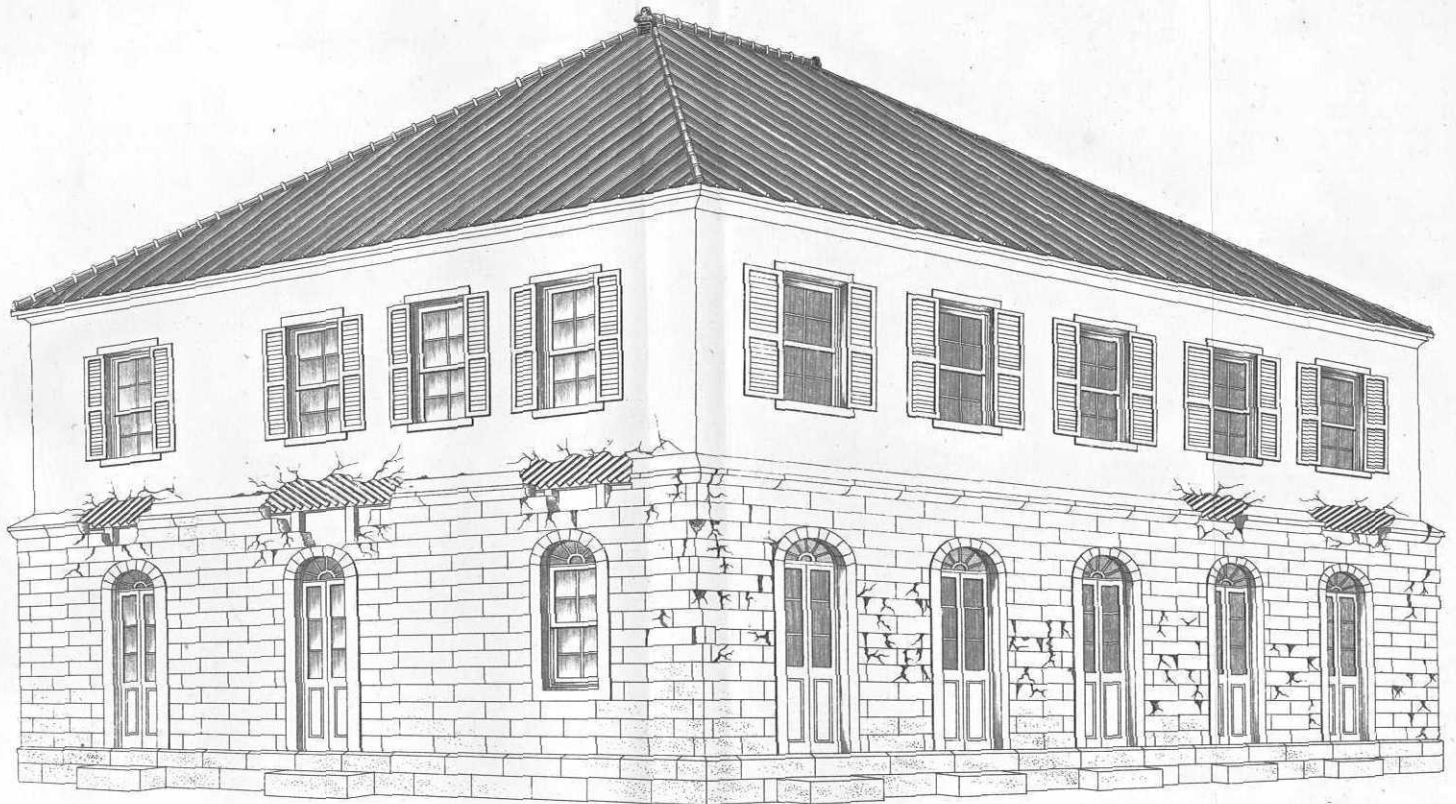
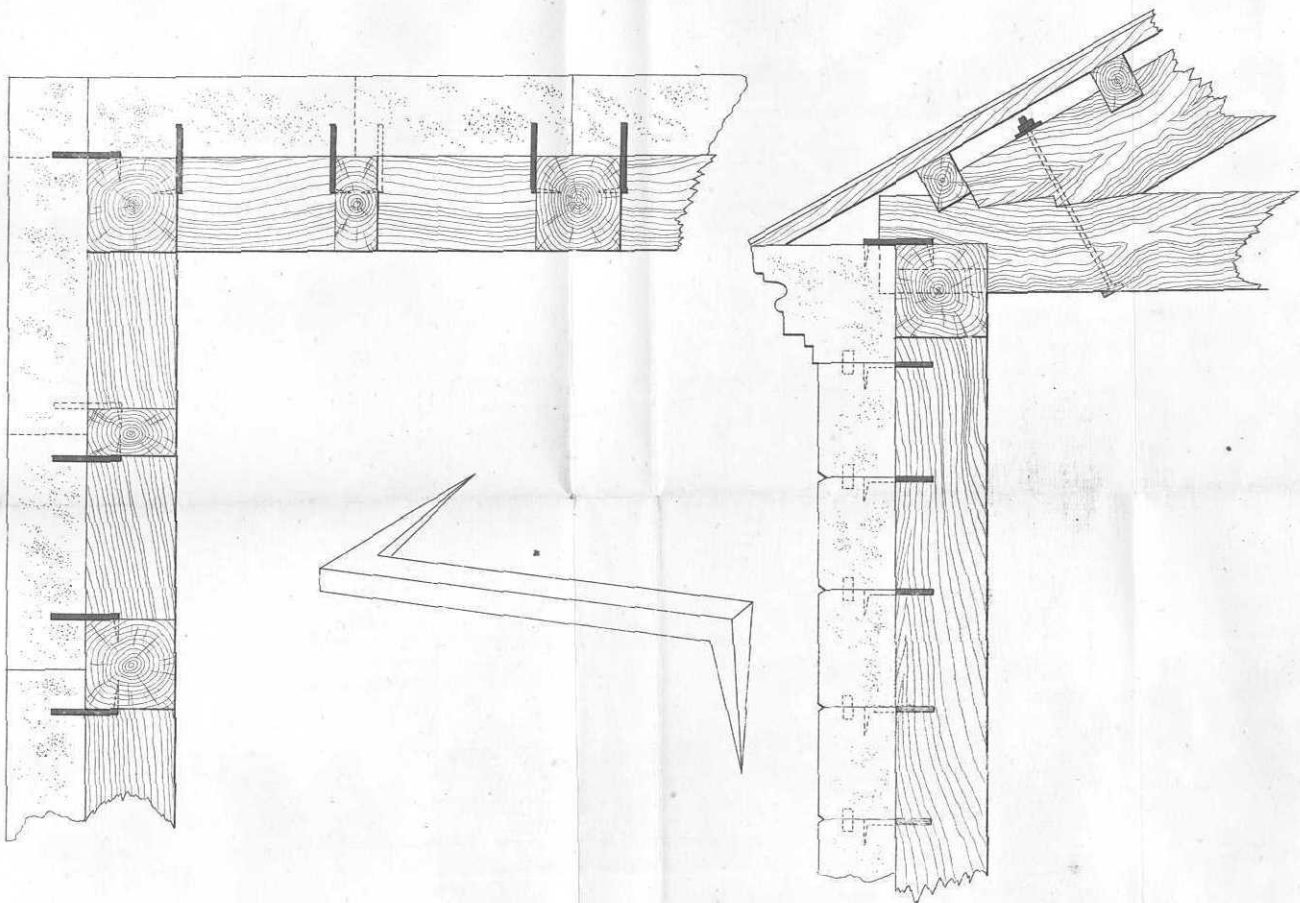
The houses which suffered most were the composite structures of wood and stone. They are built of wooden frames encased with stone blocks, each of the latter measuring 2 ft. 9 in. long, 9 in. wide, and 6 in. thick, and being clamped to the wooden planks inside by three iron-nails. Plate III. shows one of these houses that was affected by the recent shocks, together with the details of the stone attachments. The nail, called *kasugai*, is 5 in. long and $\frac{7}{16}$ in. square, and bent at right angles at its two ends. The stone is soft and brittle, being volcanic rock of the worst quality. In time the iron-nails get rusty, and the stones are so acted on by rain and frost as to be easily cracked, or detached from the wooden frames, even by moderate shakings. These buildings, erroneously called European houses, already exist in abundance, and unfortunately increase each year in number. They are
