14. *Heights of Tunamis and Damage to Structures.*

By Nobuji NASU,

Earthquake Research Institute.

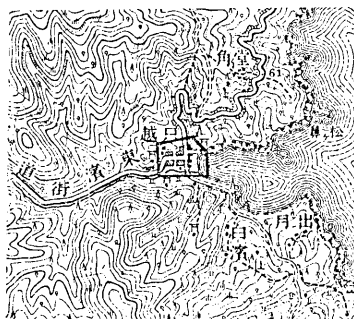
Fig. 7. Map of Tadakosi. 1/50,000.

The area enclosed by thick lines was surveyed.

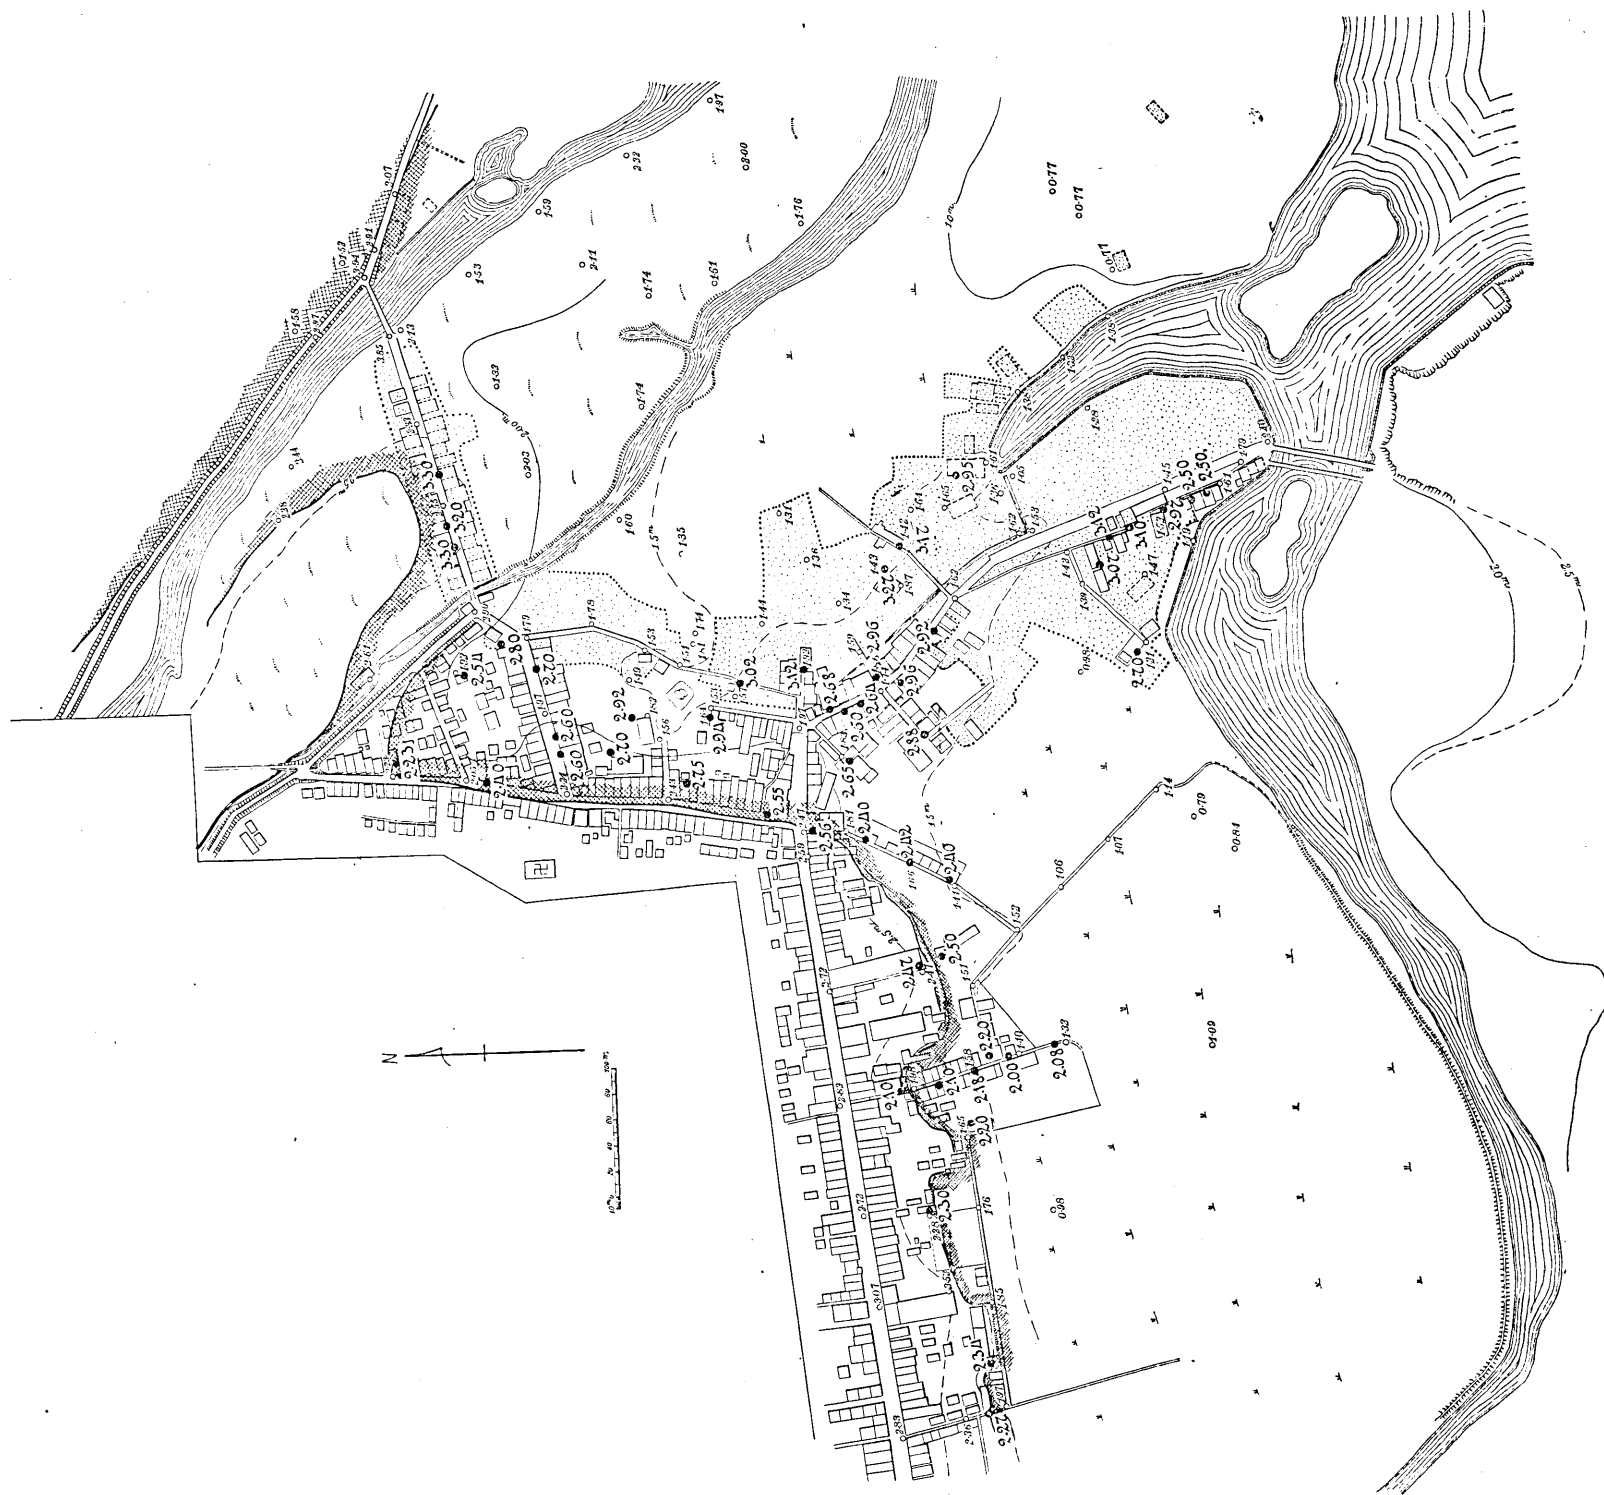
Fig. 23. Ooduti. ($\frac{20}{77}$ \times the original map)

Ooduti. All houses near the seashore were destroyed. The reduced heights of the water was about 3.5 m. As the ground was very flat the inundated area was comparatively large. The houses which were destroyed were those on low ground, less than 2 m above mean sea level. (See Fig. 23.)
