*Survey Report on the Tsunami of the Michoacan, Mexico
Earthquake of September 19, 1985*

Abstract

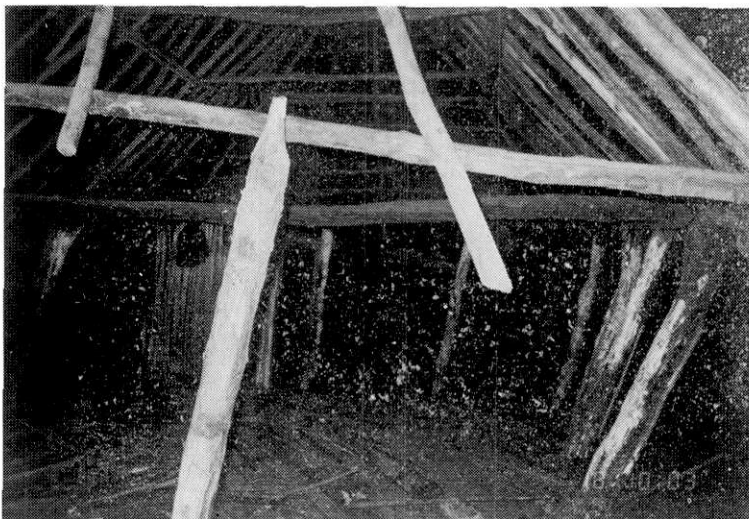
Fig. 3. Damage of thatched hut at Barra del Potosi. Pieces of furniture in the hut were washed away.

The small village of Barra del Potosi, 14 km southeast of Zihuatanejo, suffered considerable damage. It is situated at the southeastern extremity of Bahia el Potosi bay, facing southwest. The area remained disturbed after the tsunami. Residents living near the sea first noticed unusual sea disturbance. They observed an initial withdrawal of sea and escaped to high ground or to a stone-masonry house for safety. There was no loss of life. One observer reported that water had reached to the top of a coconut tree on the beach, but the tree showed no evidence of the tsunami at the time of our investigation. Some huts of light construction on the beach were seriously damaged, many posts being uprooted or tilted (Fig. 3). They were of wood-skeleton structure with a thatched roof. Pieces of furniture in the huts were washed out to sea. The tsunami height was estimated at 4 meters. The move of the community to a safe place from the beach was under plan at the time of our survey.

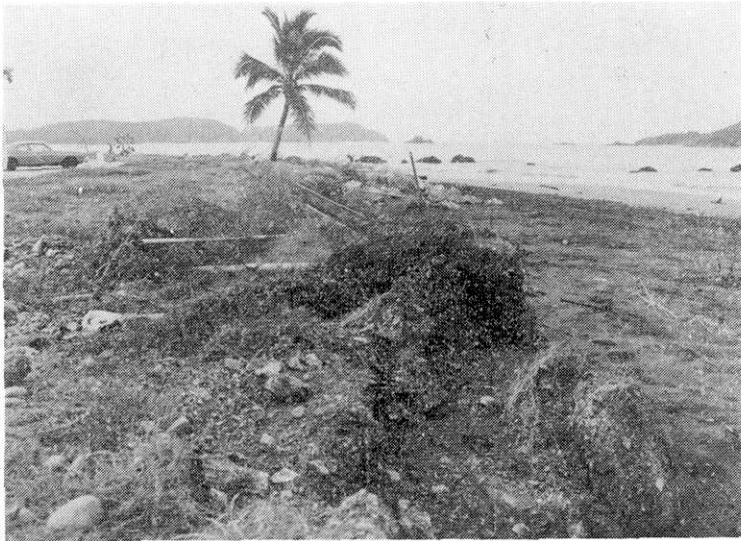
Fig. 4. Damage of fences at Playa Linda.

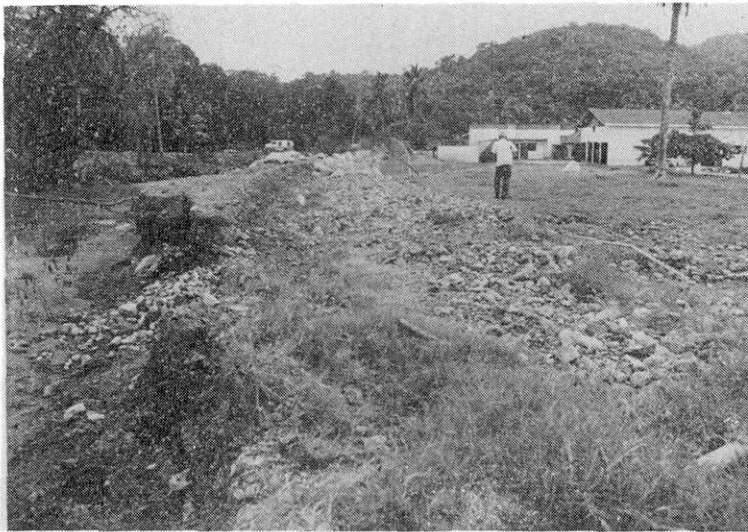
Fig. 5. Damage to the banks of the small stream at Playa Linda. The photo faces the sea.

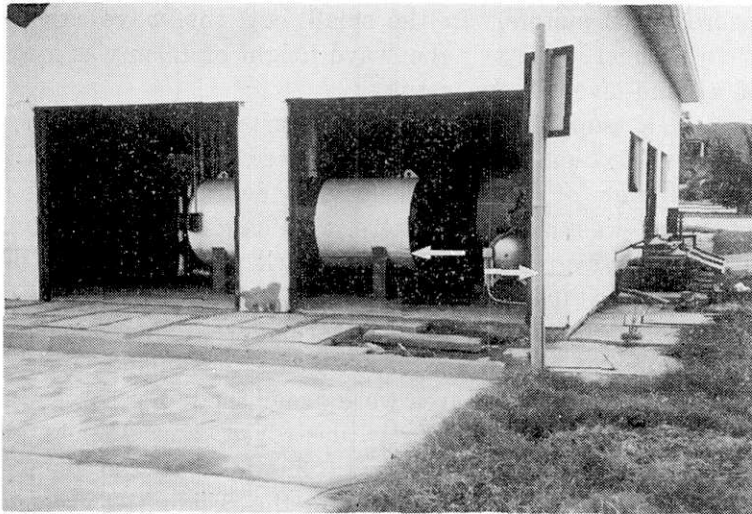
Fig. 6. Boilerhouse at Playa Linda. Note arrows where the tsunami left dark traces behind.
