24. *Ground Cracks at Matsushiro Probably of
Underlying Strike-slip Fault Origin, II*
—*The Matsushiro Earthquake Fault.*

By Kazuaki NAKAMURA and Yukimasa TSUNEISHI,

Earthquake Research Institute.

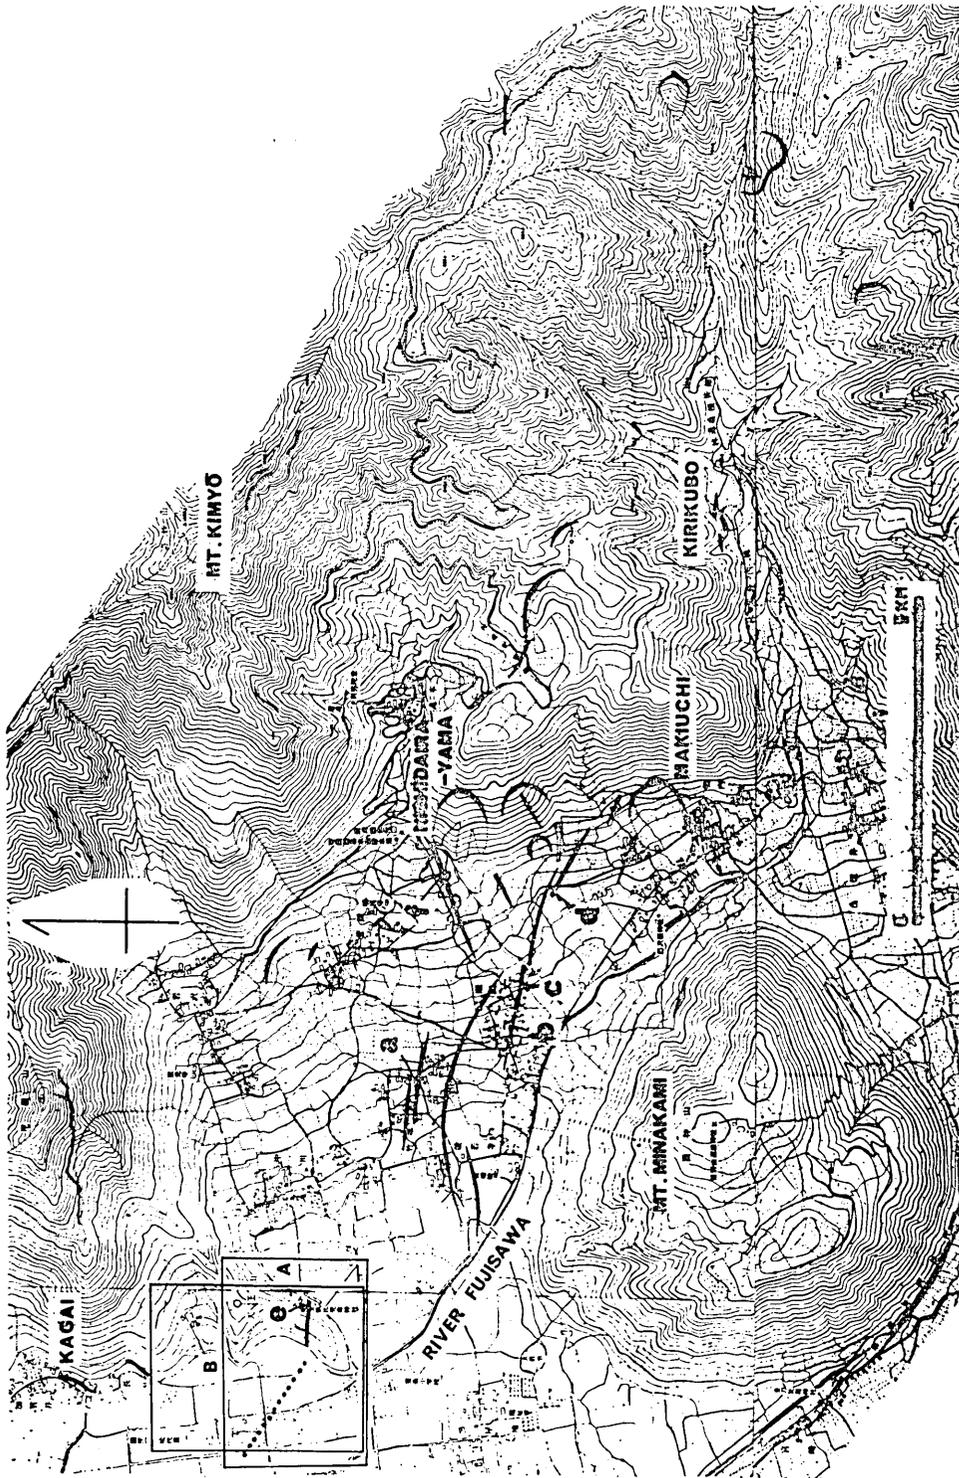
Fig. 11. Map showing the distribution of fissure zones (a group of ground cracks) regardless of their origin. There may be some more which the writers have not observed. Dotted line in the extreme left indicates the axis of deformation of concrete levees. Landslides are shown by thin dotted lines with fissure zones at Nishidaira-yama, Makiuchi, Kirikubo and the one in the lower right. Quadangles in the upper left are areas covered by Figs. 44(A) and 47(B).

Distribution of fissure zones or groups of ground cracks as mapped by the writers up to march 1967 is shown in Fig. 11. Their distribution as of June, 1966 has already been shown in Figs. 1 and 2 of the first paper. Additional ground cracking was not observed until the end of August, 1966. From the end of August to October, 1966, or during and after the last culmination of seismicity, a number of ground cracks were formed some of which were associated with areal new ground water outflow. Since October no new cracks have developed and the older cracks have become more and more obscure in part as a result of winter frost and snow. By the spring of 1967 most of the cracks could be located in the field only indirectly by displaced structures such as the concrete base of a house. Volume of outflowing water has also decreased, leaving chemical precipitates at some of the springs.

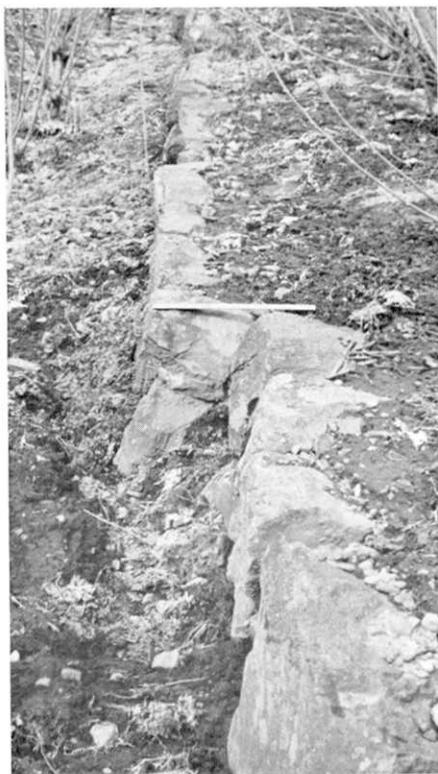
Fig. 13. Broken concrete slab at locality F₁-a, showing left-lateral displacement of crack A on Sept. 16, 1966. The same crack in April, May and June, 1966 was shown in Fig. 6 in the first paper. Oblique view is given in Fig. 27. Width of clino-compass is 6.5 cm.

first paper. Locality F_{1-a} is in its garden. The appearance of a concrete slab crossed by the zone is illustrated in Fig. 6 of the first paper and in Fig. 13. Further to the west, there is a terraced field where ground cracks similar to those east of the cross road were observed. The western end of the zone was inside a house. The concrete foundation of the east side of the house was cracked at three points and opened 6 mm in total amount. On the inside extension of the largest crack (4 mm wide) a collapsed mud wall was noted. No damage was observed at the western side of the house, which has no concrete foundation. On the ground there were a few short cracks with trends similar to those of the fissure zone, but a definite distinction from ordinary desiccation cracks was difficult.

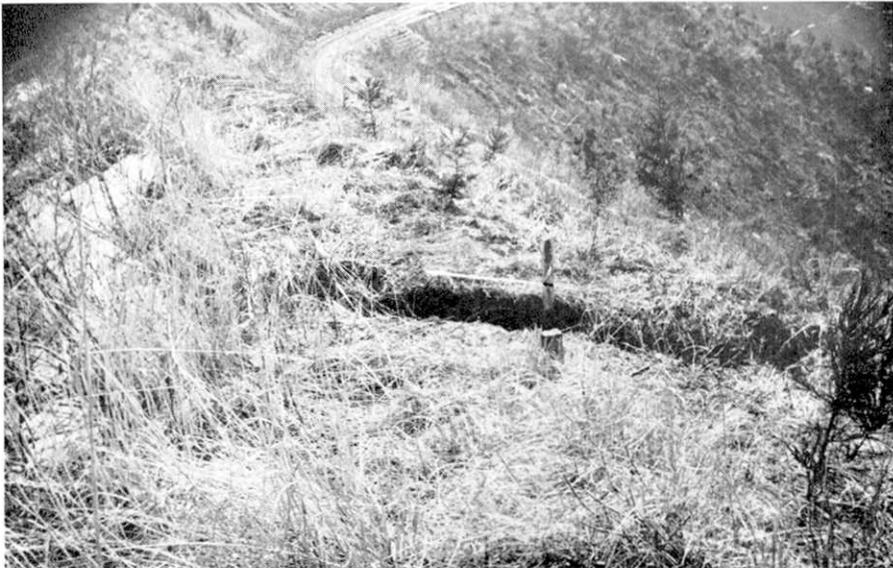
Fig. 16. A ground crack crossing a narrow ridge (F₁₄). Relative subsidence of this side amounts to 30 cm. Looking south. Horizontal scale on the up-thrown side is 1 m. Photograph taken March 17, 1967.

Zone F₁₄ consisted of a single continuous ground crack trending almost EW which coincides with a geologic fault. It obliquely crosses a narrow ridge in a N60°W direction. The north side subsided about 30 cm and no appreciable lateral slip was observed (Fig. 16). These features may not be explained as a simple effect of gravitational sliding, but might represent the result of displacement along a pre-existed fault plane due to earthquake vibration. As its distribution is isolated from other fissure zones, it is excluded in the following discussion.

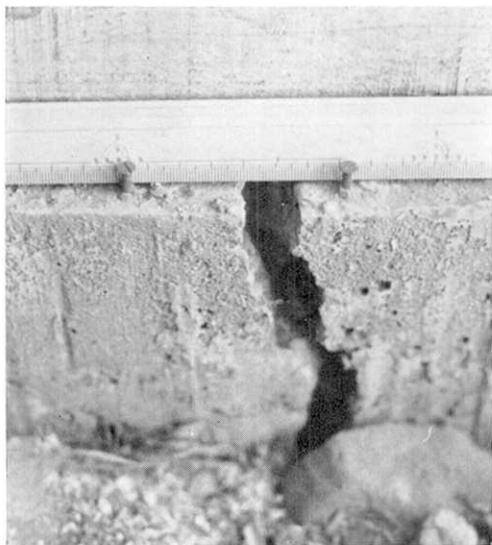
Fig. 19. Method of type Ic-s at Station F₂-b (In), where a crack occurred crossing a concrete base of a wooden house. Photograph taken Jan. 26, 1967.

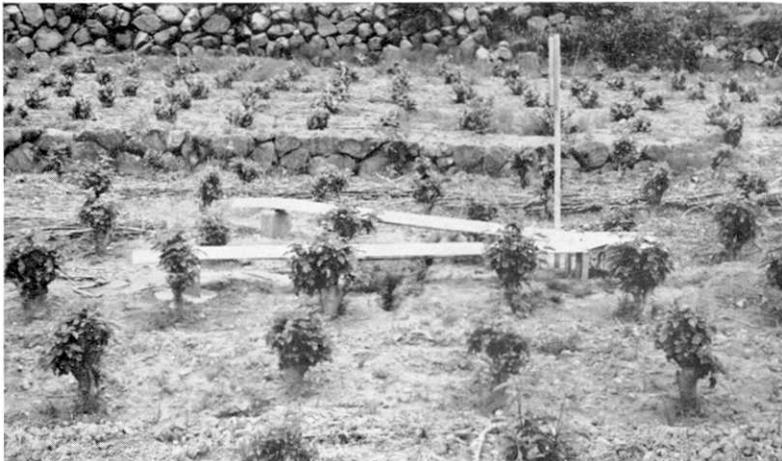
Fig. 21. Displacementmeter of type IIb-v installed in a mulberry field at Station F₃-d. Relation to ground cracks is shown in Fig. 28.

F₃-d: Zone F_3 crosses a mulberry field where there are no convenient constructions for measurement (Fig. 28), and method type II (Fig. 21) was used. The measurement at this locality became impossible after the middle of September due to the submergence of the station and collapse and loosening of the soil under an extraordinary volume of

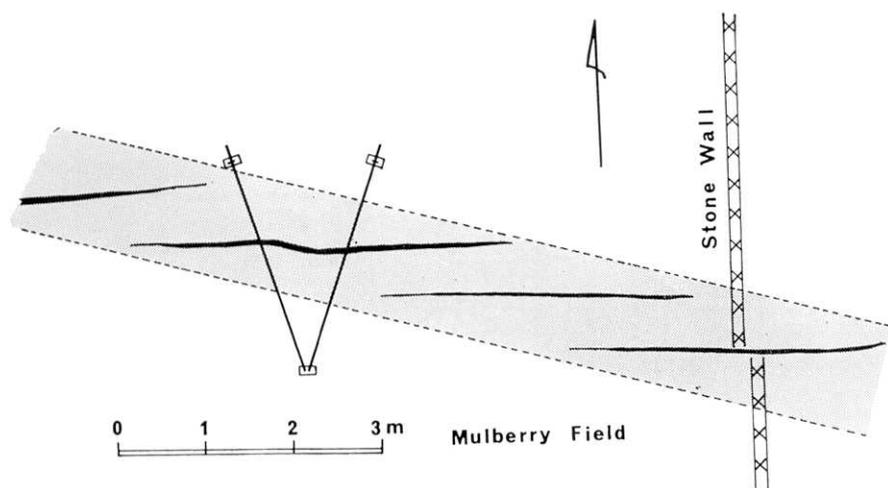
Fig. 28. Sketch map of Station F₃-d. Stippled area is the fissure zone F₃. A photograph of offset wall is given in Fig. 14.

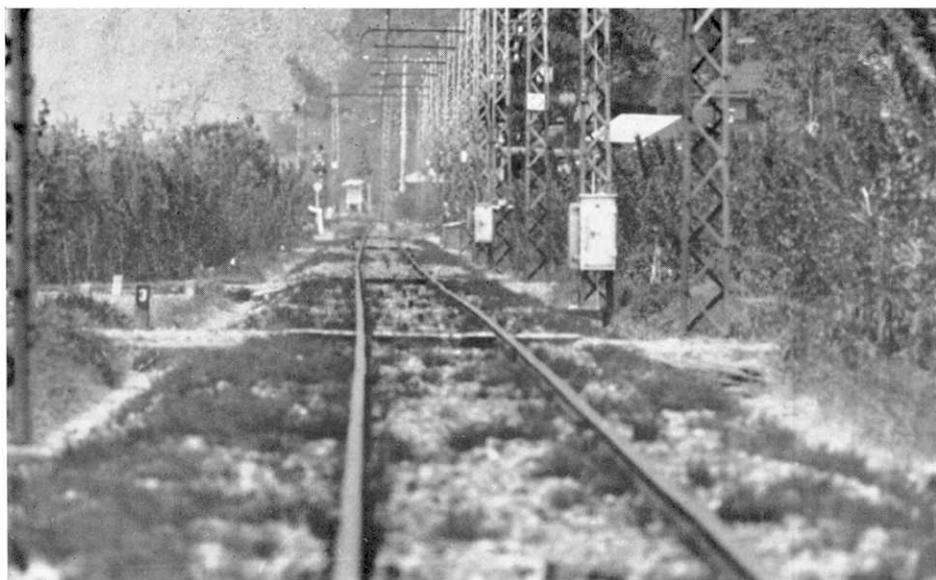
Fig. 45. Deformation of a railroad track.

The deformation of the track, as observable with the naked eye is shown, somewhat exaggerated in Fig. 45b. An instrumental survey has not been made of the railroad line. According to personnel responsible for track maintenance, the bending was noticed in April, 1966 and further increased during August and September of the same year. Bending was accompanied by increased clearance of joints between rails and breakage of bolts severe enough to require repair work. The deformed track consists of, roughly speaking, two parallel lines and an oblique intermediate part. There are three bending points with an additional one in the oblique part. Thus, during September the east-side rail of the southern bend was replaced by one which is 45 mm longer than the old one. Next, in November the west-side rail of the northern bend was

Vertical displacement is also apparent by careful naked-eye observation from distant places as shown in Fig. 45c which was taken at the southern extremity of Fig. 45a·b. Although the change of level is very gradual, it is clear that the northern side of rail No. 20 has subsided by a few tens of centimetres.

A buried left-lateral fault hypothesis is able to explain all the foregoing evidences. Moreover, it explains that the left-lateral fissure zones arranged *en echelon* are distributed in a narrow area and that comparable phenomena to ground cracking are observed, such as the deformation of a railroad track (Fig. 45), water pipes (Fig. 47) and concrete levees (Fig. 44) on the northwestern extension of the area. The hypothesis is consistent with the systematic distribution of the first P'polarity of the major⁸⁾ and micro⁹⁾ Matsushiro earthquakes, in that it assumes an accumulated maximum compression in an E-W direction as discussed in the first paper (p. 1382).

Further northwestern extension would be defined by the stretch of deformed railroad track, judging from similarities in the sense of vertical and horizontal displacement with the assumed fault and from coincidence of rapid displacement with the high seismicity period. The two outer bending points in Fig. 45b would define the width of strong deformation belt.

In the case of the railroad track (Fig. 45), the total length of rails increased as the result of replacement from September to December, 1966, by 404 mm in eastern rails and 310 mm in western ones. 357 mm, the average of the two, gives the approximate amount of extension of the ground in a direction $N20^{\circ}E$ in a horizontal span of about 500 m, although there are factors suggesting that this value could be somewhat larger or smaller. The clearances of joints seem to have become generally narrower as compared with the preseismic ones in the section concerned thereby tending to exaggerate the extension, whereas possible slip to some degree between rails and ground would tend to decrease it.

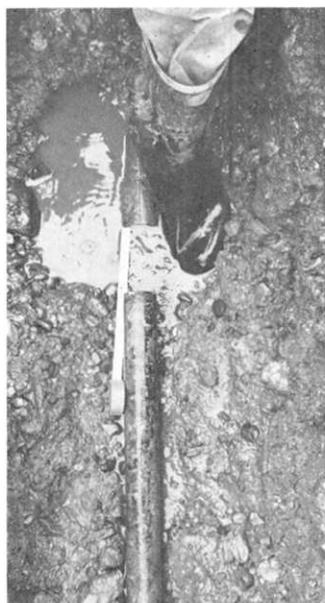
Fig. 48. Photograph showing the pull apart damage of a water pipe in shallow underground. Number 9 in Fig. 47 and Table 5. The distance is 10.5 cm. Photograph taken by Mr. Isao Kasuga, on September 9, 1966.
