31. *Geology of Imaichi District with Special Reference to the Earthquake of Dec. 26, 1949. (II)*

By Ryōhei MORIMOTO,

Earthquake Research Institute.

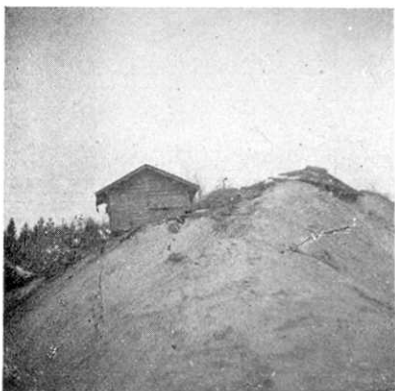
Fig. 7. Slipping of the soil along the weathered layer at the surface of the porphyritic granite, near Kusagyū.

took place along the bottom of the layer of the surface soil. The thickness of the slipping layer is less than 1 m in most places in this granite region (Fig. 7). At Nakayama, a granite terrain, land slips are not so conspicuous as at the above-mentioned granite terrain. The granite of Nakayama is different in its rock facies from the granite near Kusagyu or Okurugawa; it contains no porphyritic perthite. The occurrence of the remarkable surface changes in the granite terrain near Kusagyu and Okurugawa may be attributed chiefly to the petrographic cause. Slippings of the comparatively thin deposits of surface soil with similar appearance are frequently met with on the slopes of the mountainland in the southwestern part of this meizoseismic area where the compact Palaeozoic rocks are exposed (Fig. 8). The Palaeozoic rocks in this district are shale, slate, sandstone, conglomerate, and hornfels derived from them, and in many cases they are highly silicified into hard compact rocks. In these rocks as well as in the granite, there is no geological discontinuity. The distribution of these land slips which are exclusively of small scale is greatly influenced by the local topography. Some of them were destructive and took place along road cuttings, e.g. those along the Ooashi River.

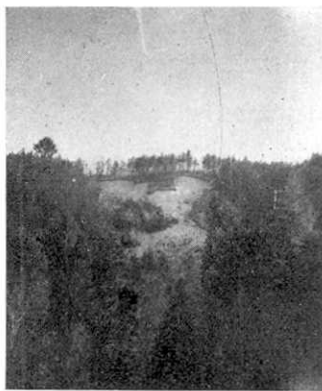
Fig. 8. Slipping of the thin soil on the slope of Palaeozoic mountain near Yamaguchi, on the right side of the Kuro River.

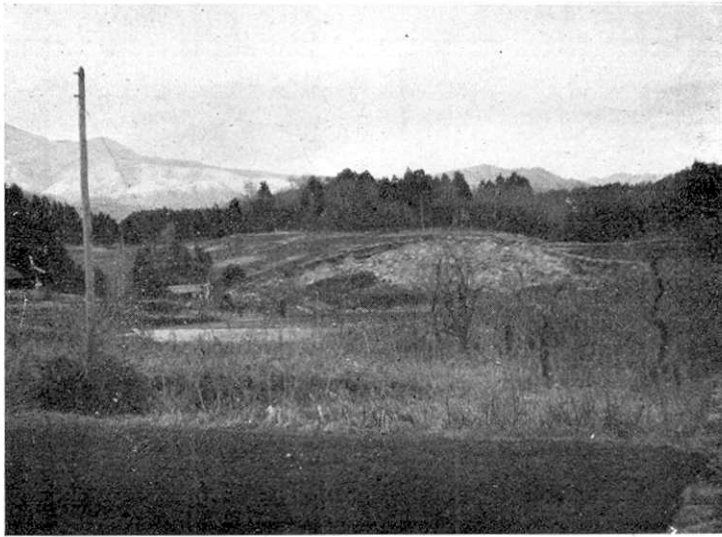
Fig. 11. A northward view of the amphitheatre-like land slip at Numauchi, about 100 m across in the E-W direction.

Chasms were formed on the wheat corn field at Numauchi, 3 km west of Imaichi, and 3 km southeast of the town of Nikko, at the time of the earthquake of 8:18 a.m., December 26. The gently sloped surface of the corn field changed into an amphitheatre-like topography, about 100 m long in EW-direction and about 5 m deep (Fig. 11) at the time of the succeeding earthquake of 8:26 a.m. The

original dips of the surface and of the strata were gentle, not attaining to 10 degrees southwards. Displacement of the slipped land mass was not uniform; larger in the central portion of the collapsed area, smaller in the marginal portion, attaining to 30 m or more in the remarkably slipped portion. The area of the corn field damaged is roughly estimated as $4 \times 10^3 \text{ m}^2$. The mass which slipped or collapsed into mosaic aggregate of blocks consists mainly of reddish brown pumice. The slipped plane was not recognized here.

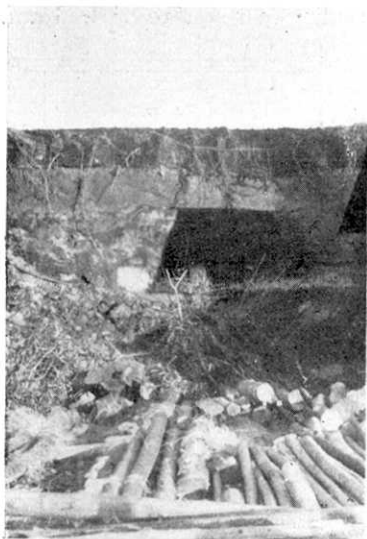
Fig. 12. The geologic succession of the strata near Itabashi. (Cf. Figs. 9 and 10. Photo. by H. Kawasumi.)

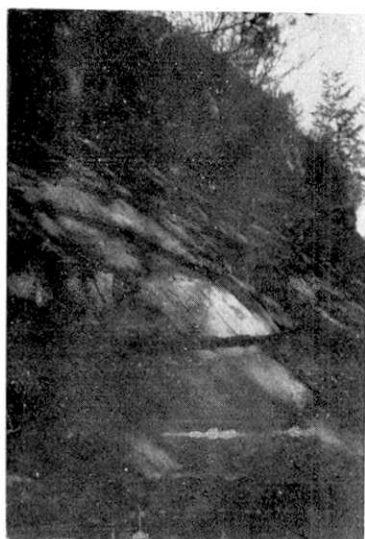
Fig. 13. An exposure along the road-cutting through Ushiroyama. Notice the slipping along the lower boundary of a white clay bed intercalated in the loam beds. (Cf. Figs. 9 and 10, Photo. by H. Kawasumi.)

Slipping is apt to be brought about along the boundary plane with these intercalated beds. Near Numachi, a compact clayey loam bed, overlaid conformably with the above-mentioned aeolian pumice beds, such as the uppermost "Kanumazuchi" and "Imaichizuchi", suddenly grades into a coarse undecomposed pumice bed at the depth of 3.7 m from the surface, and further into a coarse sandy bed at 5 m. There is no evidence to show that any displacement of the strata under this compact loam took place.
