30. *The Great Indian Earthquake of January 15, 1934.*

By Nobuji NASU,

Earthquake Research Institute.

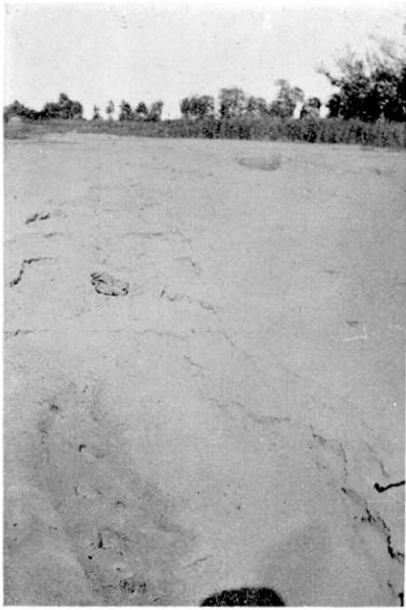
Fig. 2. Sand-deposits and fissures,

The cracks were often double, with short branches, but the general effect was an avenue of sand about 50 yards wide and stretching across the country in an unbroken length for a mile. One walking across the country at right angles to one of these sand avenues would meet with others at a distance of 400~500 yards running roughly in a parallel direction.

These sand avenues were like the crests of waves several hundreds yards apart. (See Figs. 2~5).

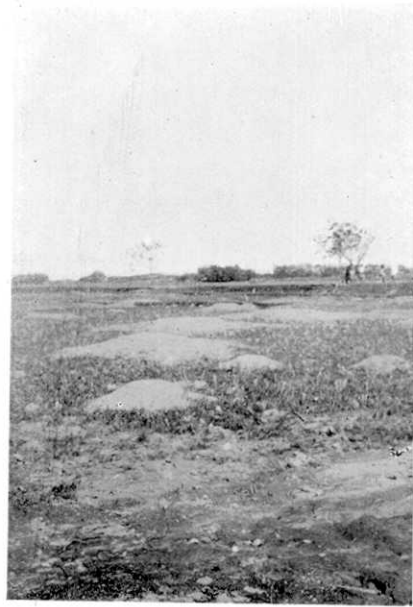
Fig. 3. Craters of ejected sand,

(2) At places where the outpouring pressure was not so great the water bearing sand was forced up through small fissures that did not reach the ground surface. These burst out through small isolated craters of sand varying from 1 ft to 3 or 4 ft in diameter. These craters are not the tops of turbular openings going down many feet into the earth.

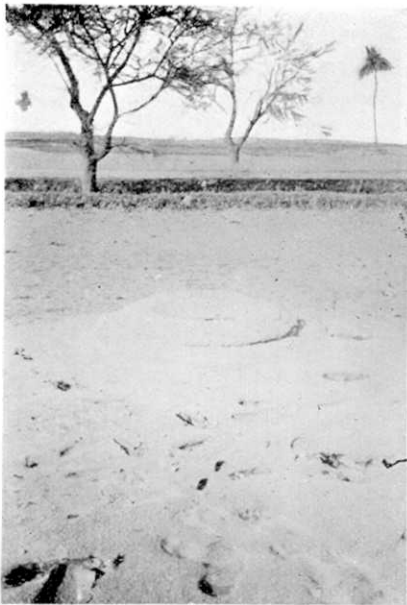
Fig. 4. Craters of ejected sand,

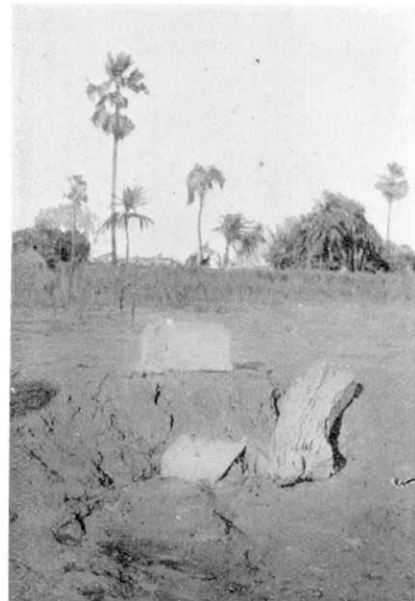
Fig. 5. Two old baked curved tiles and part of wooden cutting edge (Jamo) of the long forgotten well deposited on the surface by the outrash of sand,

(4) Another type of sand deposit is the basin-like hollow, about 5 ft in diameter and one ft or two ft deep. Hollows of this type were found at places where there had formerly been wells. The site of an old well, now filled in and lying under cultivated land, but whose existence was revealed only through the sand that had gushed out through it, assumes the form just described.

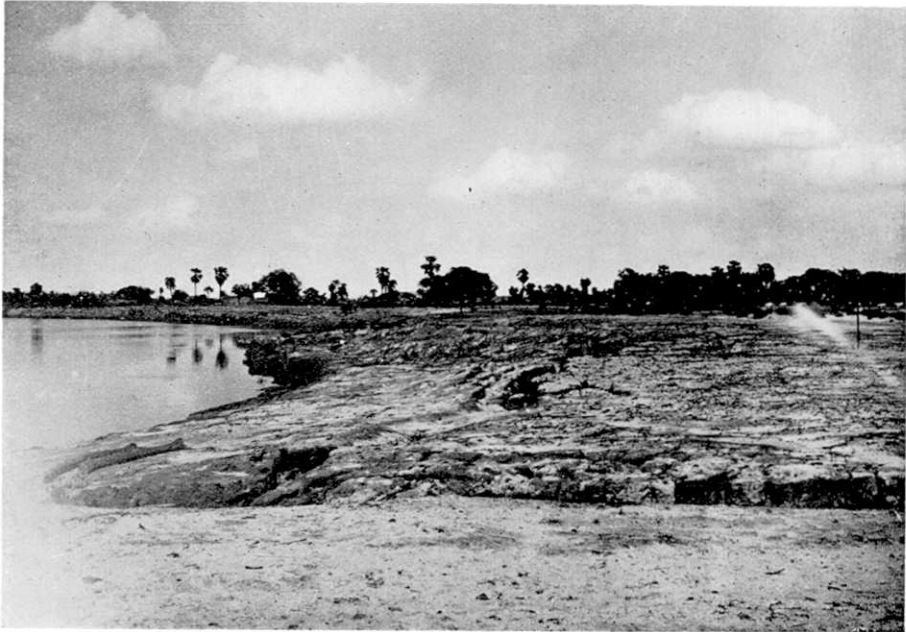
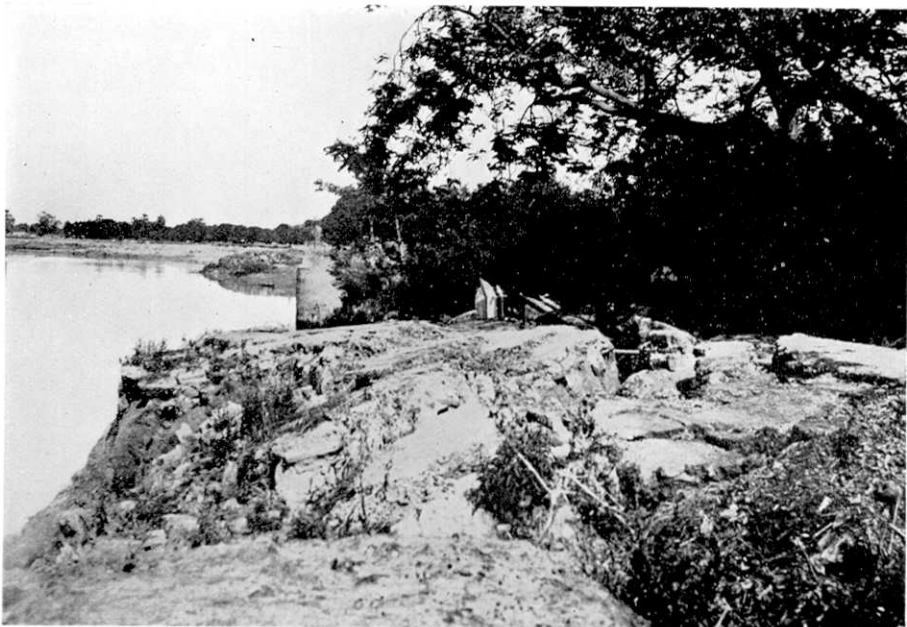
Fig. 9.

Fissures in the river banks near Muzaffarpur.

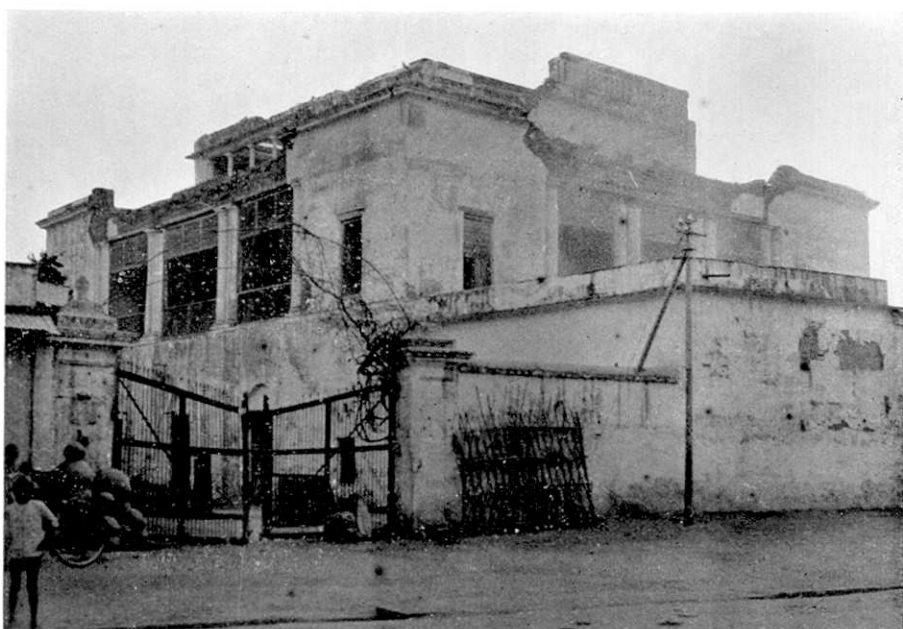
Fig. 11. An office building in Patna. *N. Nasu, Photo.*

Fig. 12. A private residence in Patna. *N. Nasu, Photo.*

Examples of houses that had their upper parts were broken off by the earthquake.

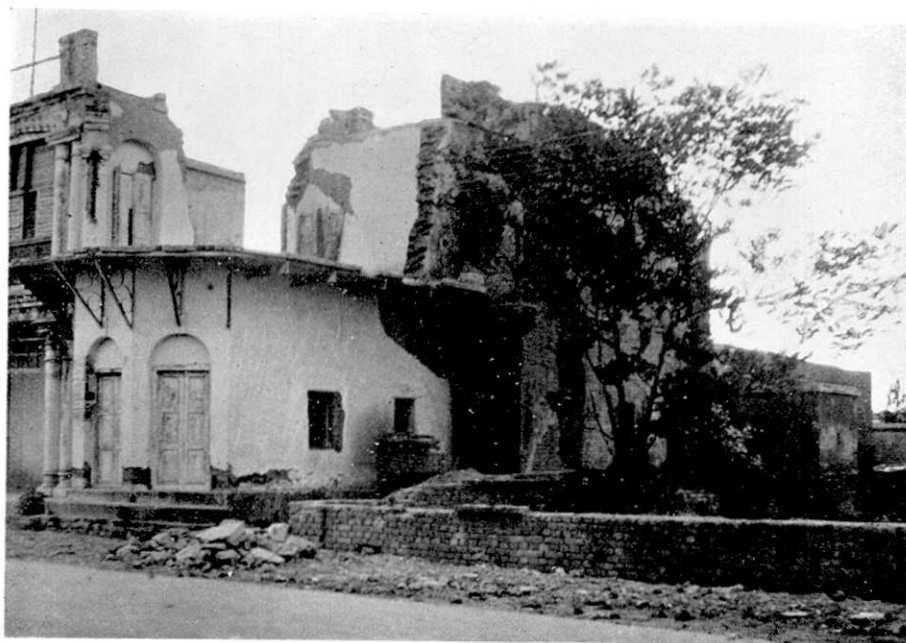
Fig. 13. Aprivate residence in Patna.

Fig. 14. Aprivate residence in Muzaffarpur.

Examples of houses whose upper stories were severely damaged.

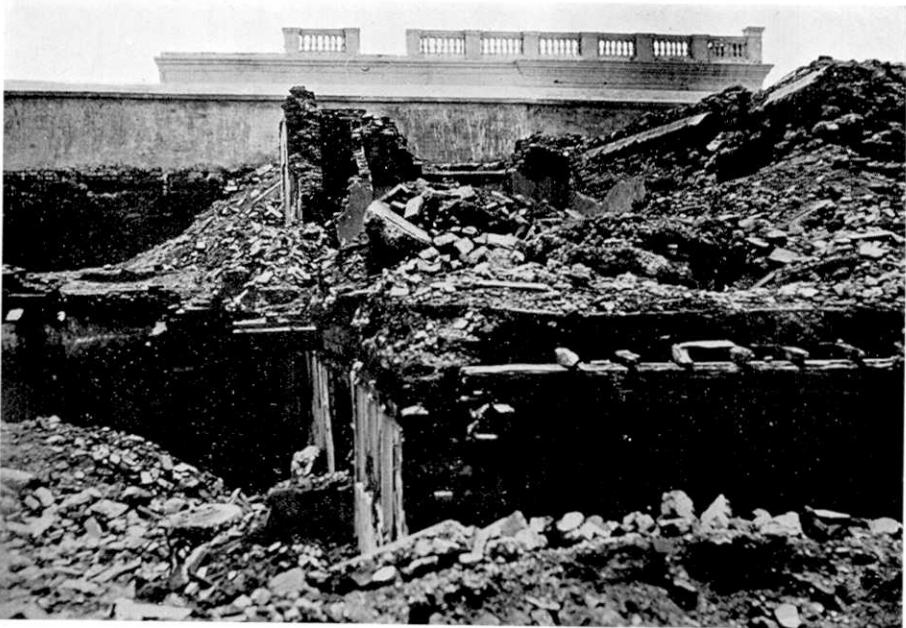
Fig. 16. ditto.

Fig. 15. Two-storied houses completely ruined near the Monghyr Raj's Palace.

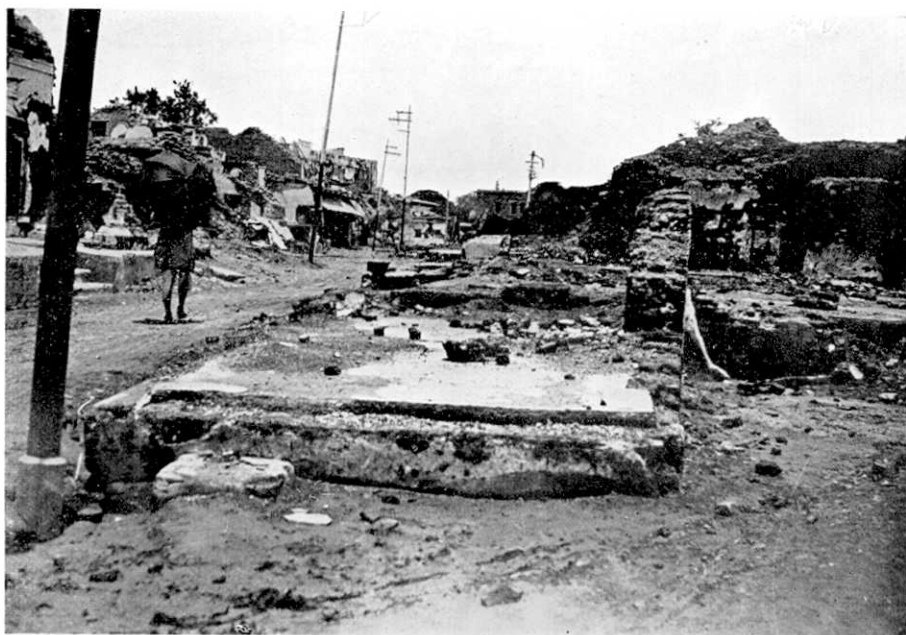
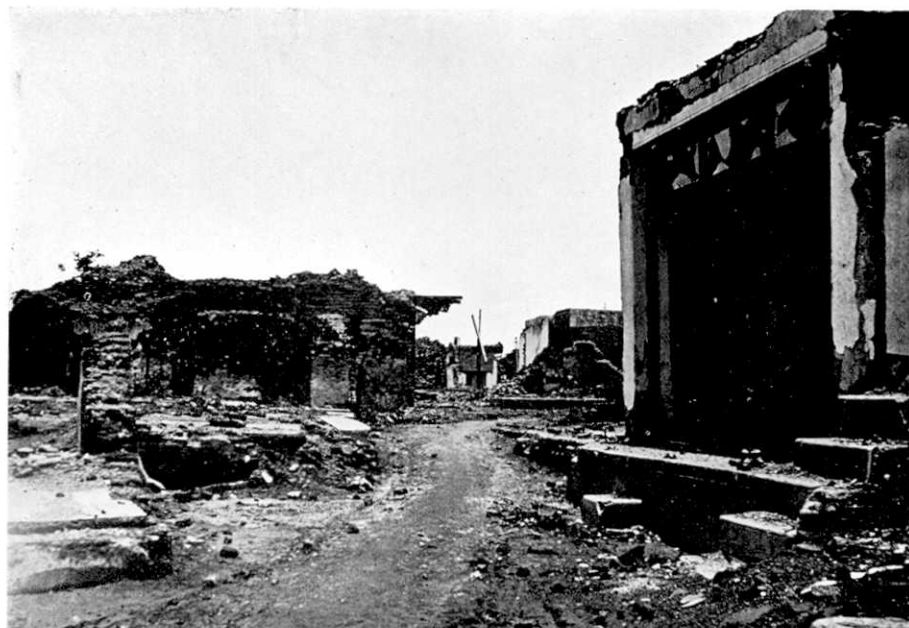
Fig. 18. ditto.

Fig. 17. Ruined town of Monghyr.

Monghyr is built on both alluvium and archæan rocks. As is usual, houses built on hard rocks suffered less damage than those built on alluvium. The fort wall collapsed in many places, but the buildings inside it (on archæan rocks) escaped destruction with only slight damage. The main damage to *pucca* buildings occurred on the alluvium along the edge of the high ground.

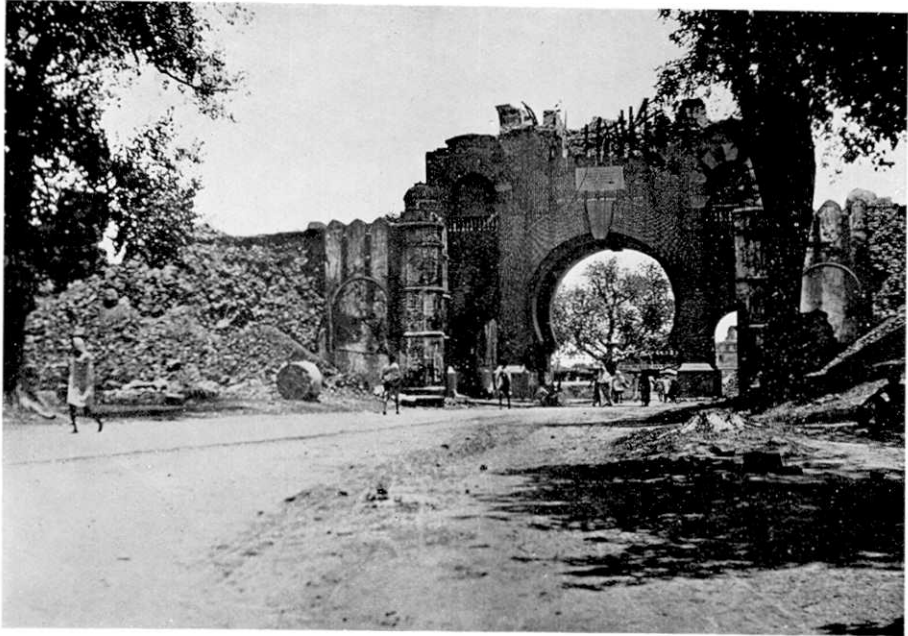
Fig. 19. Gate of Fort Monghyr damaged by the earthquake. *N. Nasu, Photo.*
