20. 臺灣羅東附近一等水準測量檢測成果報告

20. Change in the Heights of the Bench Marks along the Route Passing Ratô, Taiwan (Formosa).

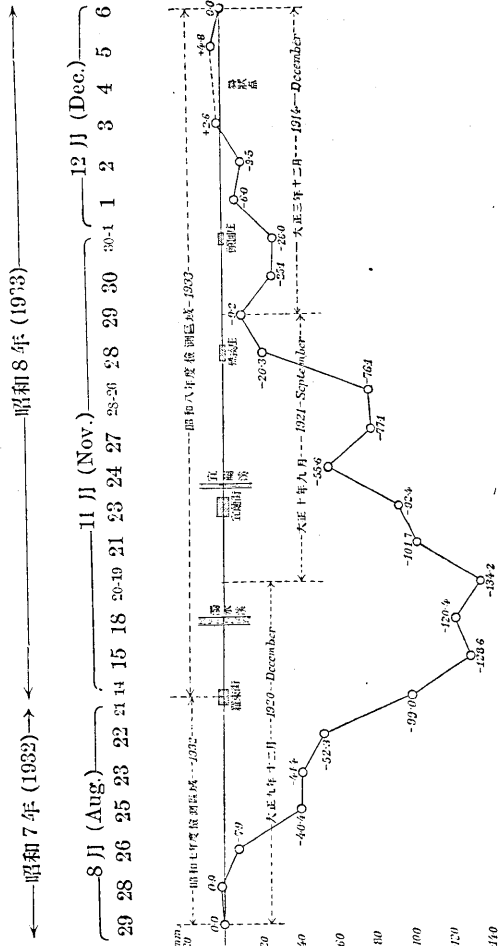
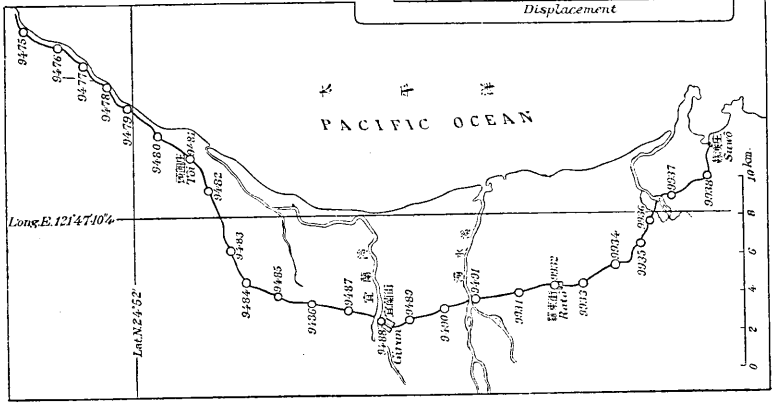
The changes in the heights of the bench-marks as revealed by the comparison of the result of the above-mentioned measurement with that of the earlier one are shown in the accompanying figure, through the permission of the Survey.

第 1 圖 臺灣羅東附近一等水準檢測變動圖
Change in the Heights of the Bench Marks along the Route Passing Ratō, Taiwan (Formosa).

The line of precise levelling passing Ratô, Taiwan, was relevelled out in 1932-1933 by the Military Land Survey.
