## 46. *Landslide at Tôge, Katagami-mura, Osaka-Hu.*<sup>1)</sup>

By Naomi MIYABE,

Earthquake Research Institute.

(Read Feb. 16, 1932.—Received June 20, 1932.)

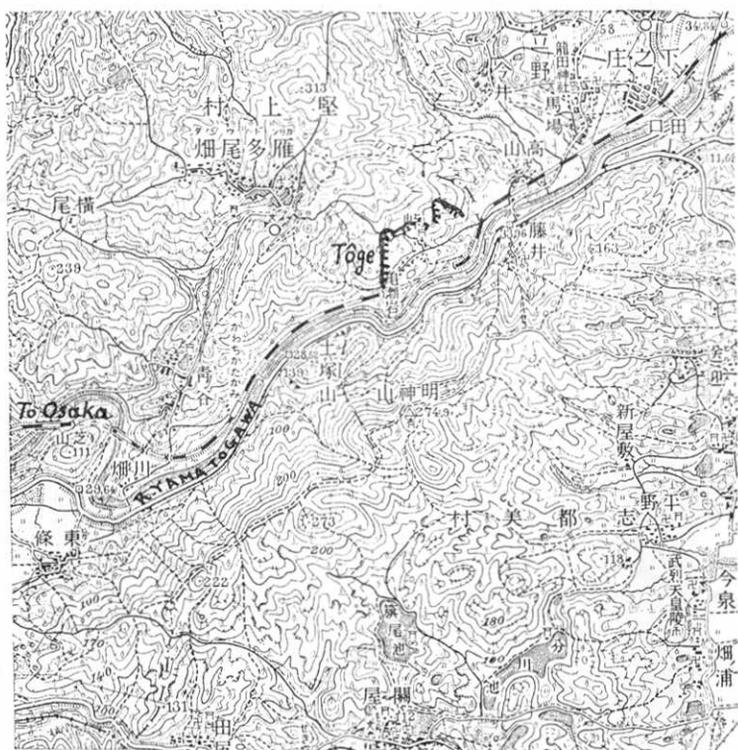
Fig. 1. Topographical Feature in the Vicinity of the Village of Tôge.

2. The map, Fig. 1, shows the location of the village of Tôge and the topographical features of its environs. It will be seen from the figure that the slope on which the village is situated is gentler than the opposite slope across the Yamatogawa (river). The topographical feature of this gentle slope, together with the curious trend of the river-course, suggests frequent landslides here in recent geological time.

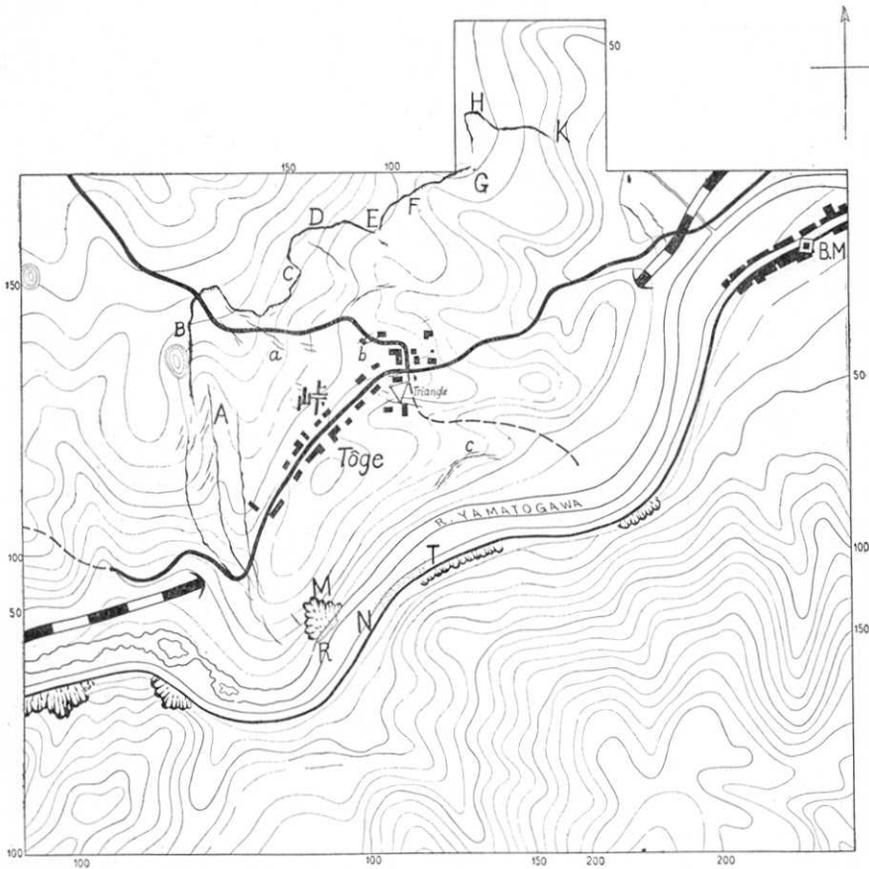
Fig. 2. Distribution of Cracks in the Vicinity of the Village of Tôge, Osaka-Hu.

The area not slipping is bounded by a zone of major cracks, while in the area itself minor cracks have developed here and there. The distribution of these cracks are shown in Fig. 2, and parts of them also in Figs. 5, 6, and 7 (Pl. LXXXVII & LXXXVIII).

On tracing the trend of the zone of major cracks, its continuity is interrupted by a sudden change in direction at the point marked E in the Fig. 2. In observing these cracks, Mr. Nasu<sup>4)</sup> noticed that the cracks at a place westward of point E differed in rate of growth from those at a place eastward of it. For case of reference, therefore, the cracks have been divided into two groups, the Eastern and Western, in accordance with their location and mode of growth.

In the Western group, the cracks at A (Fig. 2) consist of several parallel fissures *en échelon*, which might have been produced by a shear movement. These cracks are traceable southward down to R, where the uplifted bed (probably a result of the landslide) of the Yamatogawa river is exposed. At the place marked M, popularly called "Owankake" and "Ubagakake", considerable quantities of sand and gravel drop from time to time into the river below.

The cracks B and C which were the first to be discovered, have grown since then and become the largest of them all. The movement of the area that is sliding is recognized at these places by the opening of cracks and formation of steps, and has been found to be in the direction approximately perpendicular to the trend of the cracks at these places. It is here also that the horizontal and vertical movements of the sliding earth mass have been most marked. Shear type cracks are observed in the region lying between C and D.

The existence of these shear cracks between C and D and the cracks *en échelon* between A and B, is consistent with the presence of tension cracks between B and C, and consequently with the implication that the movement of the sliding earth mass is being directed perpendicular to the trend of the cracks at B and C, that is, from N to S.

As already mentioned, the trend of the cracks of the Eastern group, i.e., the cracks EFGHK (Fig. 2), are traceable over the rice fields and the railway track from K to the eastern portal of the Kamenose railway tunnel.

by NT in Fig. 2 (cf. photo Fig. 8, Pl. LXXXVIII). This fact seems to strengthen the conclusion that the movement of the earth mass is in such a manner that it as a whole slides over some curved surface down to the south as shown schematically in Fig. 3.

第二圖は滑落地域における龜裂の分布を示したものであるが、龜裂の大きさ、數等は其後次第に増加しつゝあるので現在の龜裂の分布とは多少異なるかもしれない。

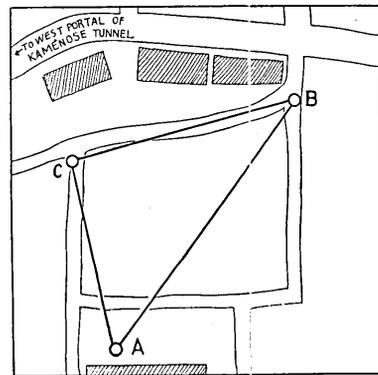
Fig. 4.

The writer has measured the lengths and angles of a triangle framed in Tôge (Fig. 4) for the purpose of investigating the variations in the deformation of the earth's surface with respect to time. These measurements were carried out three times since the 1st of February this year, with results as shown in Table I.

From these results, elongations and contractions of the lateral sides of the triangle for different time intervals were obtained by means of a simple calculation, whence the horizontal deformation of the triangular area its computed by the formula

and the inexperience of the observer, the result obtained as above shows the general mode of time-variation of the deformation of the triangle. These values of  $dS/S$  point to considerable horizontal deformation in the sliding earth mass.

Moreover, vertical displacements of two vertices of the triangle relative to the third vertex show that the triangle tilted to the N or NW. Such deformation of the sliding earth mass may probably damage houses, cause cracks in walls (cf. photo Fig. 9, Pl. LXXXIX), tilt pillars, and bend door sills.

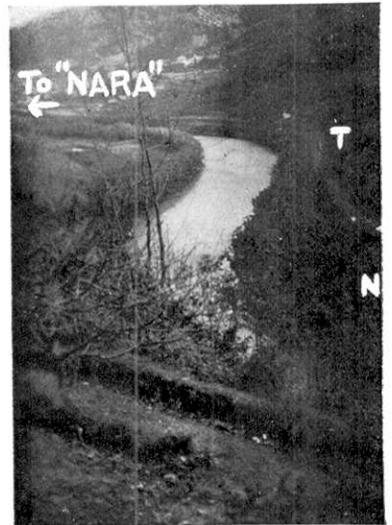
Fig. 8. The Yamatogawa viewed from Minamihara.  
(Photo. on the 3rd of February).

On the southern side of the Yamatogawa (river) a continuation of a sliding earth is observed at an upheaval of several metres of a part of a highway, the prefectural road joining Osaka and Nara, and denoted

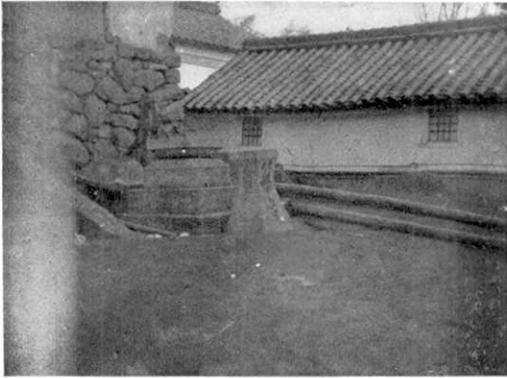
Fig. 9. A house attacked by the deformation of the earth's mass.

二月中旬には、地域内の家屋が損傷を被るやうになり、壁の龜裂(寫眞第九圖)、柱の傾斜、敷居の撓曲等が見られた。これは、恐らく滑落地域内の土地の變形によるものであらうと思はれる。地域内に設けた假の三角形につき、その邊長の時變化からその附近の土地の變形を算出したものは第一、二表に示されてゐる。これによつても、可成の程度の變形があつたことを推察することが出来る。

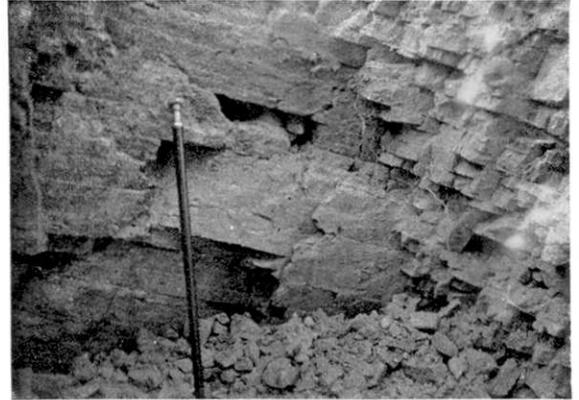
Fig. 10. Slaty Joints.

この地辻の眞因は今のところ不明であるが、今まで見た所では、土地を構成する地層の性質が關係の深いことは推察出来る。この附近の土地の上層なる安山岩層中には第一〇圖寫眞に示す様なプレート様節理が発達して居て、崩れやすく、最上層は殆ど風化して粘土化してゐる。

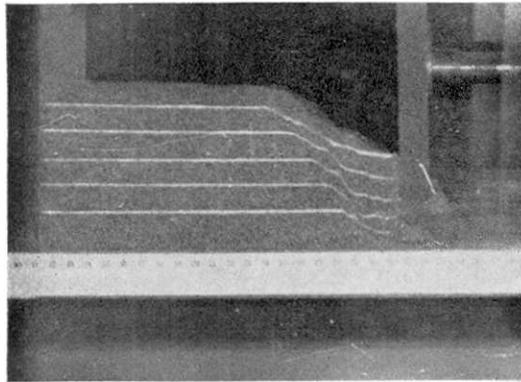
Fig. 11. Deformation of the Sand mass produced by receding the wall.

We could compare the deformation of a sliding earth mass with the results of an experiment<sup>6)</sup> that was made a few years ago at our Institute with layers of sand. The experiment consisted in disturbing horizontal layers of sand packed in a box made with sides of glass, by gradually pulling away with uniform speed one of the end sides of the rectangular box, when the sand mass slips down forming irregular step faults<sup>7)</sup> (cf. photo Fig. 11, Pl. LXXXIX). These irregular formation of step faults may have been due partly to slight lack of homogeneity in the sand mass. In the actual case of the earth's crust, want of homogeneity, such as the varying surface configurations, different geological formations, and the presence of cocluded waters in the sliding earth mass, may complicate the mode of deformation of the mass even though it may be sliding as a whole with uniform mean speed, as seen in the records that were obtained by Mr. Nasu.<sup>8)</sup>
