Review

# The impact of tsunami in coastal areas: Coastal protection and disaster prevention measures—Experiences from Japanese coasts

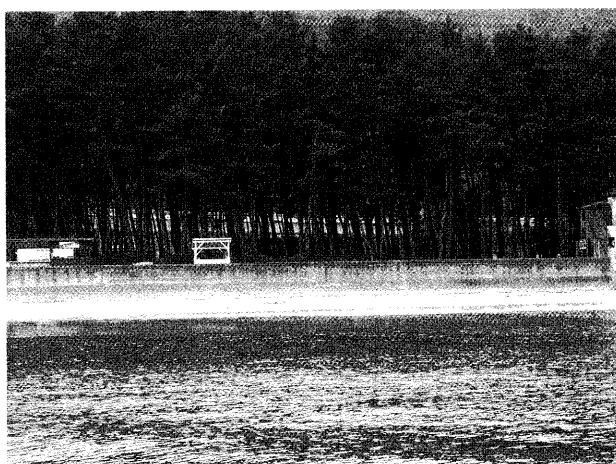
**Fig. 3.** Nami-ita Beach (Iwate Pref.).

The beautiful sandy beach, Nami-ita is located in Funakoshi Bay, which is a good example for the coastal protection measures against tsunami. The length of the beach is about 300 m and about 50 m width. Immediately after the sandy beach, there is a sea wall of about 4 m height and at that level, pine trees are planted densely for about 30 m width and at 6 m height from that level, the highways was constructed (Fig. 3). The breakwaters using concrete structure and artificial reef modules with regular intervals are also constructed to reduce the tsunami power. It was revealed during one of the discussions the first author had with the scientists from Iwate University that over 200 years back the elders planned the living areas with landscapes of much height for protection from unexpected natural disasters, but at that time no one really realized its importance, but now they are remembered.

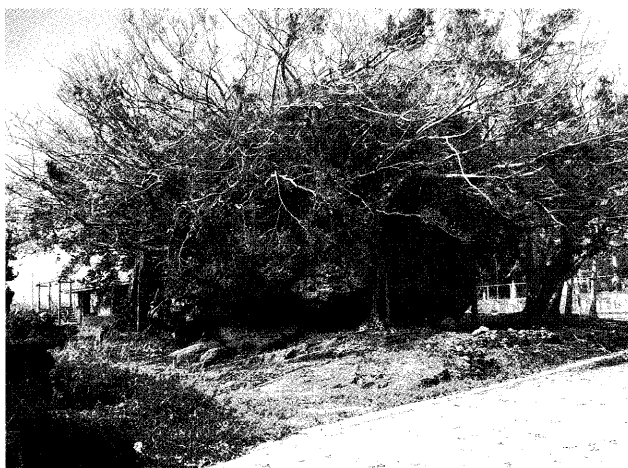
**Fig. 8.** Boulders washed ashore along Ohama beach during 1771 Yaeyama tsunami.

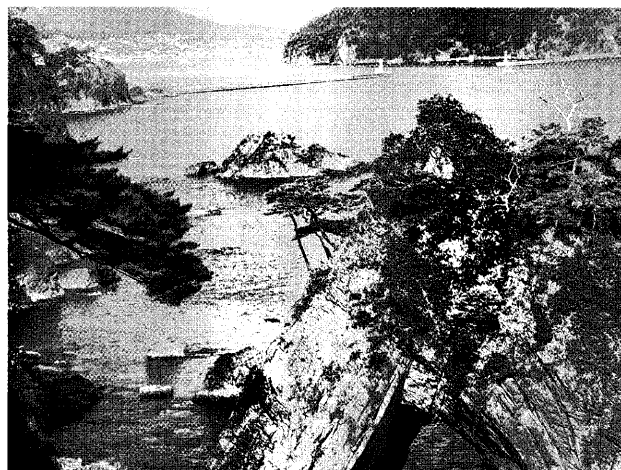
**Fig. 10.** Breakwater in Ofunato bay (Iwate Pref.).

Another important developmental activity is creation of number of small fishing harbours. Each coastal village is having a fishing harbour with much protective mechanisms such as seawalls, breakwaters and water gates. For example, in Wakayama Prefecture, the Karo Bay is having not more than 40 boats, but it has a fully protected fishing harbour (Fig. 9). These kind of developmental activities increase the risk and also reduce the productivity of these areas. The Ofunato bay area is polluted because of lack of water circulation due to the construction of breakwaters (Fig. 10).
