The Sakura-jima Eruptions and Earthquakes. VI.

[Notes on the Destructive Earthquake of Jan. 12, 1914, and Miscellaneous
Remarks on the Eruptions of Sakura-jima.]

By F. OMORI.

CHAPTER I. NOTES ON THE DESTRUCTIVE SAKURA-JIMA EARTHQUAKE OF JAN. 12, 1914.

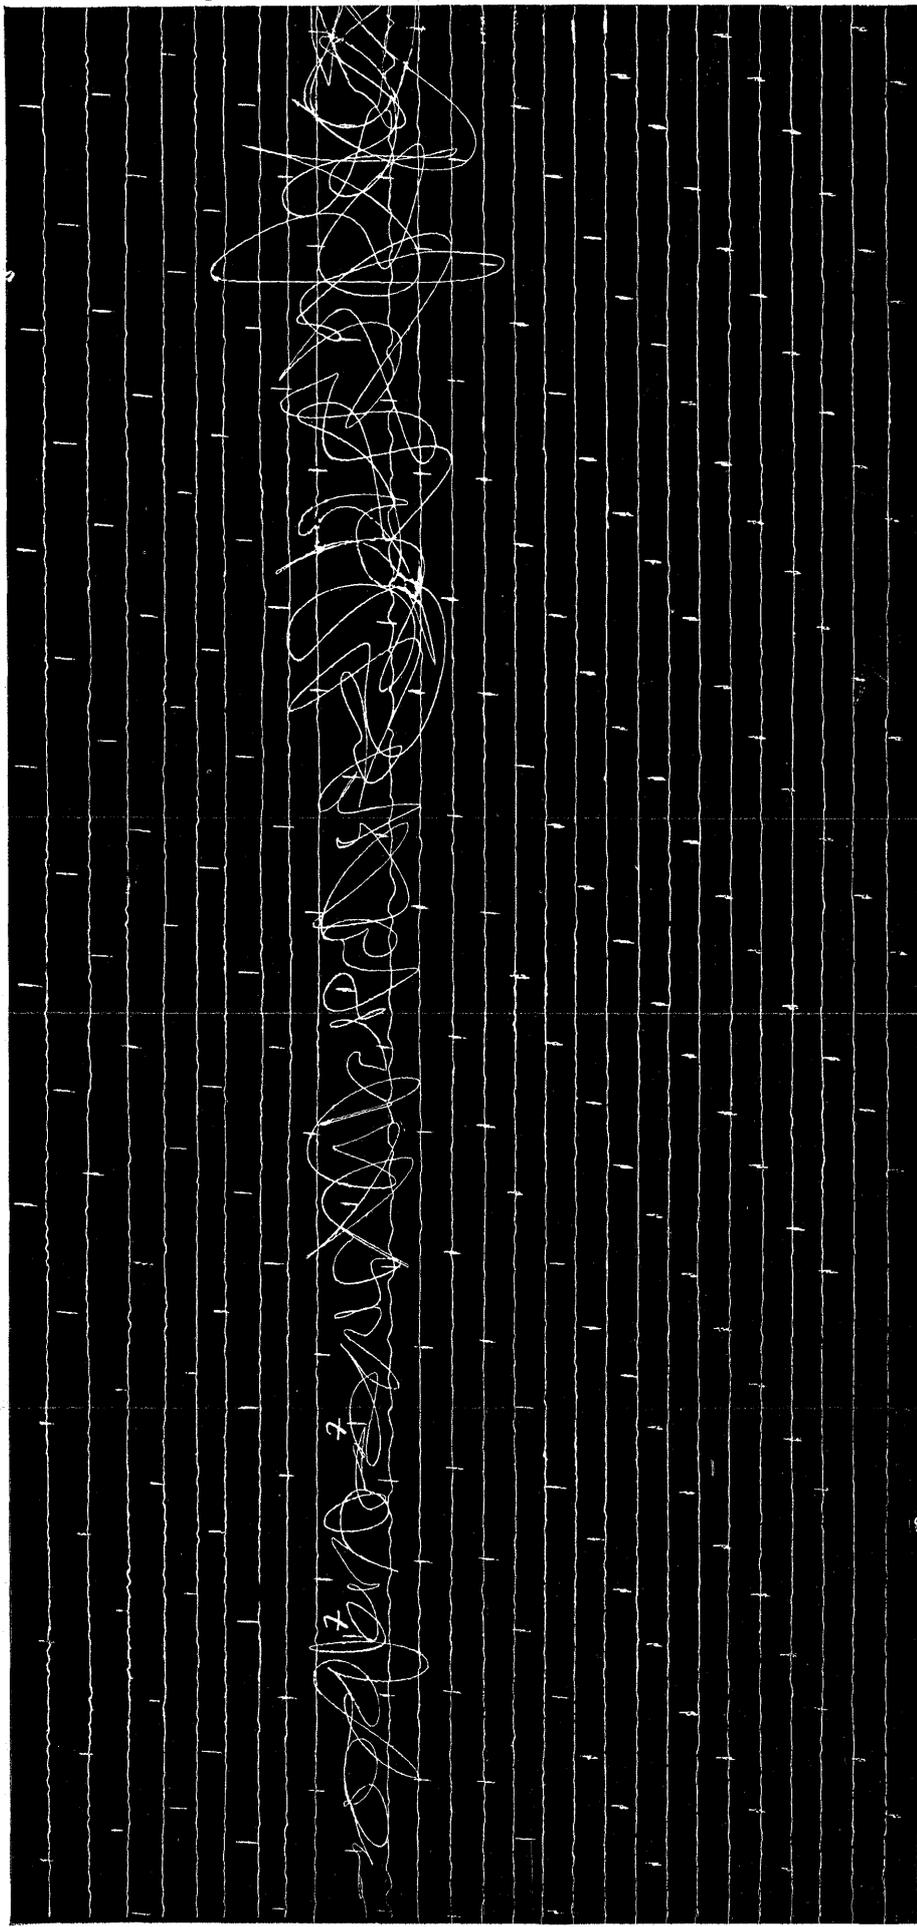
Fig. 2. B

tive Sakura-jima earthquake on Jan. 12, 1914. Figs. 2, A and 2, B (Pls. LXXXIX., A and B) is a slightly enlarged reproduction (magnification = 26) of the earlier and the main portions of the diagram furnished by the duplex pendulum tromometer, composed of the upper, or ordinary, pendulum of height = 4.0 m. and of weight = 150 kg., and of the lower, or inverted pendulum of height = 0.58 m. and of weight = 32 kg., with the resultant oscillation period of 19 sec. From the diagram it will be seen that the movements in the preliminary tremor, 2 m. 9.3 sec. in duration, were executed in the s. w.-N. E. directions; the very first displacement being, according to the high magnification instrument registers, in the direction of N. 64° E., accompanied by an upward movement. The seismic origin was, therefore, at the approximate distance of 960 km. to the S. 64° W. of Tokyo, a position quite close to Sakura-jima. In the principal portion, the motion was composed at first of the transverse vibration, but subsequently again of the large longitudinal vibration, followed by alternations of the two sets of waves of gradually decreasing amplitude.

ab.....Preliminary Tremor, composed of the longitudinal wave.
b.....Commencement of the Principal Portion, at first composed of the transverse wave, but subsequently composed of the longitudinal wave.

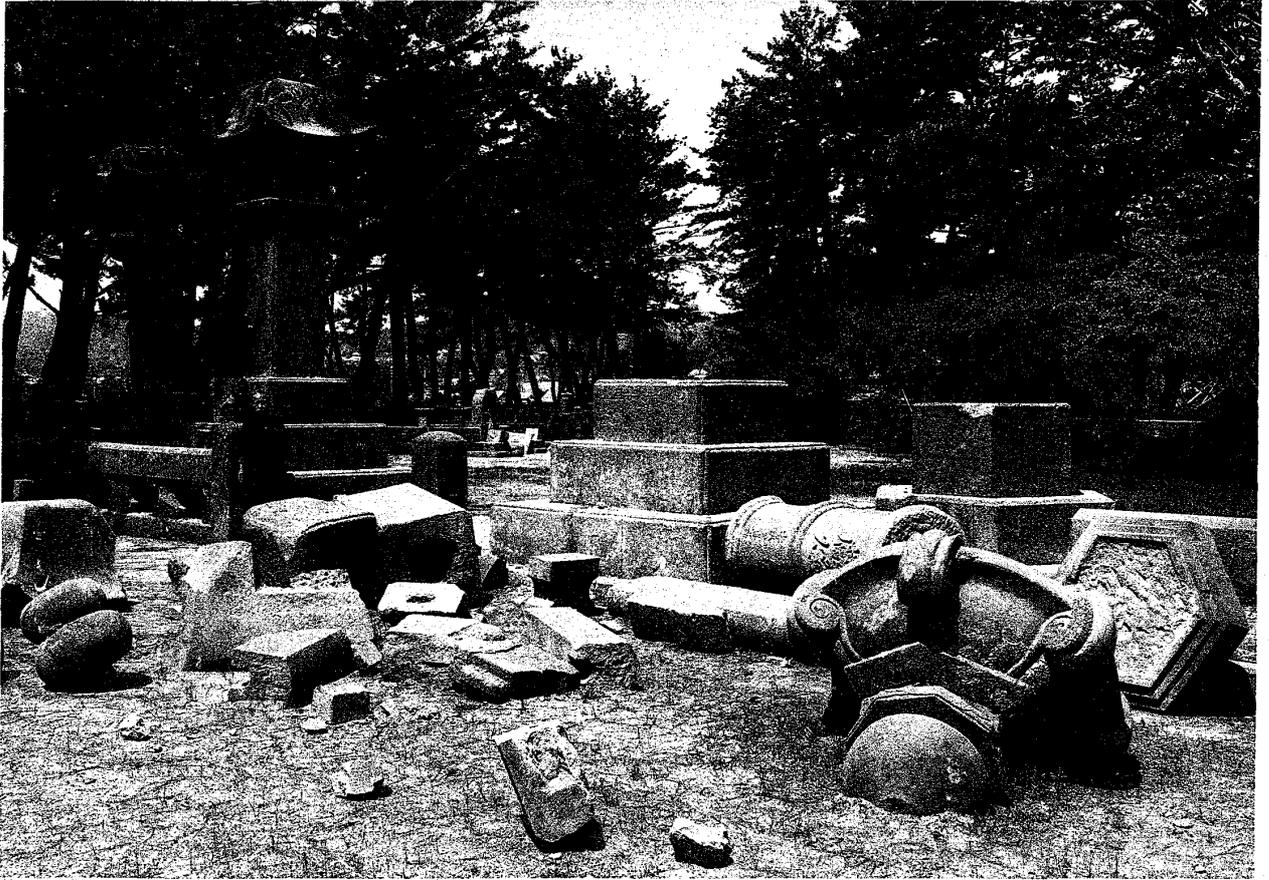
Fig. 7. Large overturned Stone Lanterns at Gion-no-su, in the northern part of Kagoshima.

7. Direction of Motion in Kagoshima. In the city of Kagoshima numerous stone lanterns and tomb stones were overturned. (See fig. 7.) These being small columns generally not cemented to the pedestal, and of heights under 2 metres, with, in the case of the former, stems square or circular in section, serve as a simple sort of standing column seismometer and give indications of the direction of the maximum earthquake motion. The observations of the overturned bodies, mentioned below, have been made in the following different places:—Terukni Shrine, West Honganji, Nanrinji, Fukshoji, etc., in the central and southern parts of the city; the military cemetery, Jokomyoji, Tanoura, etc., in the northern part.

At Tanoura (田ノ浦):—Two large stone lanterns (fig. 7) were not overturned, while two others exactly like these standing nearby were overturned respectively toward S.55°E. and S.25°E. For one of these, with the stem 59 cm. (=2x) square in section, the height (=y) of the centre of gravity is found to be 170 cm. The intensity or acceleration (=a) of the earthquake motion necessary for overturning the structure regarded as a "small body," would be $a = \frac{x}{y} \times g = 1690 \text{ mm./sec.}^2$, g being the acceleration due to the gravity. These stone lanterns, with the base dimension of nearly 2 feet, are, however, to be regarded rather as belonging to the category of "large body," and the range (=2a) of the earthquake motion necessary for the overturning would be some 37 cm., according to the equation: $2a = \frac{h}{y} \times x$, in which h (=214 cm.) is the height of the centre of percussion of the whole column with respect to the ground surface.

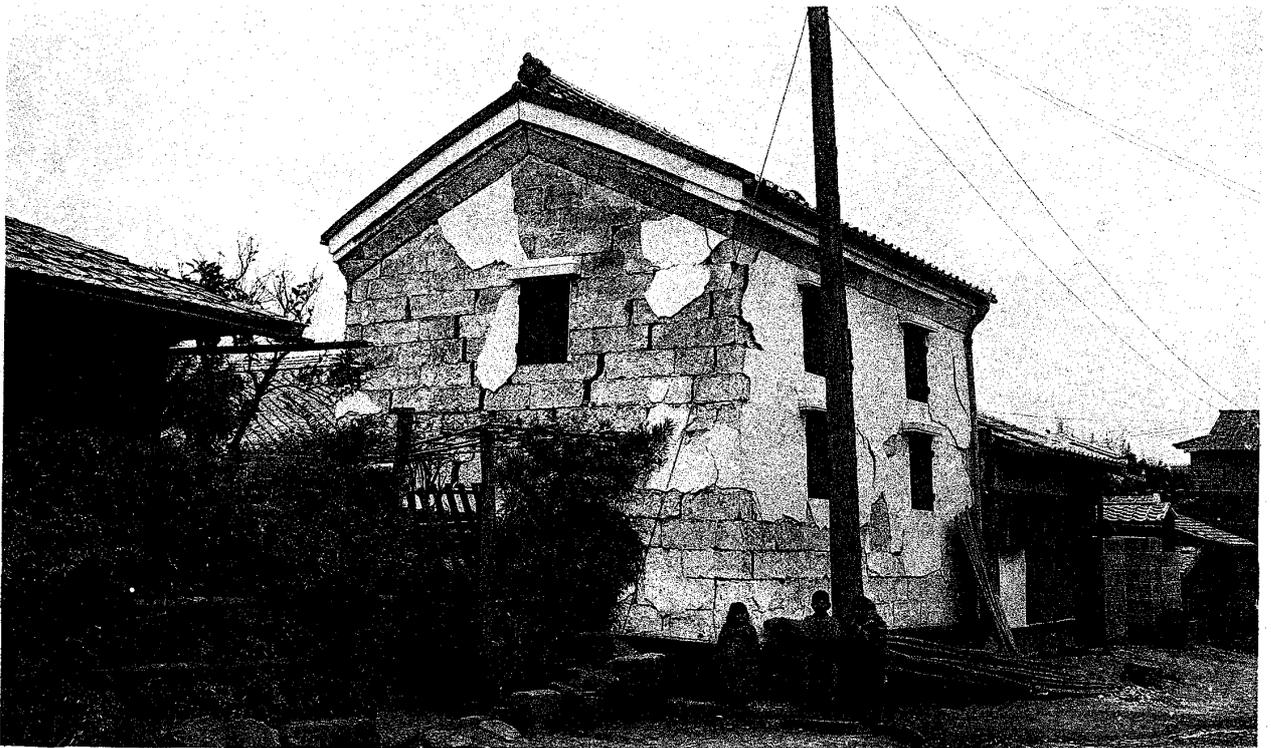
Fig. 8. A Stone Warehouse, in northern part of Kagoshima, badly cracked along mortar joints.

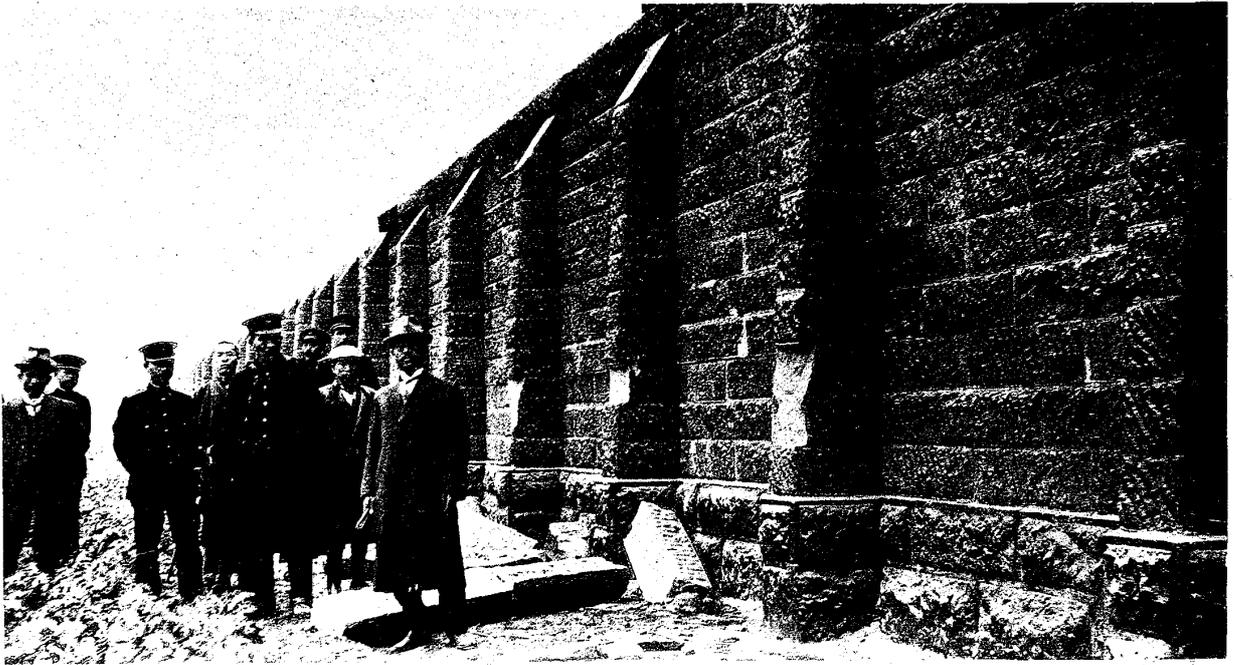
Fig. 9. Stone Fence Wall of the Kagoshima Prison. Stones below the horizontal crack line scratched off.

Fig. 9 shows the seismic damage done to the front, or east, side of the enclosure wall of the Kagoshima Prison. The wall, 15 feet in height and 1.7 feet in base thickness, (fig. 16), with buttresses on the outside at successive distances of 9 feet, was cracked near the base through the whole length; the parts of the buttresses just below the horizontal crack being in very many cases torn off and thrown down. This was the result, as is shown by the photograph, of a relatively outward motion of the portion of the wall above the plane of fracture. It seems thus likely that the first strong displacement, at the commencement of the principal portion of the earthquake, was directed westwards, or away from the Sakura-jima, while the counter and larger movement took place eastwards or toward the island.

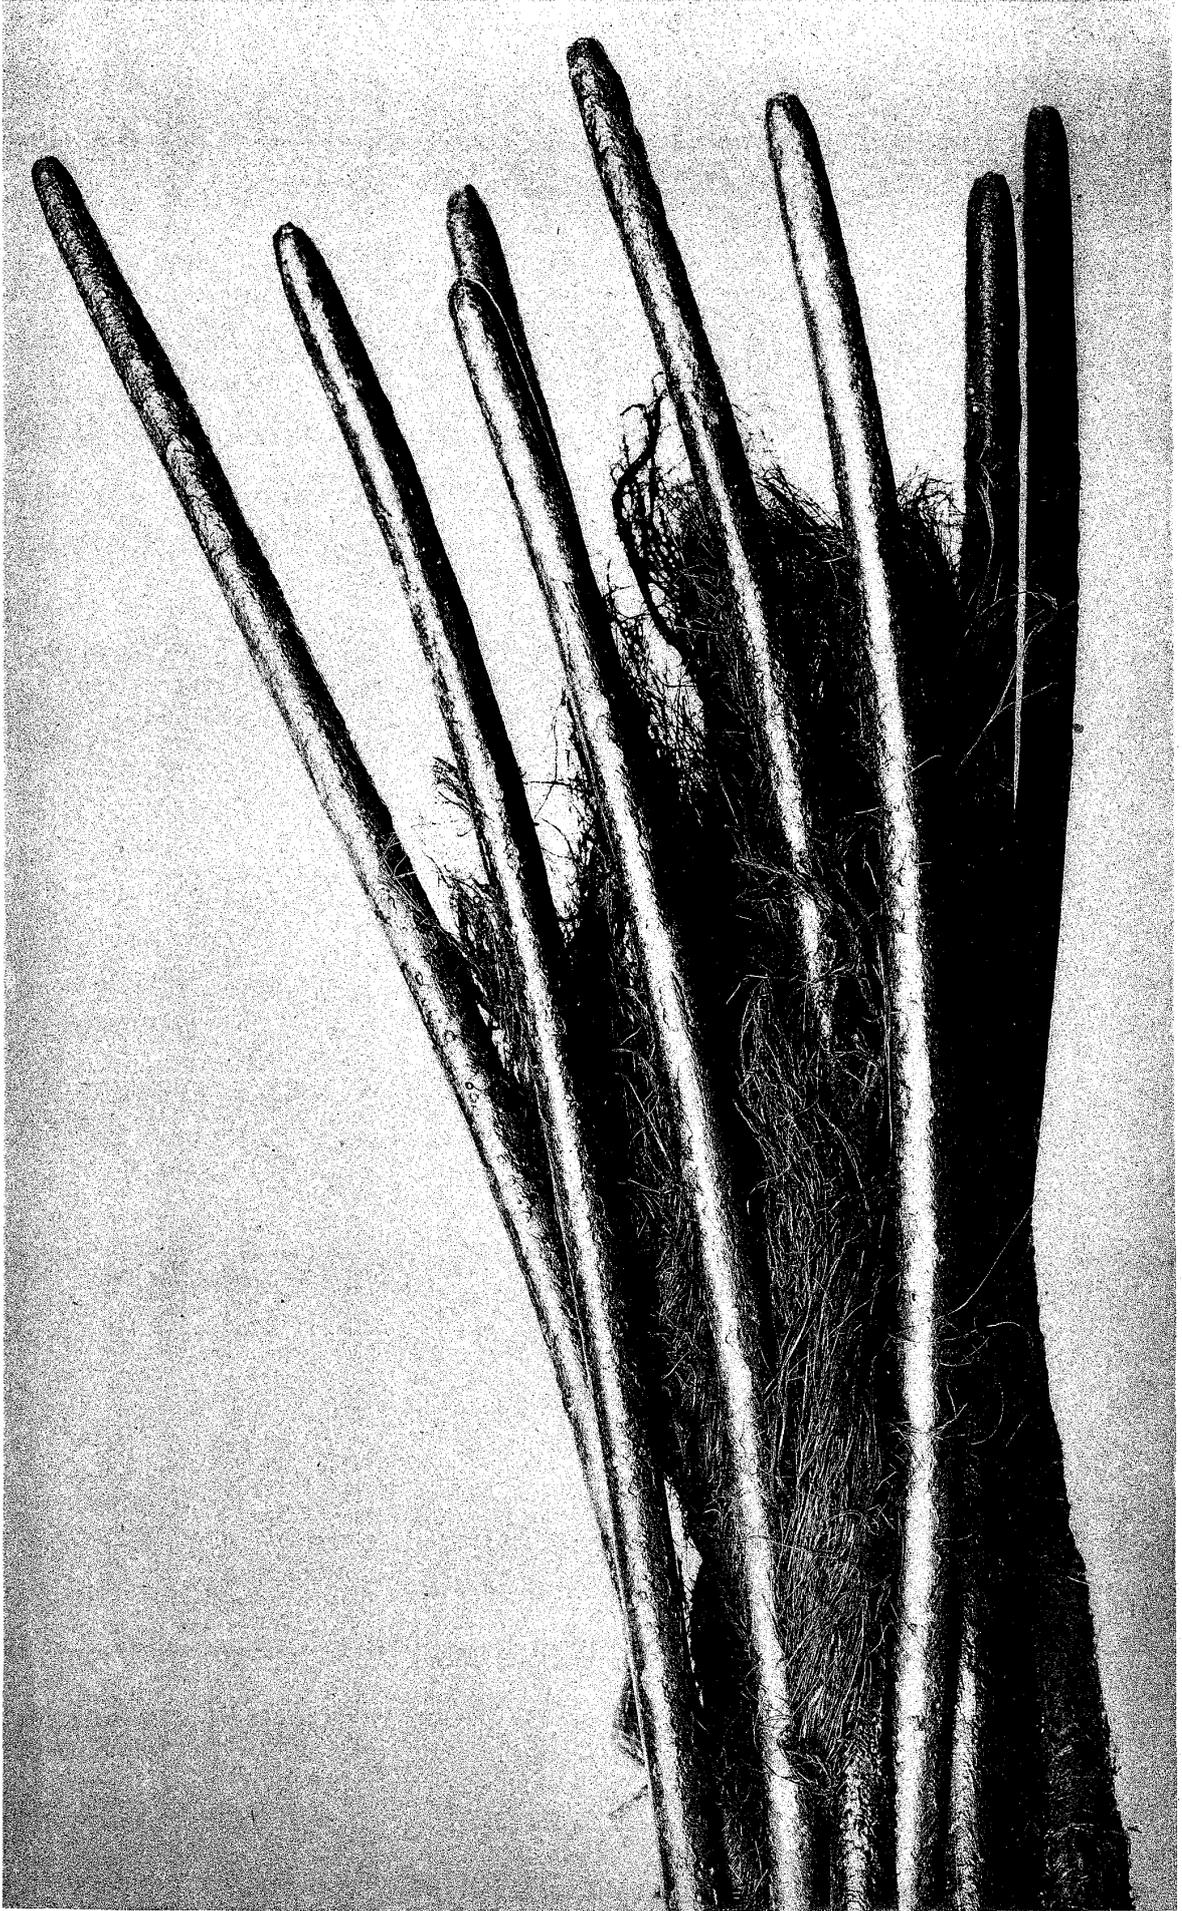
Fig. 33. An enlarged view of the Broken End of the 1" Telegraphic Cable between Kagoshima and Sakura-jima.
