博士論文

**Development of Earthquake Risk Assessment
System for Nepal**

Ramesh GURAGAIN

The University of Tokyo

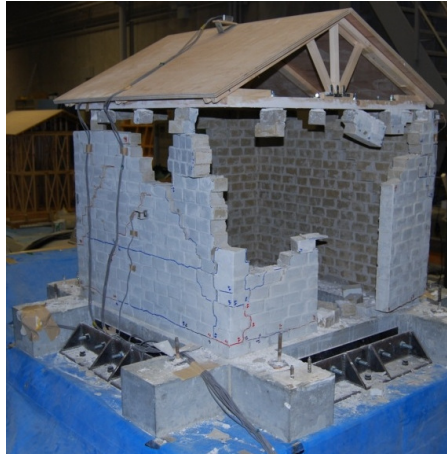
Figure 4-8: Door side photo after run 45 (5HZ-0.6g) of experiment (Sathiparan, N. 2008)

In both the cases, the masonry wall above the door and window is collapsed. Similarly, some portion of side walls has also fallen in both the experimental and numerical cases. In both the cases, the experiment as well as in numerical simulation, the initial cracks widened in further shaking ultimately leading to collapse. This behaviour is typical of non-retrofitted masonry buildings which has very limited ductility. So, the energy dissipation capacity is limited as there are few large cracks.

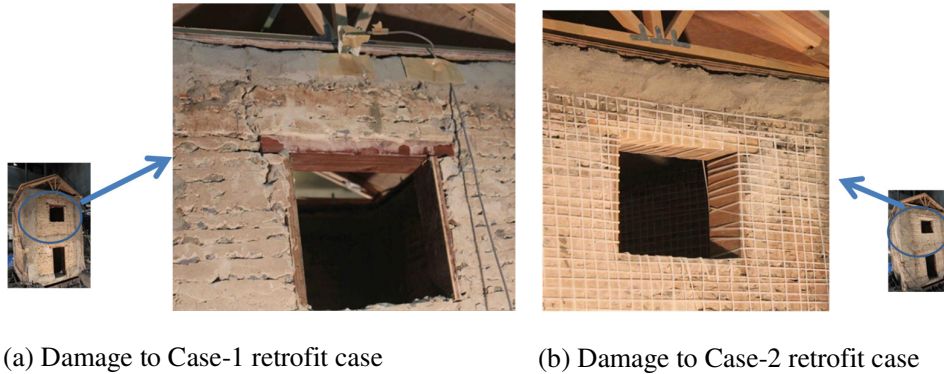
Figure 6-9: Comparison of Cracks at Run 21 (25 HZ, 0.2g)

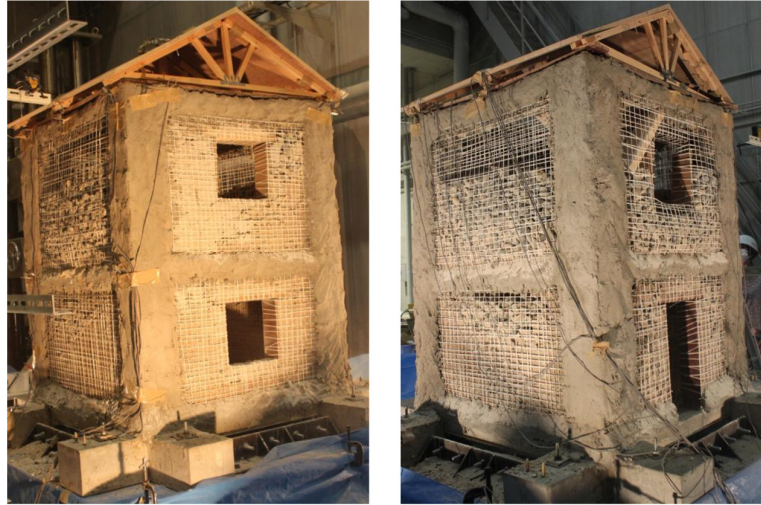
Figure 6-15: Level of Damage at Run 42 for Case-2 Retrofit
