東京大学大学院新領域創成科学研究科  
社会文化環境学専攻

修士論文

**Analysis of damages in Hikkaduwa and South West Coast of  
Sri Lanka in 2004 December Sumatra tsunami**

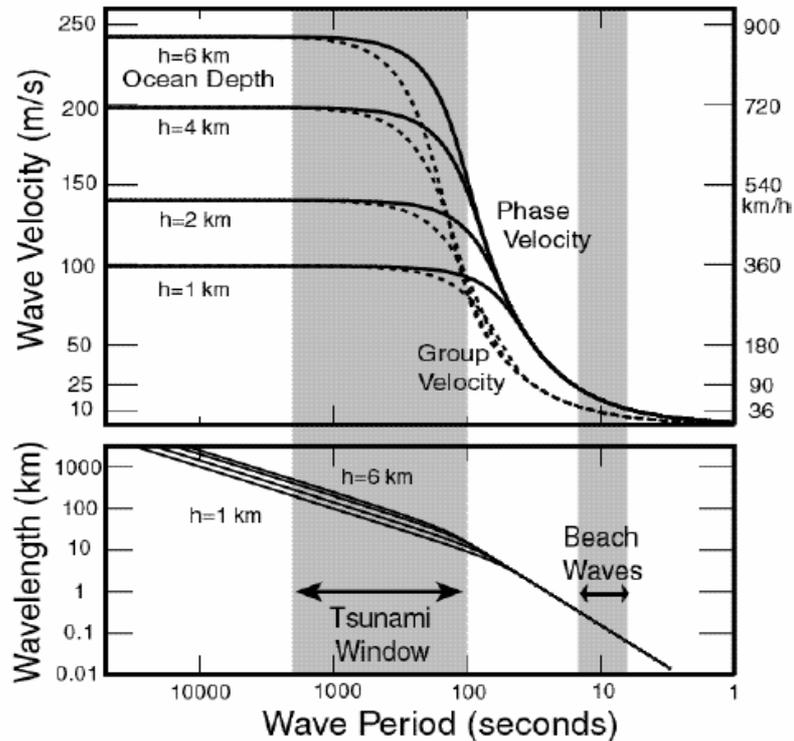
Figure 1.2 : (Top panel) Phase velocity  $c(\omega)$  (solid lines) and group velocity  $u(\omega)$  (dashed lines) of tsunami waves on a flat earth covered by oceans of 1, 2, 4 and 6 km depth. (Bottom panel) Wavelength associated with each wave period. The ‘tsunami window’ is marked.

For surface gravity waves spanning 1 to 50,000 s periods, Fig. 1.2 plots  $c(\omega)$ ,  $u(\omega)$ , and  $l(\omega)$ . These quantities vary widely, both as a function of ocean depth and wave period. Waves whose velocity or wavelength varies with frequency are called **dispersive**. During propagation, dispersion “pulls apart” originally pulse-like waves into their component frequencies. It is emphasized that dispersion’s strong influence on attenuating tsunamis. Common waves at the beach have periods near 10s and wavelengths around 100m (see Fig. 1.2).

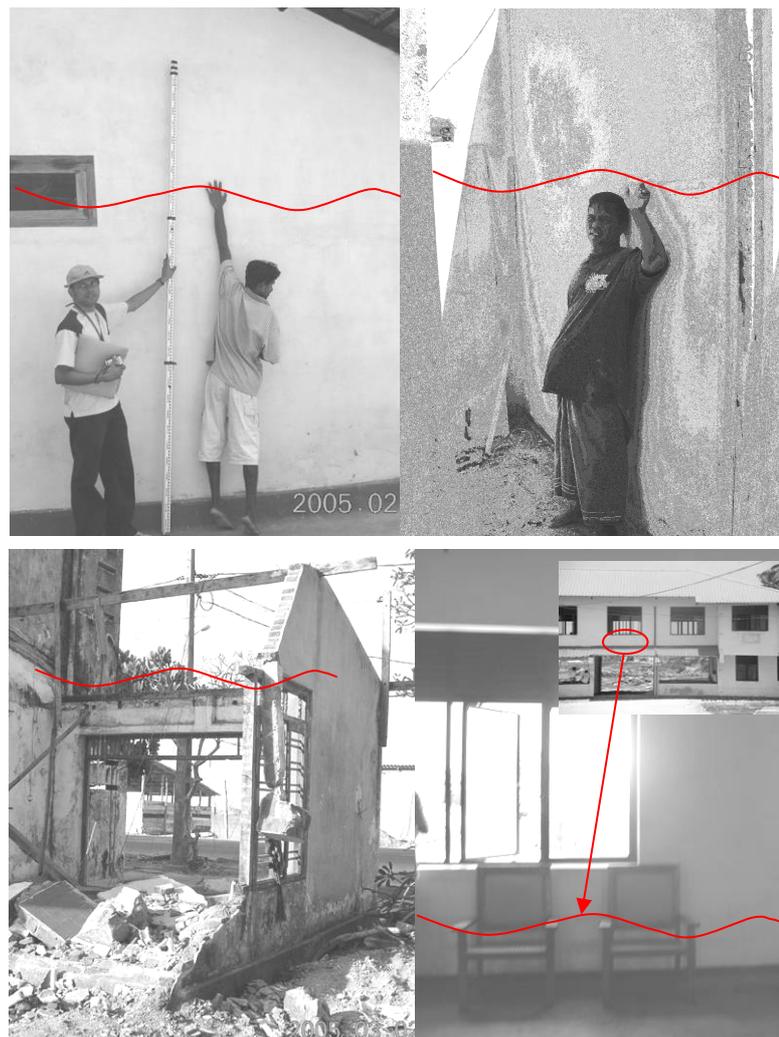
Fig 3.2: Inundation heights identified by watermarks left in the walls, damaged buildings

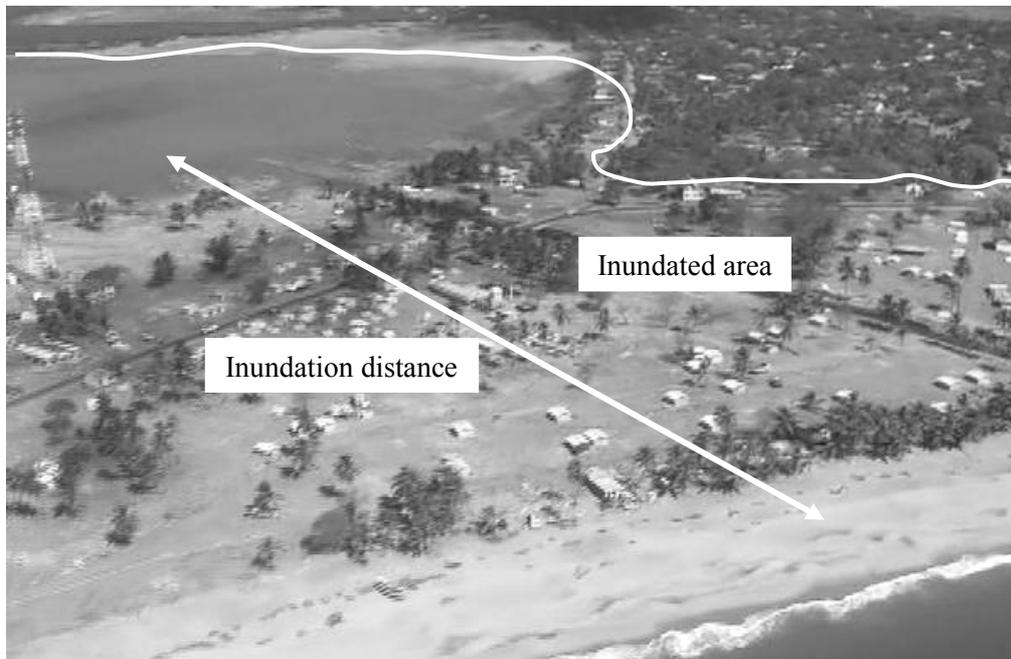
Fig 3.3: Inundation heights identified by damaged buildings, trees and scouring of the ground.

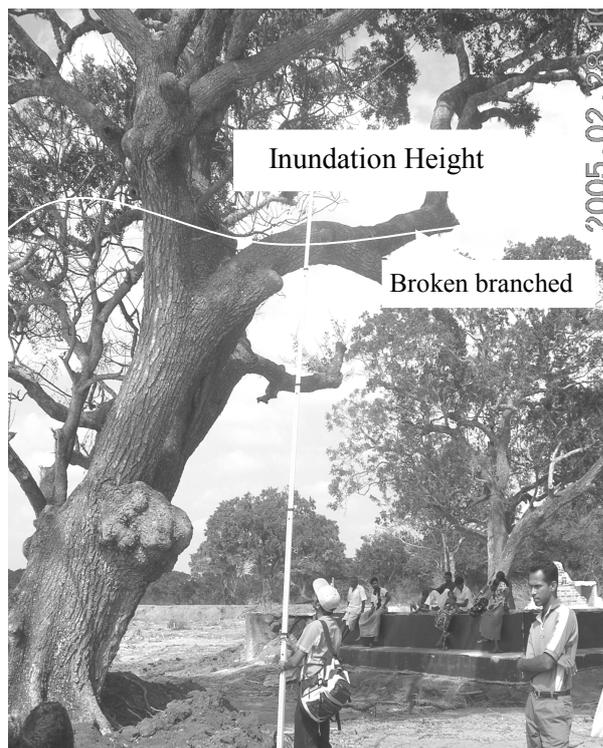
Fig 3.4: Inundation heights identified by damaged trees.

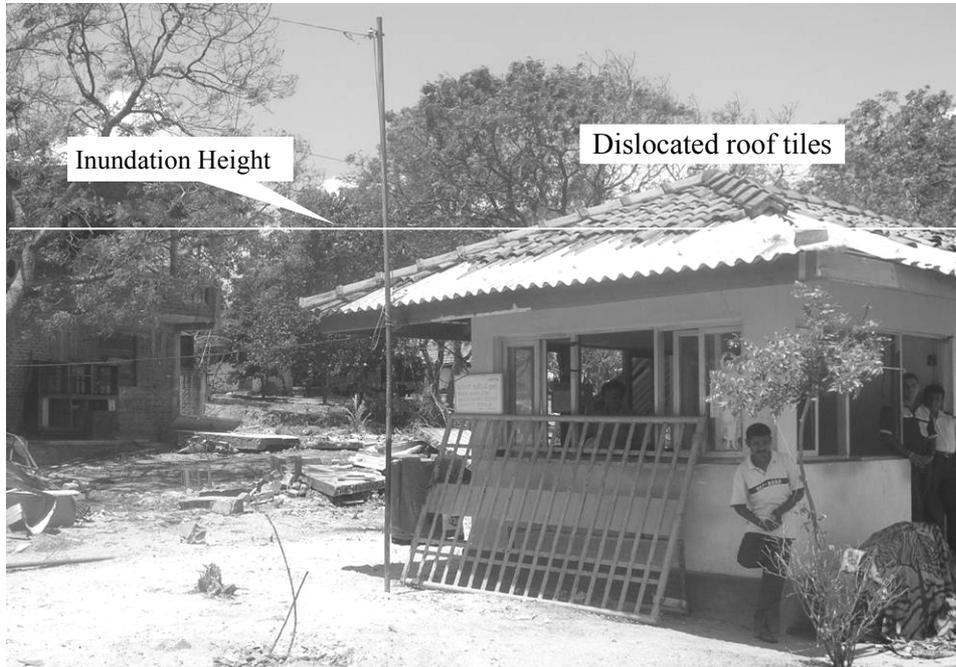
Fig 3.5: Inundation heights identified by dislocated roof tiles (Kirinda)

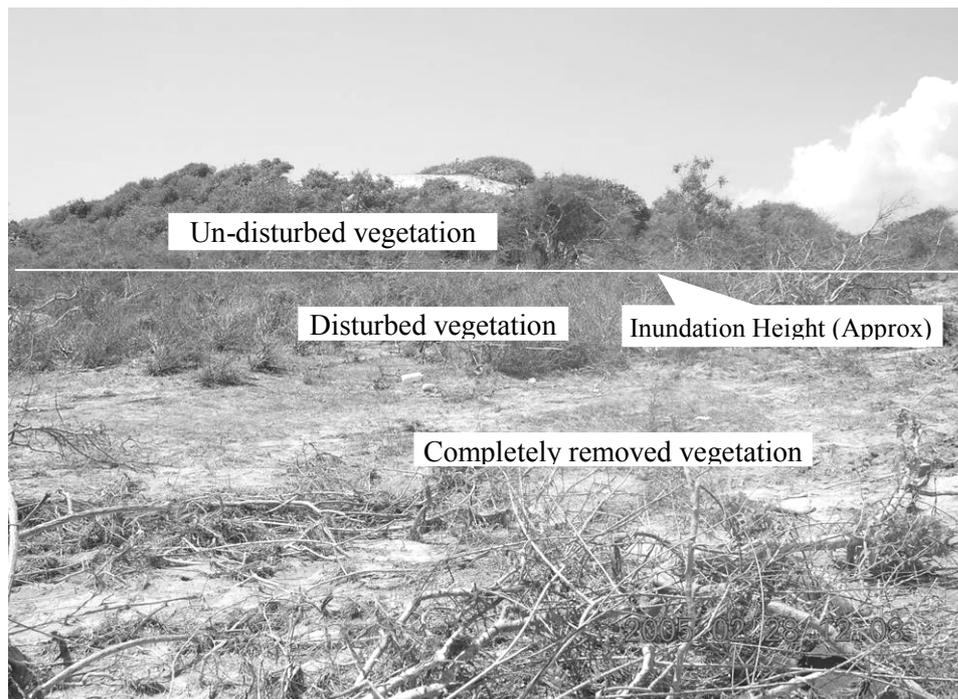
Fig 3.6: Inundation heights identified by damaged and eroded vegetation cover in sand dunes. (Yala)

Especially the abnormally broken branches in trees and mud levels left in the trees were useful. In certain cases it was found long and high sand dunes covered by vegetation, running along the coast as a dyke was partially washed away. These marks could give some reasonable clue on inundation in those areas. For an example the sand dunes in the Hambantota and Yala was observed like that. See fig 3.6.

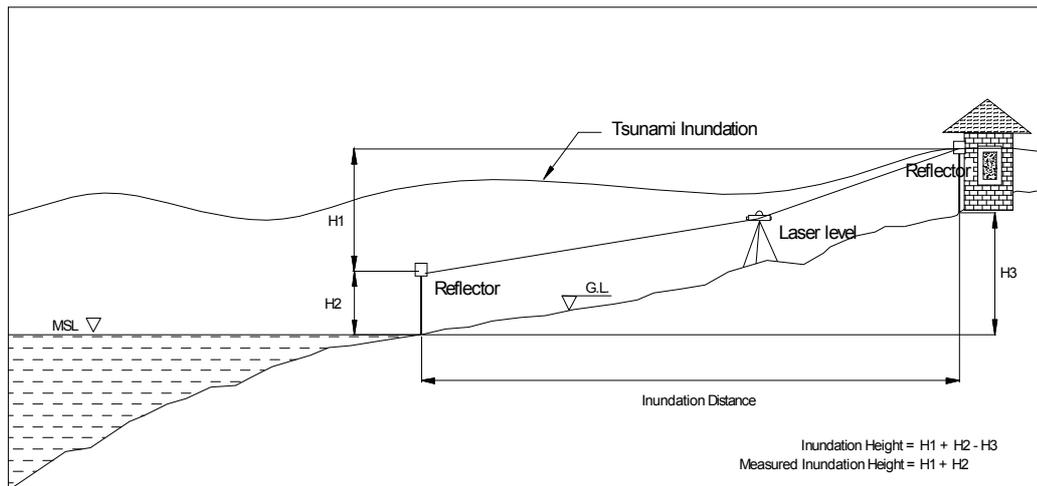
Fig 3.7: measurement of inundation heights

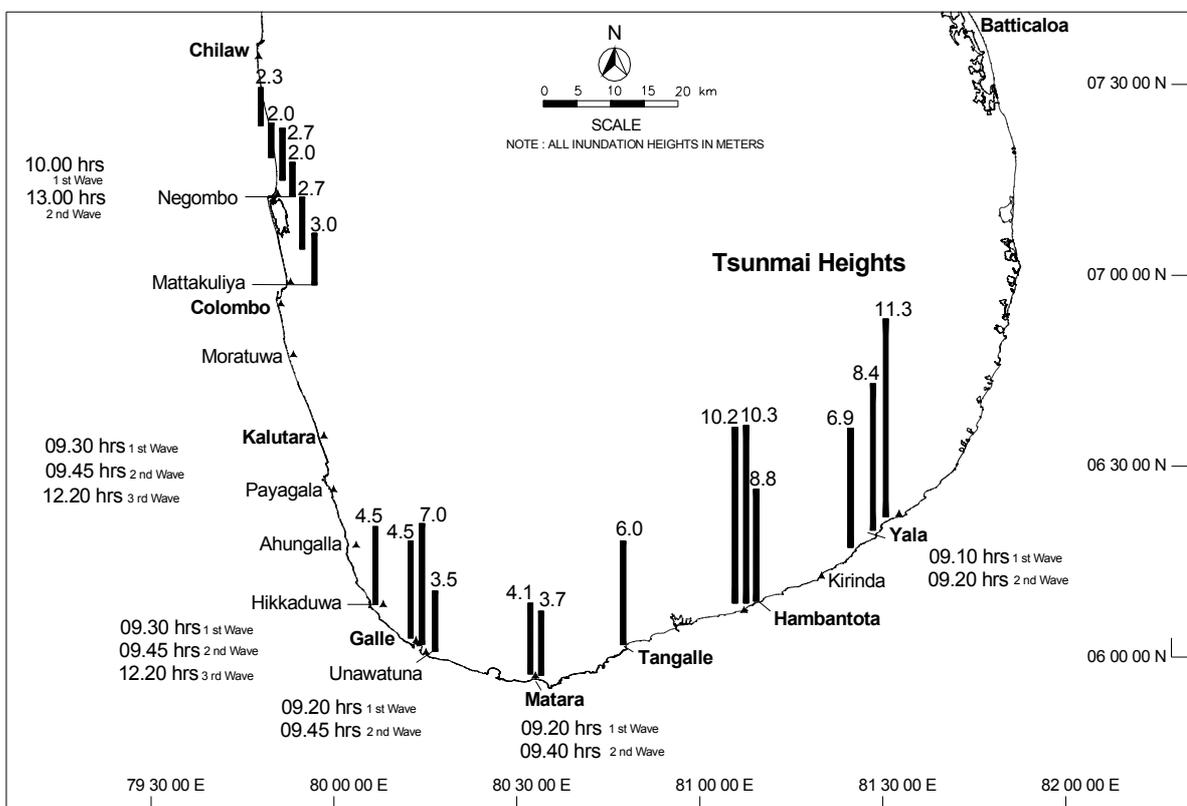
Fig 3.8: Summary of the Inundation heights (meters).

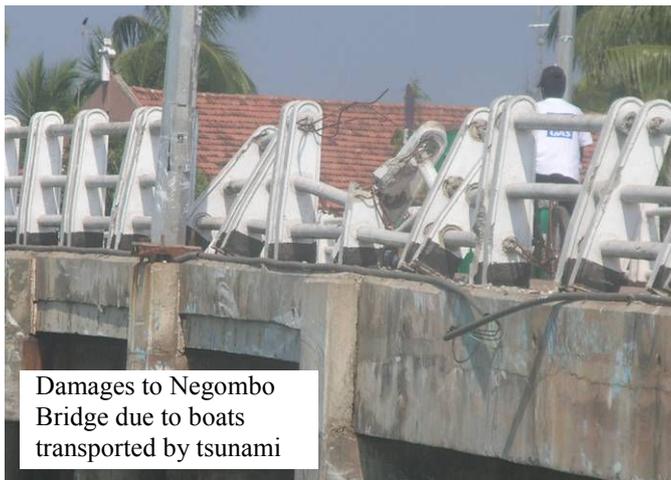
Damages to Negombo Bridge due to boats transported by tsunami

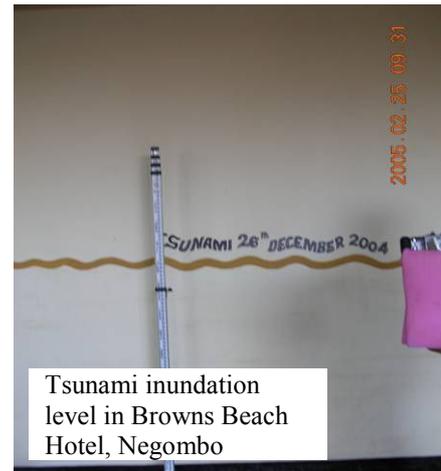
Tsunami inundation level in Browns Beach Hotel, Negombo

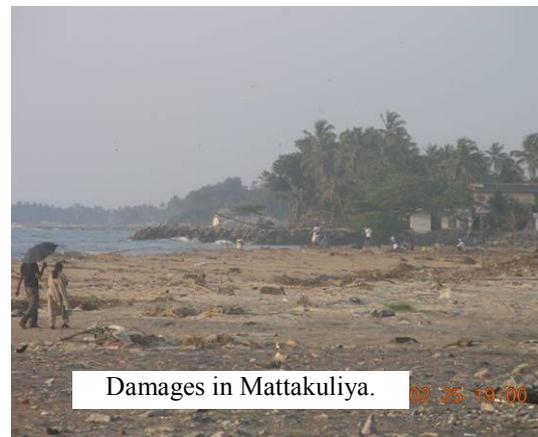
Damages in Mattakuliya.

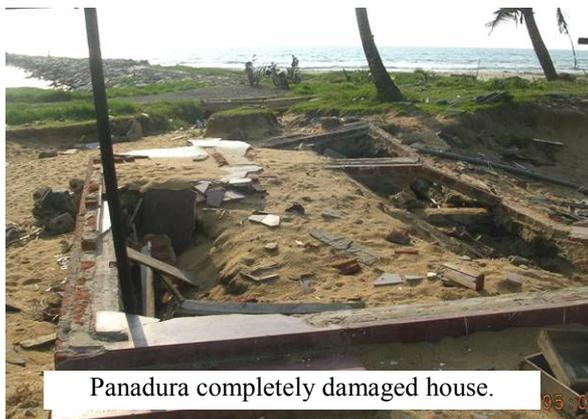
Most affected city in the west coast was identified as community housing scheme near the Panadura fishery port. It was observed that most of the houses located near to the coast were fully wiped off.

Panadura completely damaged house.

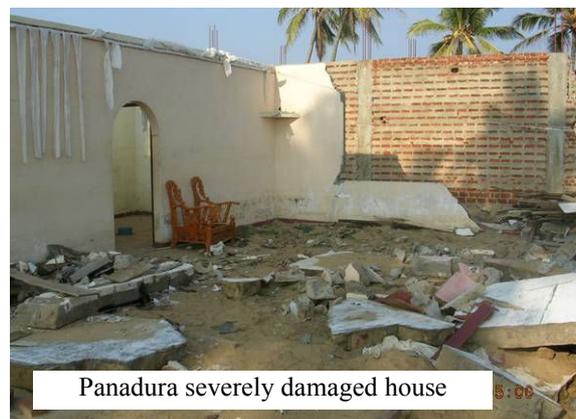
Panadura severely damaged house

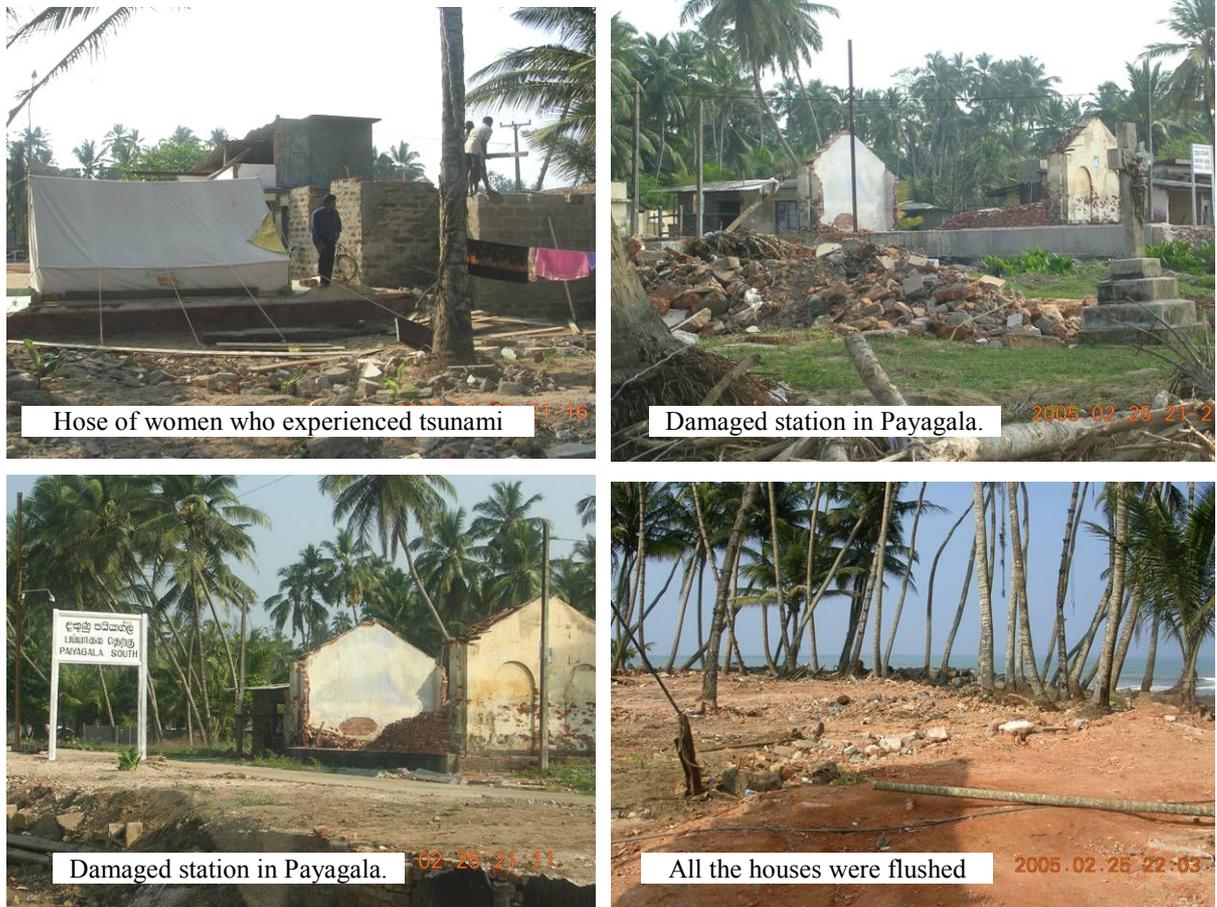
When moving towards south direction next severely affected location was the Payagala point. It was found that some of the buildings of railway station were completely washed away during the tsunami. Following figures shows the damages to the buildings in the railway station and nearby house.

Fig 3.13: Damages in Payagala point.

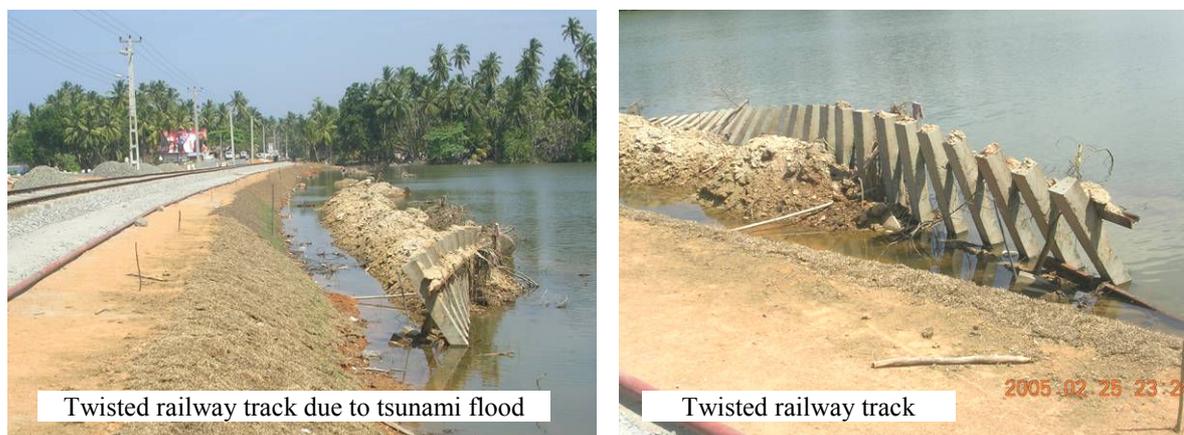
Kosgoda was the next location which found to be severely damaged. It was seen that railway track was completely destroyed. Such strong damage was caused by the heavy flow took through the Kosgoda river, which is wider in that particular area.

Fig 3.14: Damages in Kosgoda railway track.

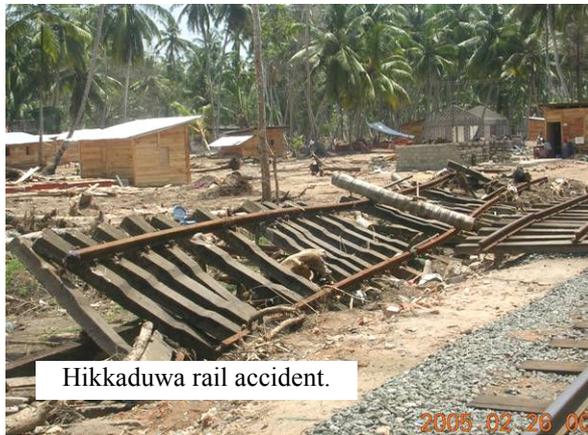
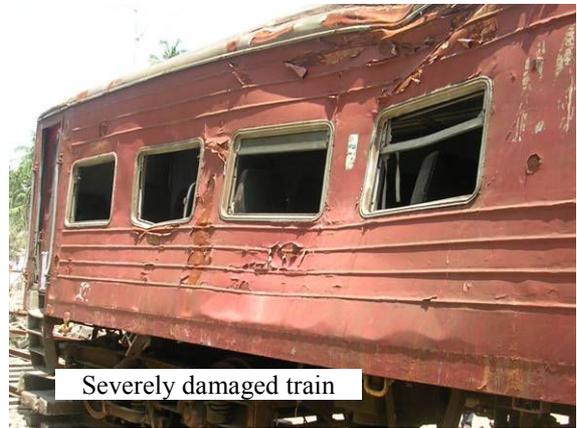
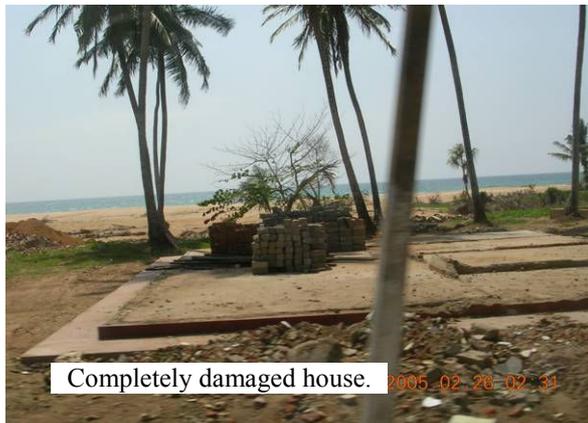
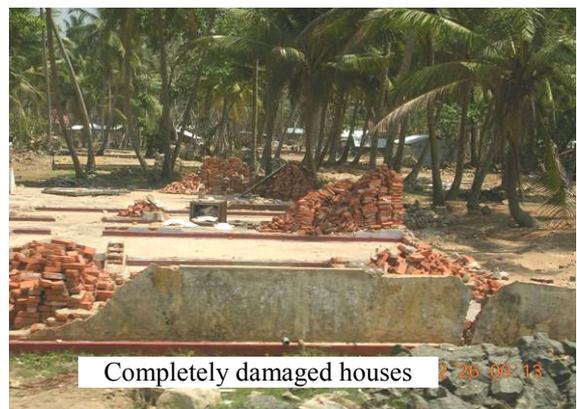
Next most important location observed was the Peraliya, where a large number of people died while train was caught by tsunami. Based on the observations it was found that area where the accident took place was just above the mean sea level and surrounding area was also low-lying. Following figures show the damages took place on that site.

Fig 3.15: Damages in Peraliya, Hikkaduwa South.

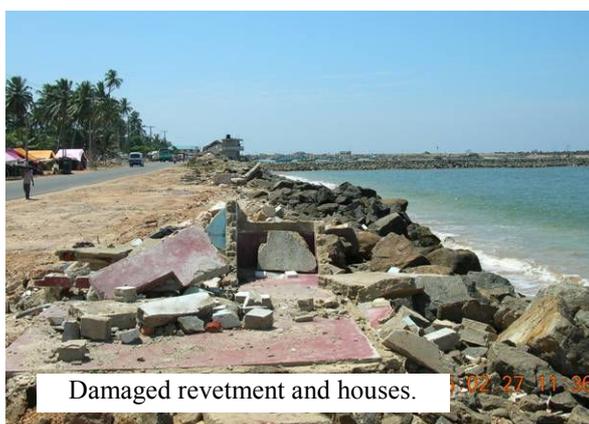
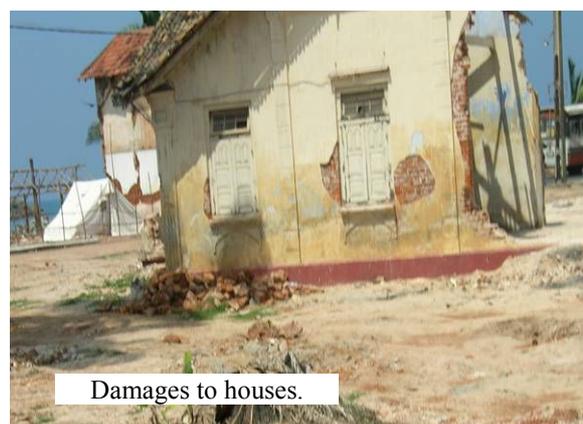
Immediately after Akurala, Hikkaduwa was found to be the next severely affected community. Damages were vivid and spread over a large area. By visual observations it was again found Hikkaduwa also experienced large waves due to localized effects of the near shore morphology. Such waves could easily wipe off many houses which were old and not strong. Following shows some of the structural damages found in Hikkaduwa.

Fig 3.16: Damages in Hikkaduwa

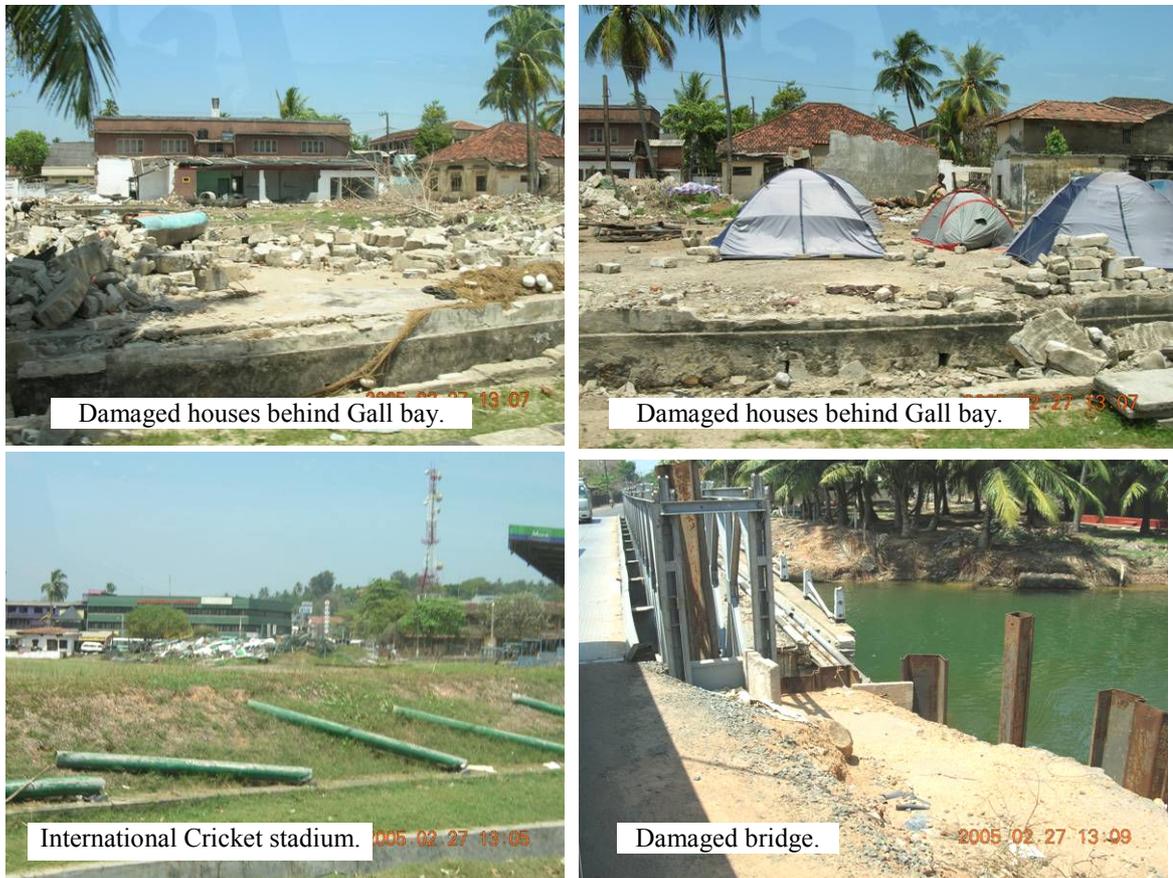
Next to the Hikkaduwa, most number of casualties was reported from Galle. Since Galle is located right behind a large bay which is surrounded by high ground areas. Hence more damages were caused by local amplification of tsunami. Following shows some of the damaged houses, building caught in tsunami.

Fig 3.17: Damages in Galle

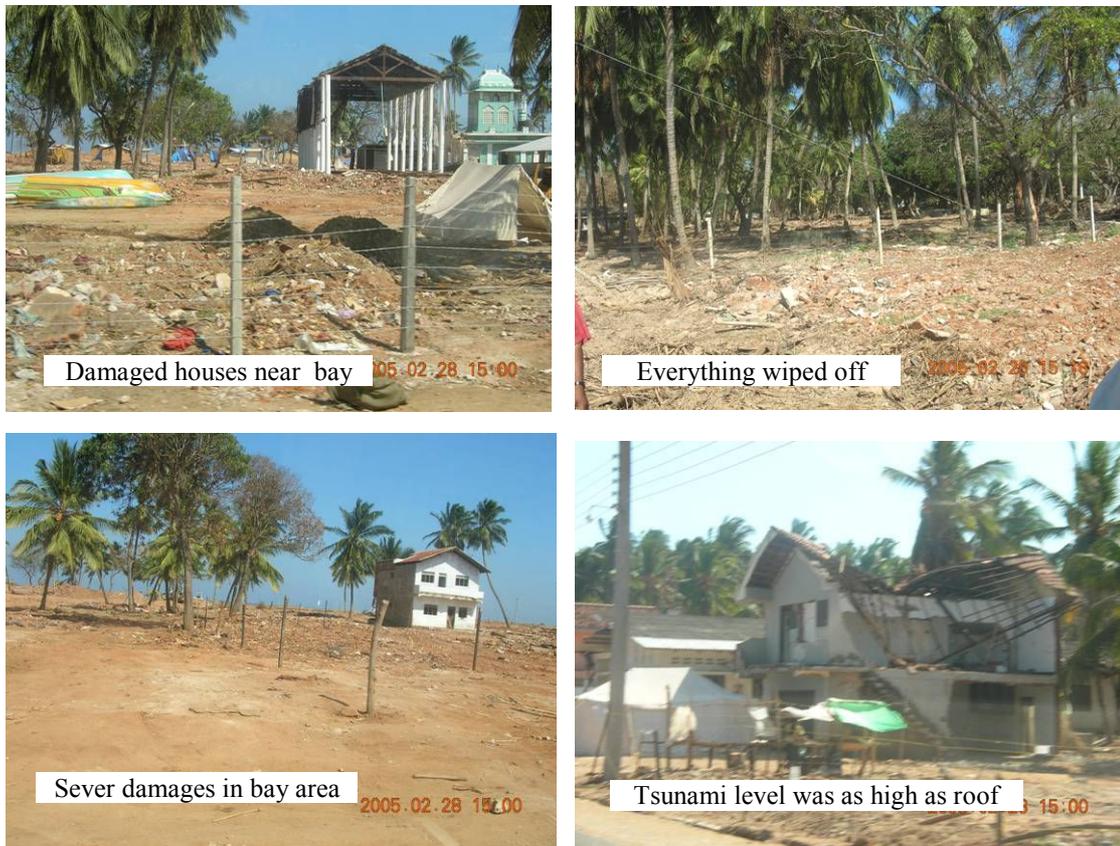
Hambantota is one of the most severely affected in the south coast since it was the most populated city located close to the sea. Following shows the damages to Hambantota.

Fig 3.19: Damages in Hambantota

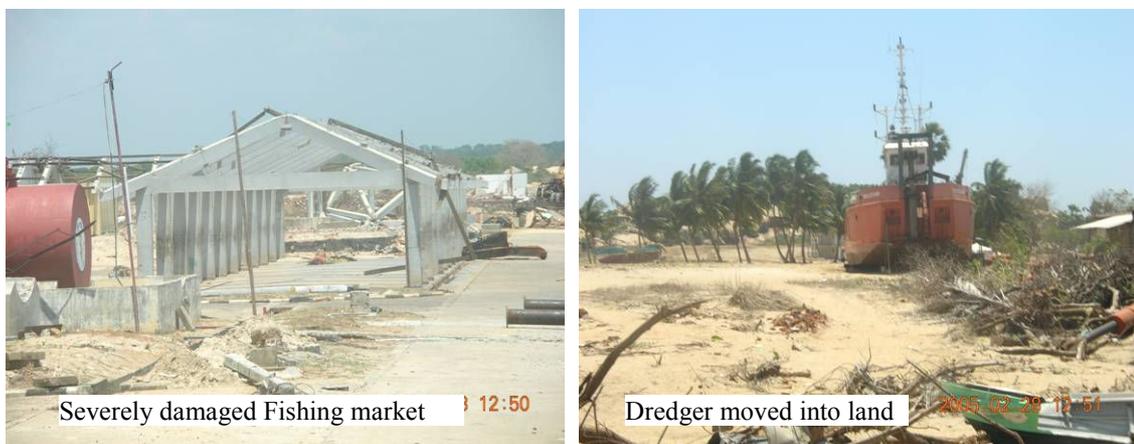
Kirinda was another good evidence for tsunami damages in the south coast. Observations made in Kirinda showed the magnitude of the trapped wave, which was moving parallel to the Kirinda Fishery Port. Also it was observed that heavy movement of sand across the shore.

Fig 3.20: Damages in Kirinda

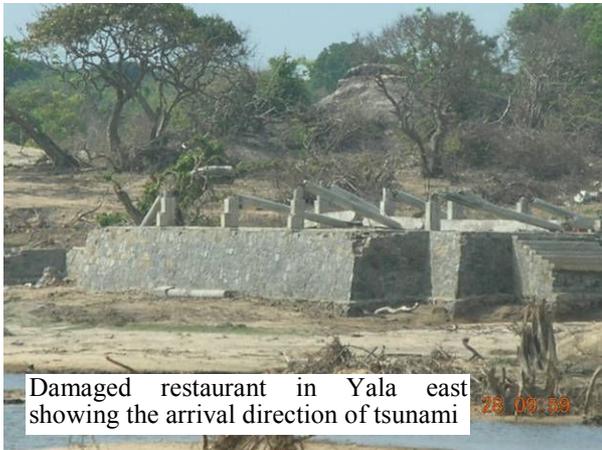
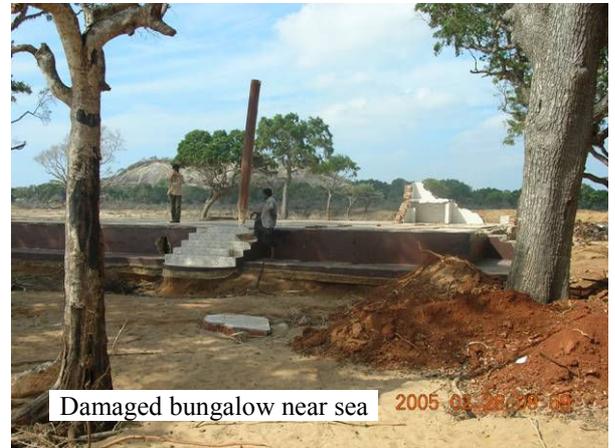
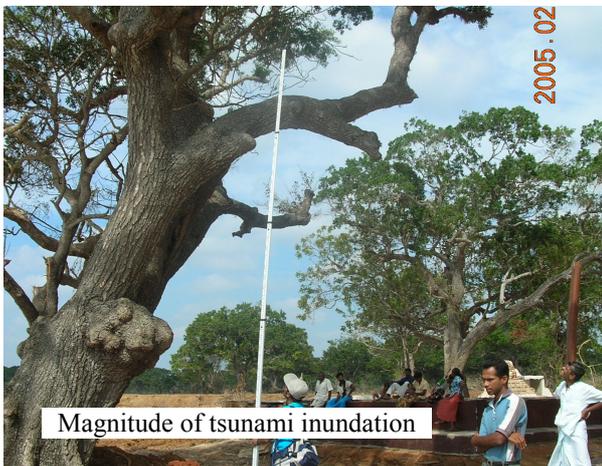
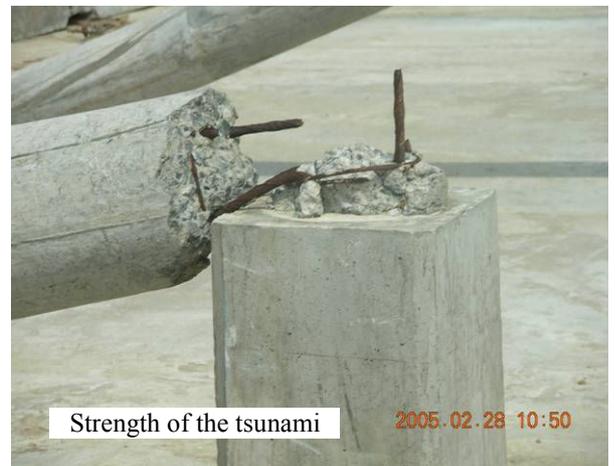
Final location of the field survey was the Yala, which is inside a national reserved forest. Damages were identified as exceptional in some of the locations .

Fig 3.21: Damages in Yala

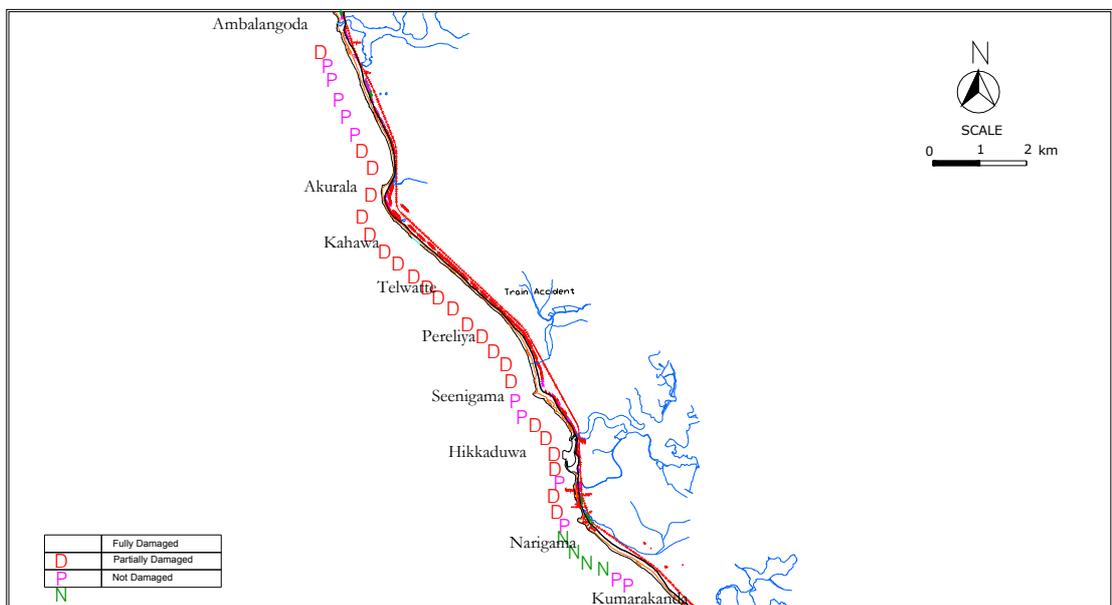
Fig 3.22: Pattern of damages to houses ( South Hikkaduwa to Ambalangoda)

Fig 3.22 – fig 3.24 shows the results obtained from visual survey in South West coast, covering Galle to Payagala.

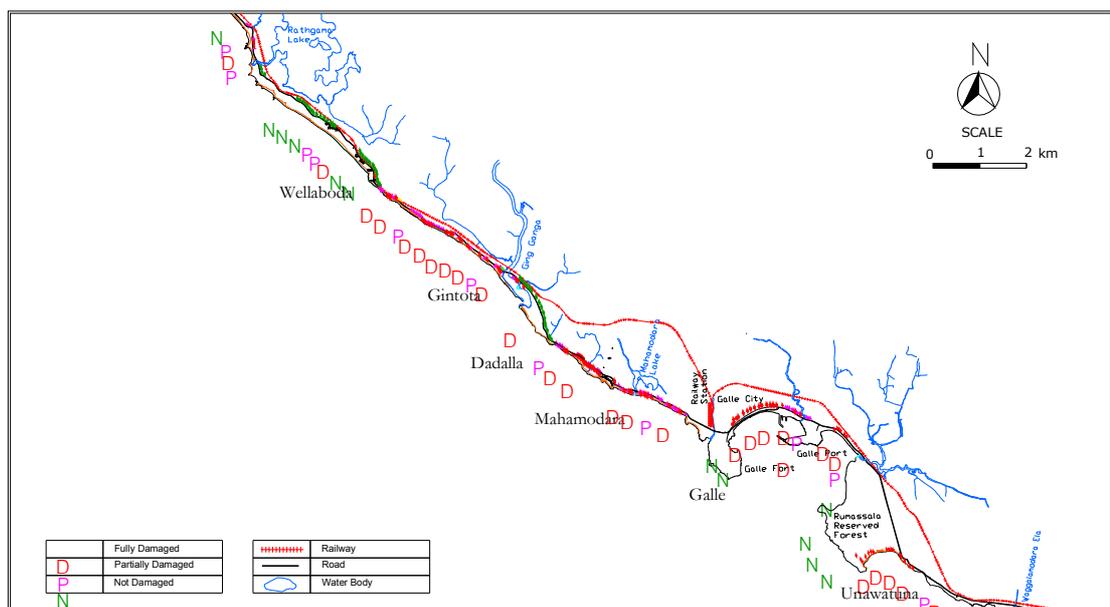
Fig 3.23: Pattern of damages to houses (Unawatuna to South of Hikkaduwa)

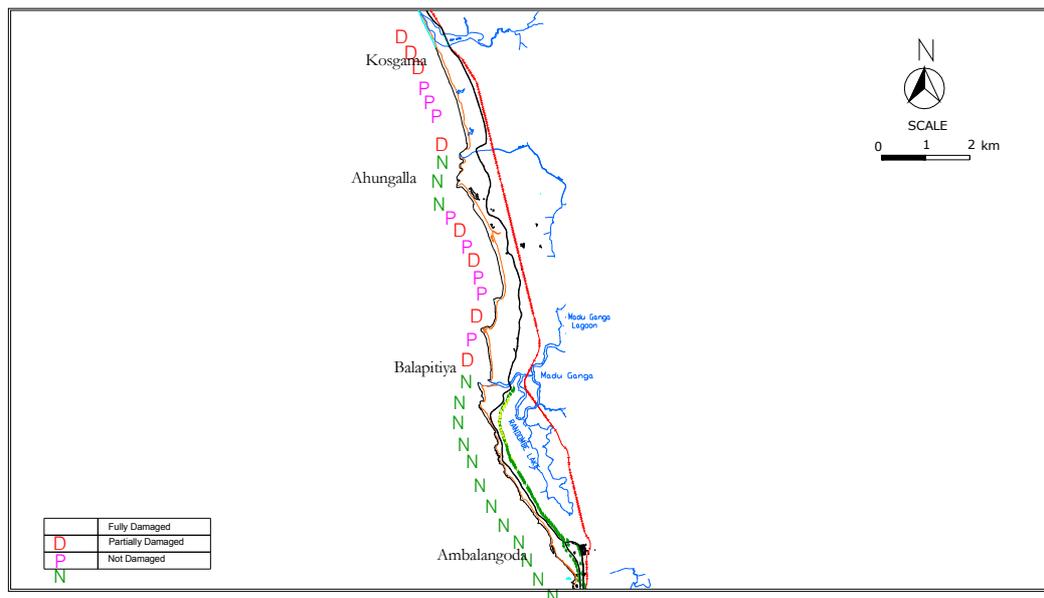
Fig 3.24: Pattern of damages to houses (From Ambalangoda to Kosgoda)

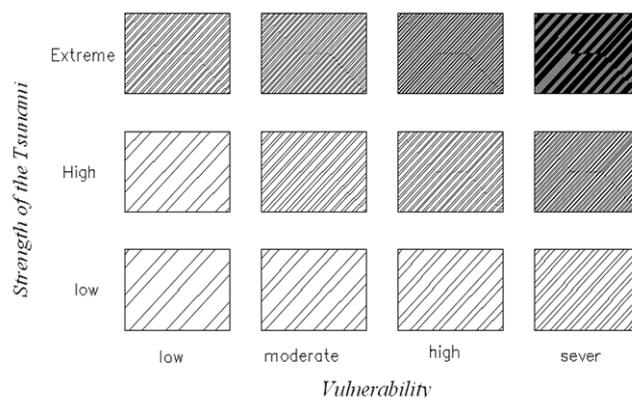
By summarizing the tsunami strength and local vulnerability, following risk potential matrix can be derived. Refer fig 3.25

Fig 3.25: Tsunami damage risk potential matrix

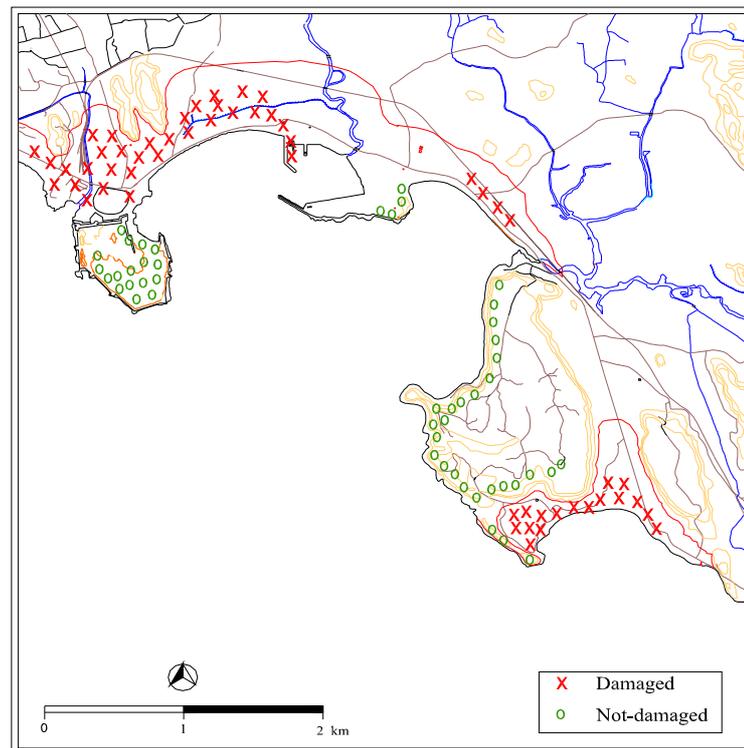
Fig 3.26: Damages to Galle.

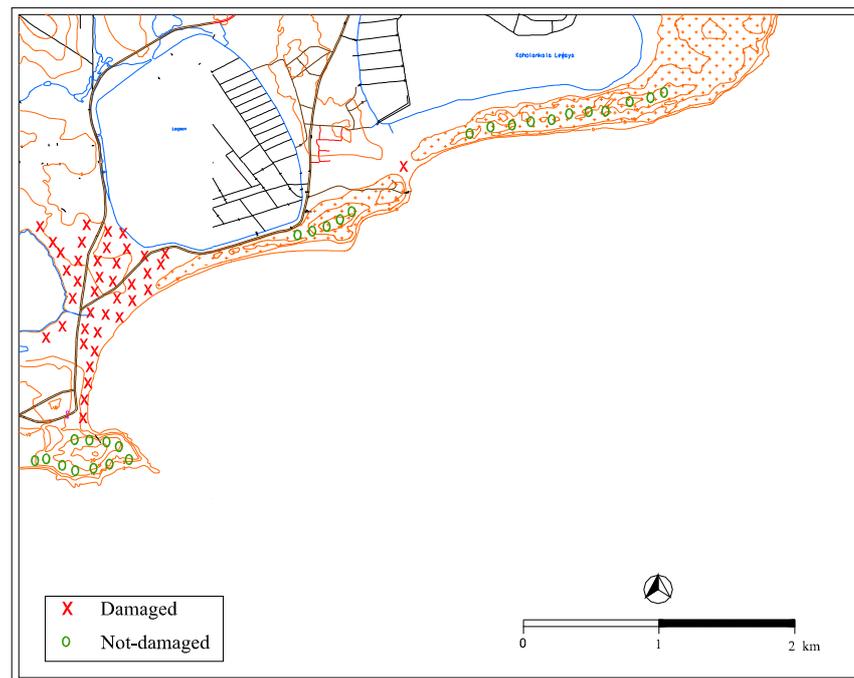
Fig 3.27: Damages to Hambantota.

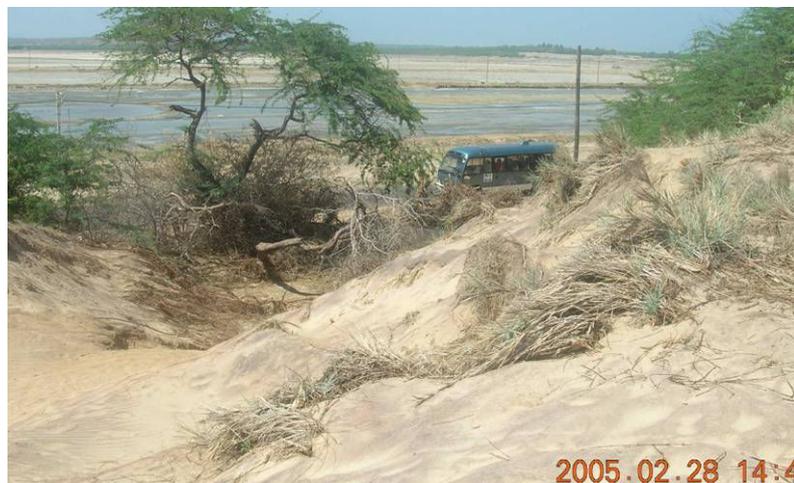
Another important fact which is noticed in Hambantota was the coastal vegetation. Even though there was not much effect in completely protecting, those were effective in increasing the resistance for wave propagation. Sand dunes covered with vegetation found to be less eroded and were very effective in protecting the hinterland. See fig 3.29.

Fig 3.28: sand dunes severely eroded in east of Hambantota.

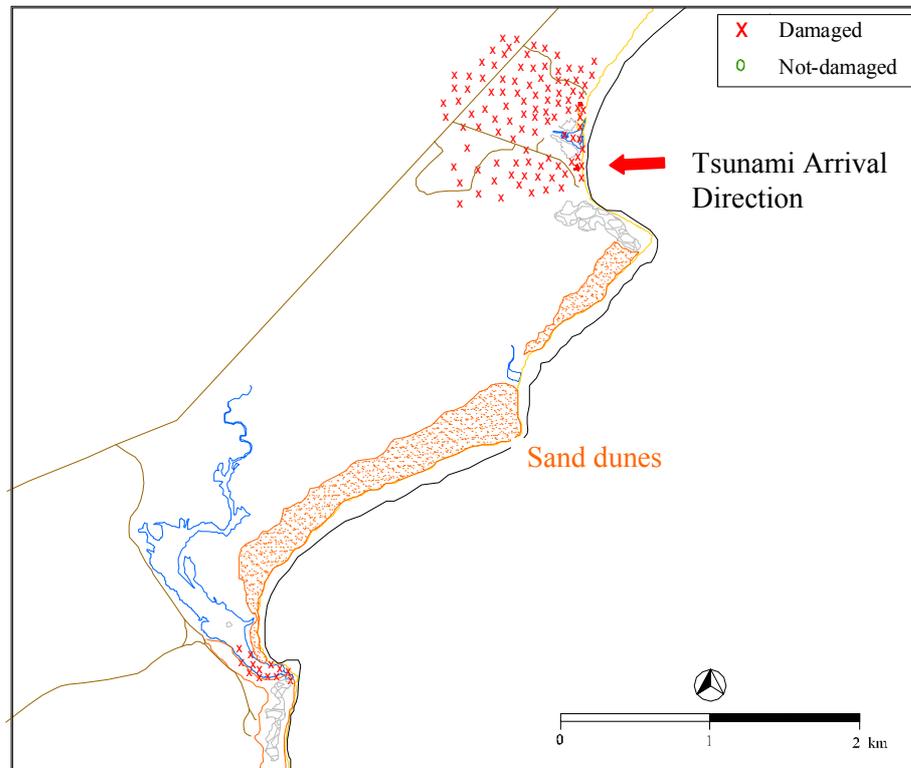
Fig 3.30: Damages to Yala.

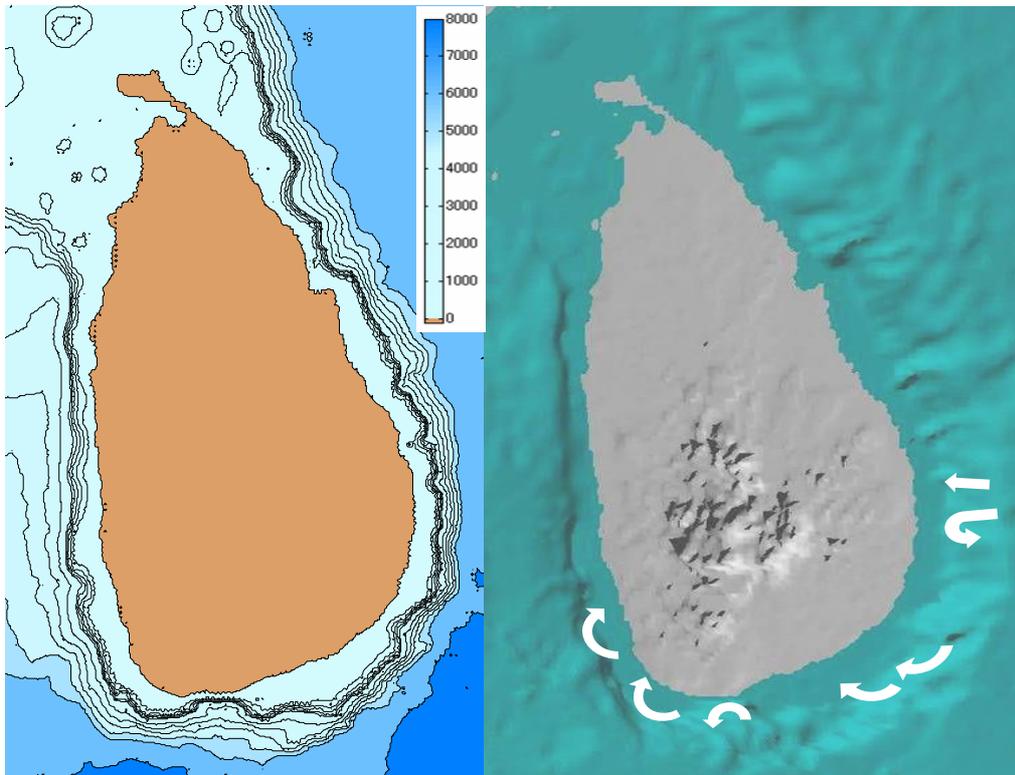
Fig 3.31: Continental shelf around Sri Lanka.

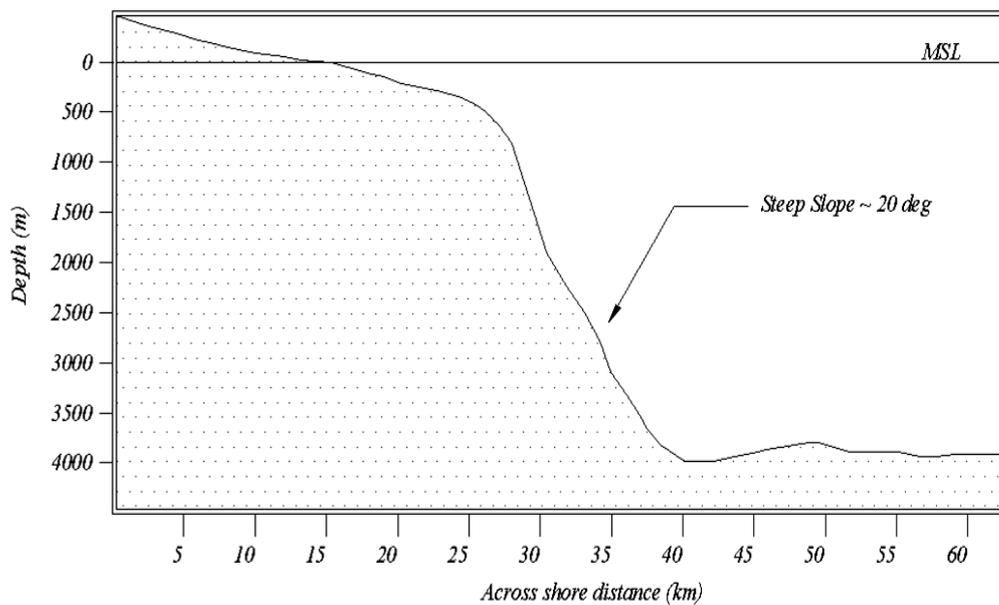
Fig 3.32: cross sectional view of continental shelf of east coast.

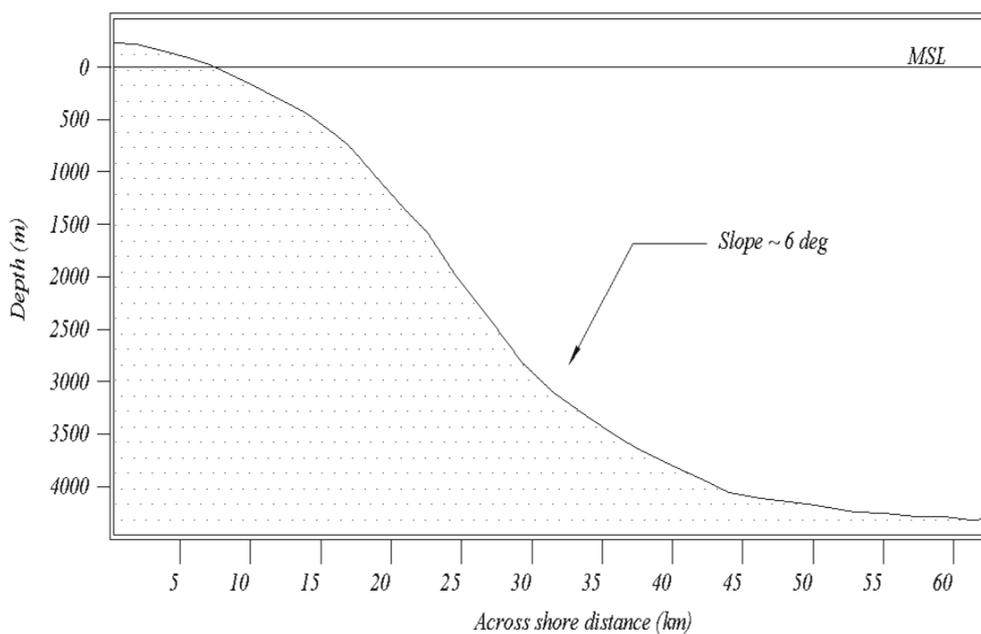
Fig 3.33: cross sectional view of continental shelf of south coast.

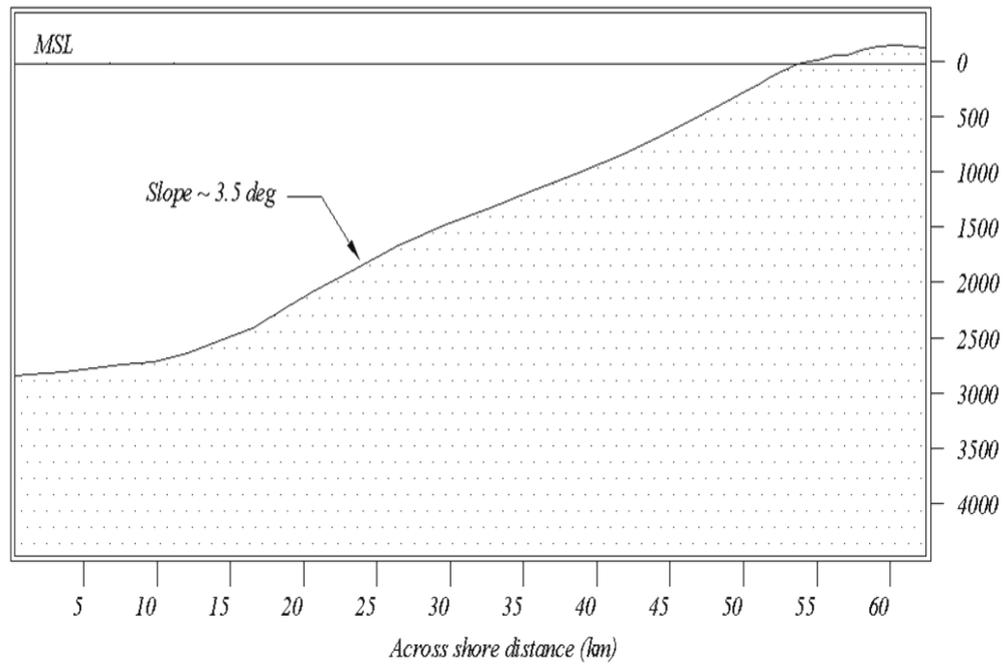
Fig 3.34: cross sectional view of continental shelf of west coast.

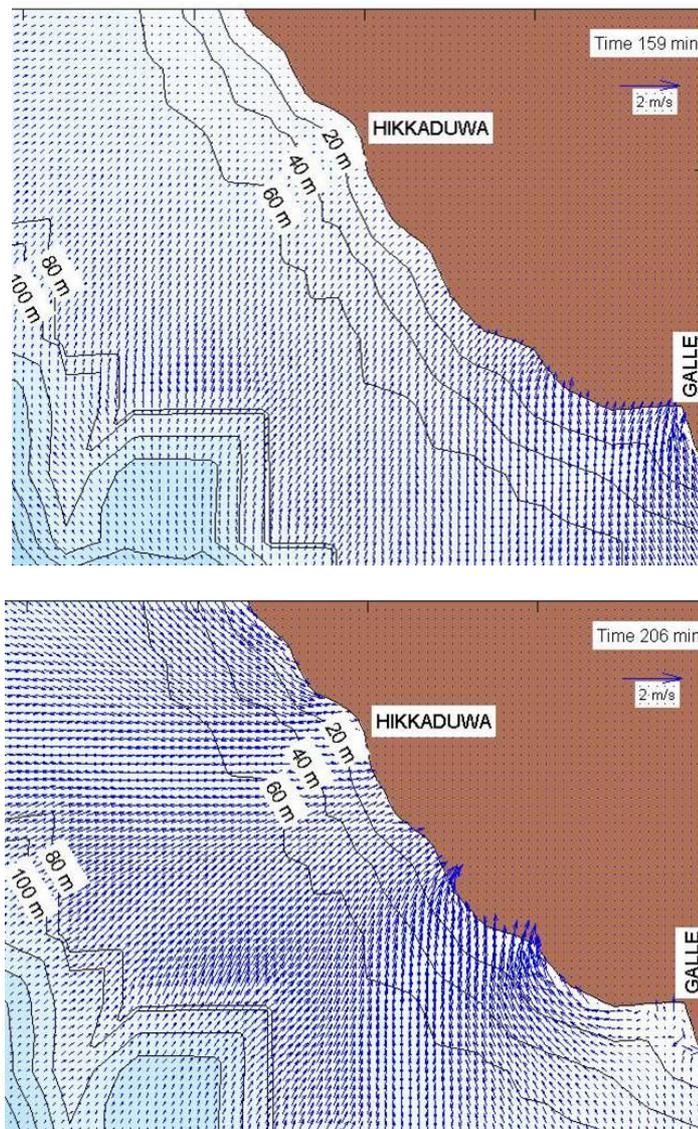
Anyhow during the field observations it was convinced that this multidirectional wave attack was experienced by most of the coastal inhabitants in Hikkaduwa area. There was no clear way to see the exact direction of wave attack since most of the observers were on the beach and couldn't see much distant towards ocean. The most reliable way to determine the tsunami attack direction is by partially damaged structures, deformed concrete poles, broken walls or disturbed vegetation. (Tsuji et al. 1995). However due to the multiple wave attacks and strong backwash it was difficult to judge the major tsunami attack direction in Hikkaduwa.

Fig 4.1 Tsunami arrived Hikkaduwa in south (bottom) and north (top)
