東京大学大学院新領域創成科学研究科  
社会文化環境学専攻

修士論文

**Analysis of damages in Hikkaduwa and South West Coast of  
Sri Lanka in 2004 December Sumatra tsunami**

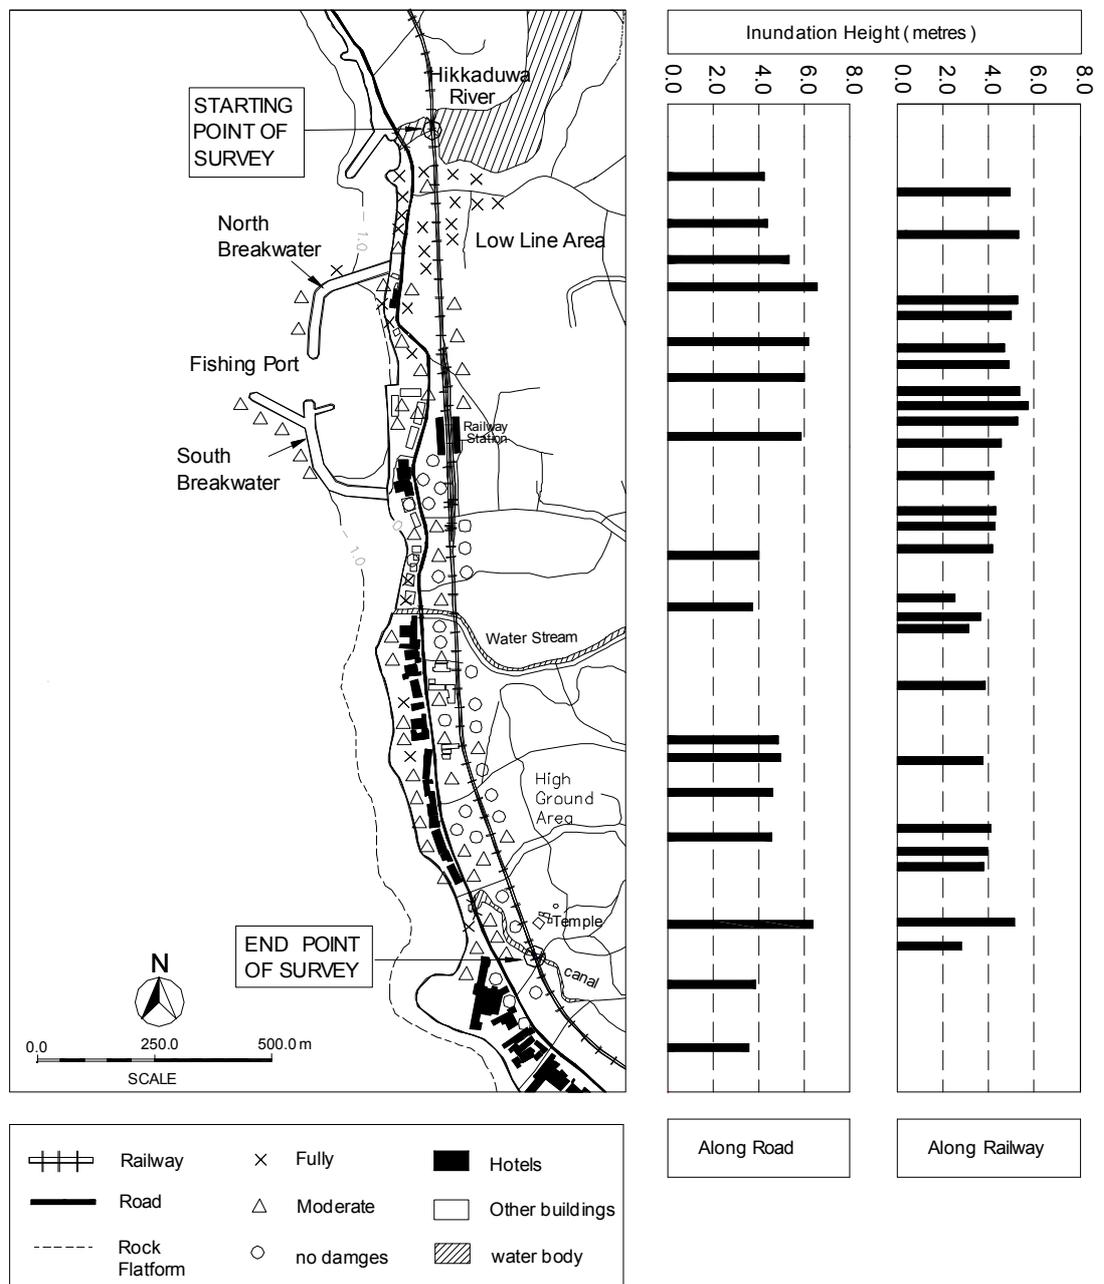
Fig 4.4 shows the summary of the observation data made in Hikkaduwa. It can be clearly seen that there is a difference between inundations observed in north of Hikkaduwa and south of Hikkaduwa. Meantime figure 4.5 and figure 4.6 shows the distribution of bathymetry and topology in sea around Hikkaduwa and Hikkaduwa city area. It can be clearly seen that edge of the continental shelf in front of Hikkaduwa was not steep hence received most of the energy transferred from south part of Sri Lanka. Those received waves were further amplified by the shallower nearshore bathymetry in Hikkaduwa. This can be seen as one of the cause of receiving very high waves in west coast of Sri Lanka.

Fig 4.4: Inundation measurements in Hikkaduwa

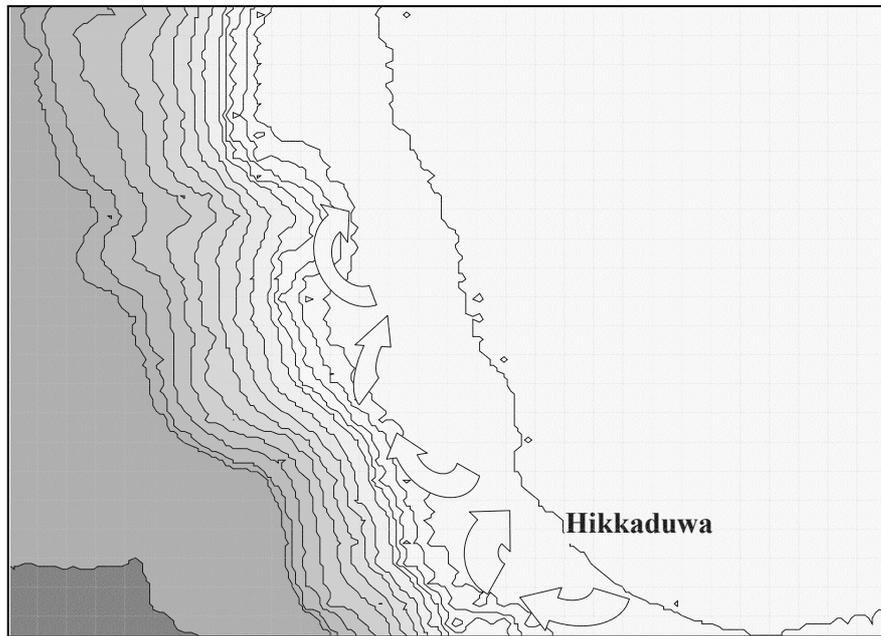
Fig 4.5: Nearshore Morphology of South west coast and west coast.

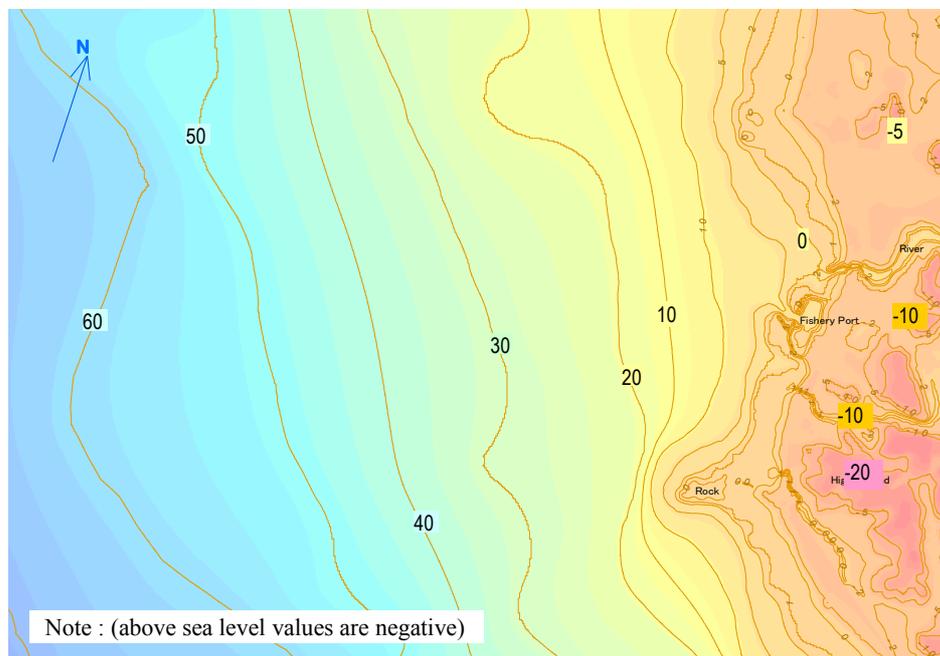
Fig 4.6: Nearshore Morphology of Hikkaduwa.

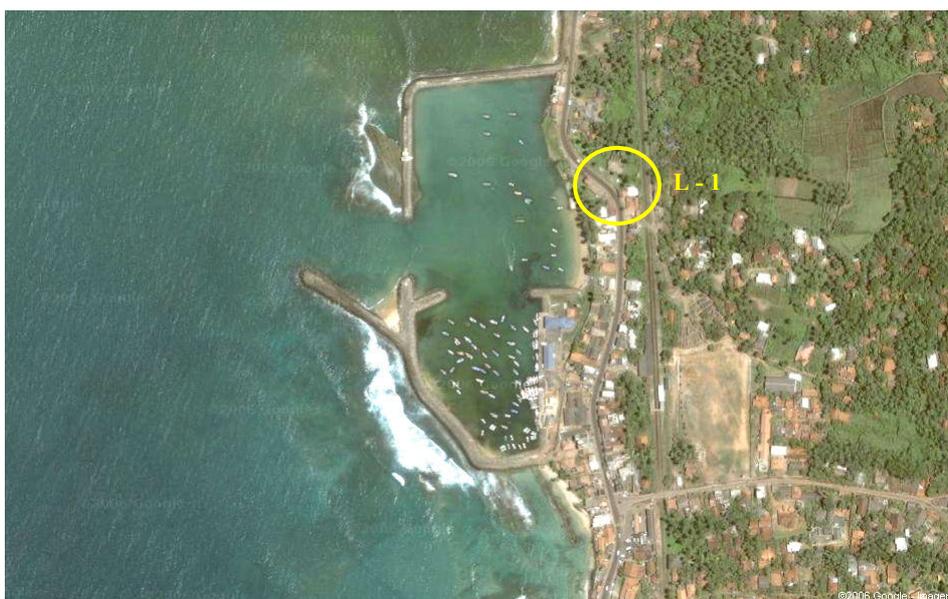
First and the most important feature we find is the fishery port in North part of city. It has two main breakwaters of average height around 4.0 m from MSL. From further investigations and observations of that area it was revealed that those backwaters were originally built on two rock cliffs which was in fact a part of the shallow water reef in Hikkaduwa town. From 4.7 it can be seen that bathymetry around the south breakwater is a kind of a small headland hence waves can easily concentrate towards the fishery port. In fact this was evident from the numerical modelling of tsunami run-up in Hikkaduwa. However the breakwaters have an effect of dissipation up to certain extent. But in case of a high tidal bore such effectiveness of a shallow breakwater is not so significant since most of the waves could easily overtop. And some of the waves could easily concentrate through the mouth of the breakwater and pushed towards beach. Even by field interviews it was found that large waves were arrived from mouth of the fishing port and moving fast towards land.

Fig 4.7: overview of the Hikkaduwa Fishery Port.

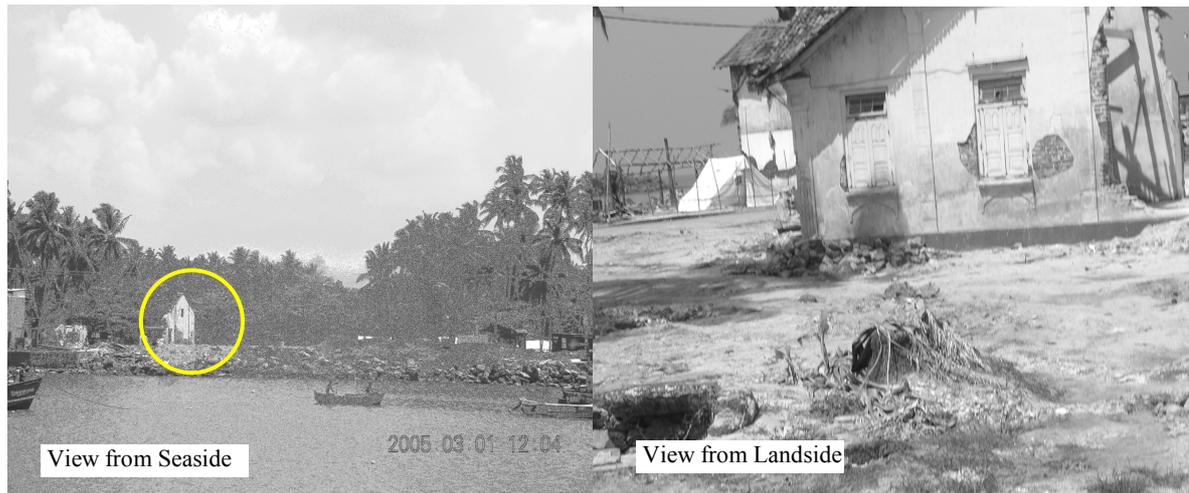
Most important evidence revealed was severe damages right behind the north breakwater and area between river mouth and north breakwater. Most of the houses attacked by the tsunami found to be severely damaged or completely washed away. Fig 4.8 shows the area behind the breakwaters suffered severe damages. Meantime by referring to the inundation heights measured, it is clear that increase of inundation heights than that of average around this area. See fig 4.10. So in Hikkaduwa it is found that north breakwater was not effective in obstructing tsunami.

Figure 4.8: Damages Observed Behind breakwaters at location L - 1

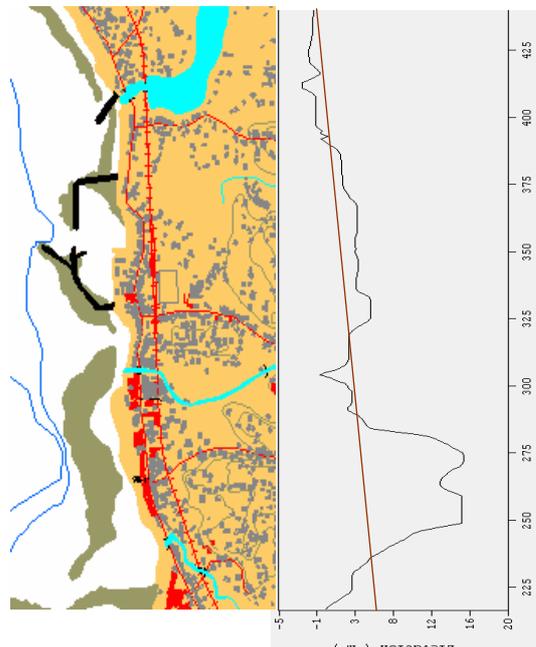
It was found during the field investigations and existing topographic data that there is a variation of ground height between north and south of Hikkaduwa. Fig 4.9. In north part of Hikkaduwa consist more flat and low-line areas. Also there is a large valley found in ether side of the river.

Fig 4.9: Distribution of ground elevation in Hikkaduwa

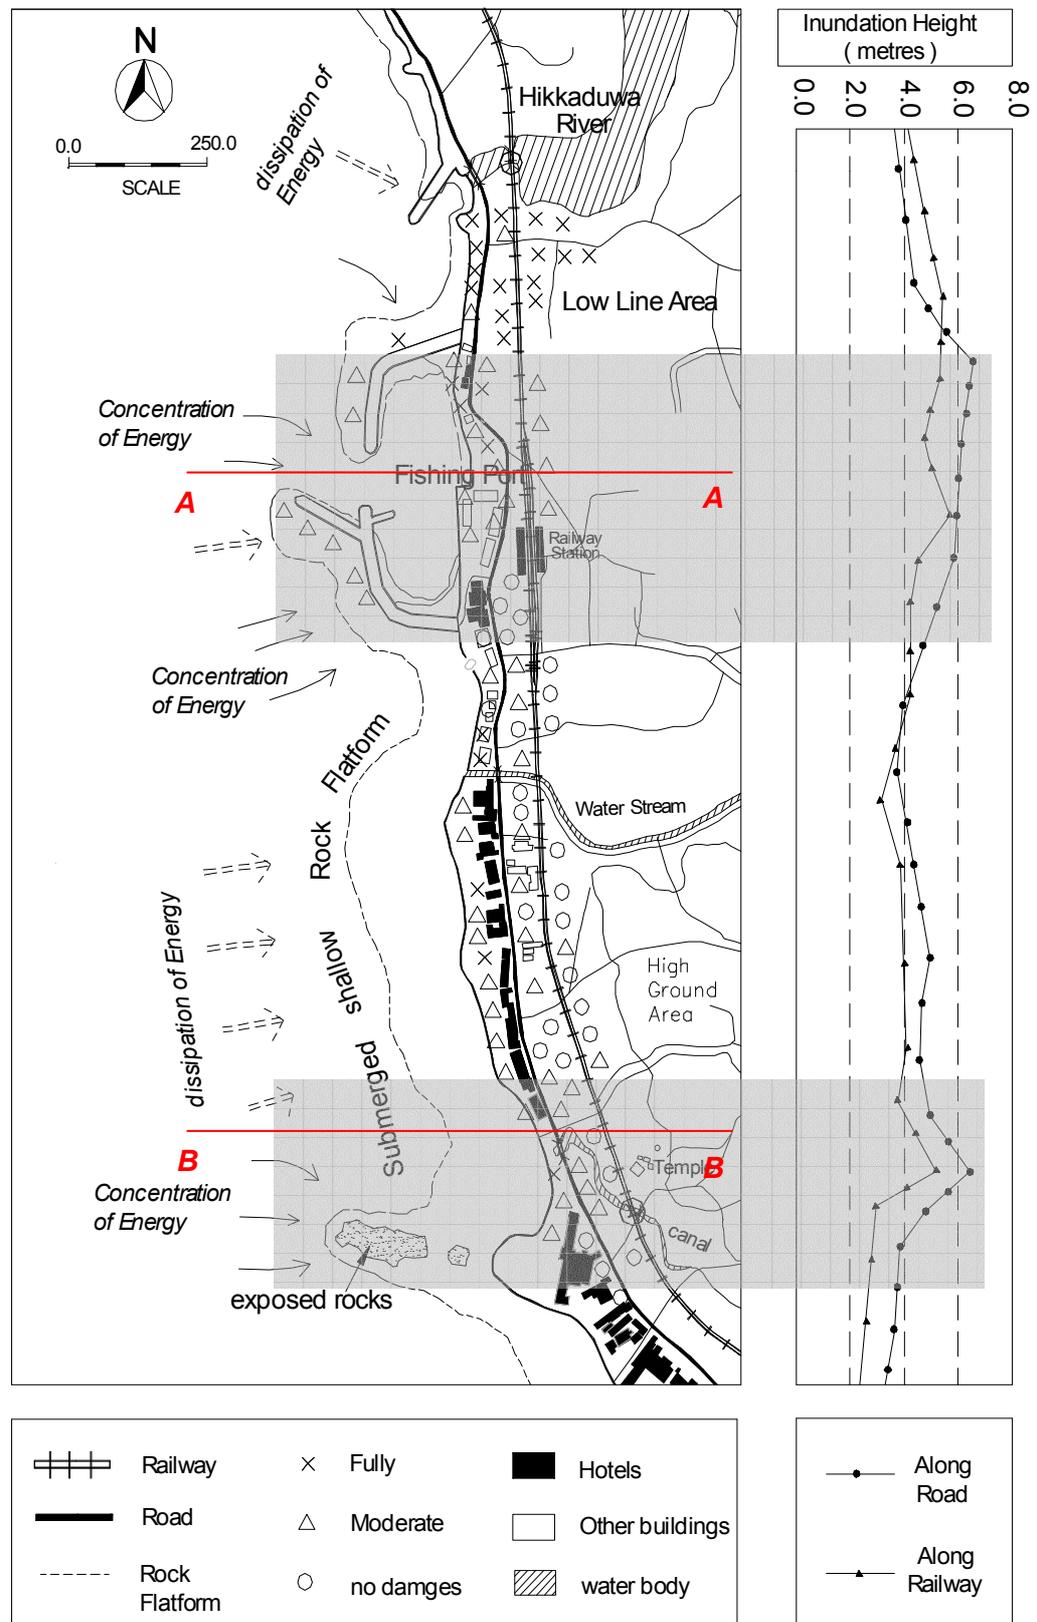
Fig 4.10 Comparison of Inundation heights

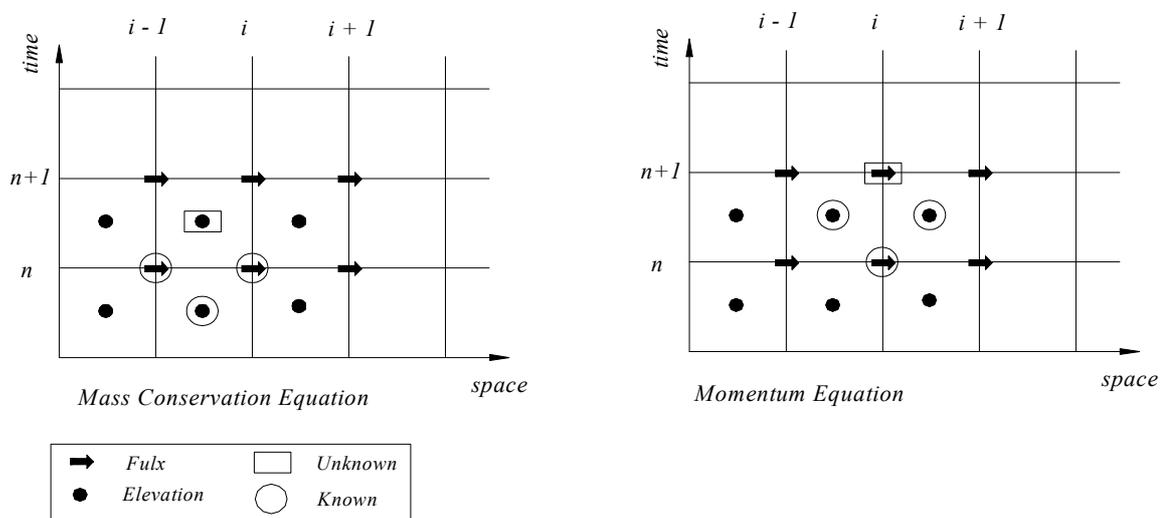
Fig 5.3 : Arrangement of points in staggered leapfrog scheme

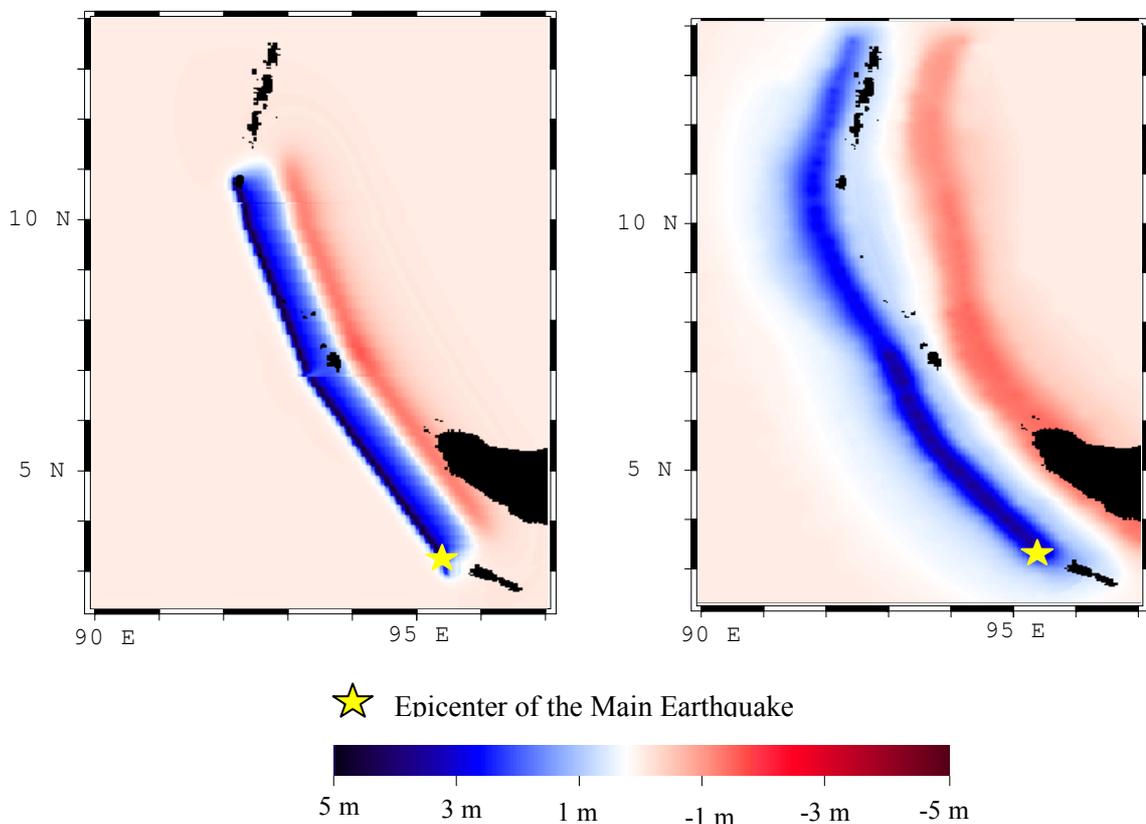
Fig 5.6.: Tsunami Initiation condition based on Koshimura (left) based on the Okadas model (right)

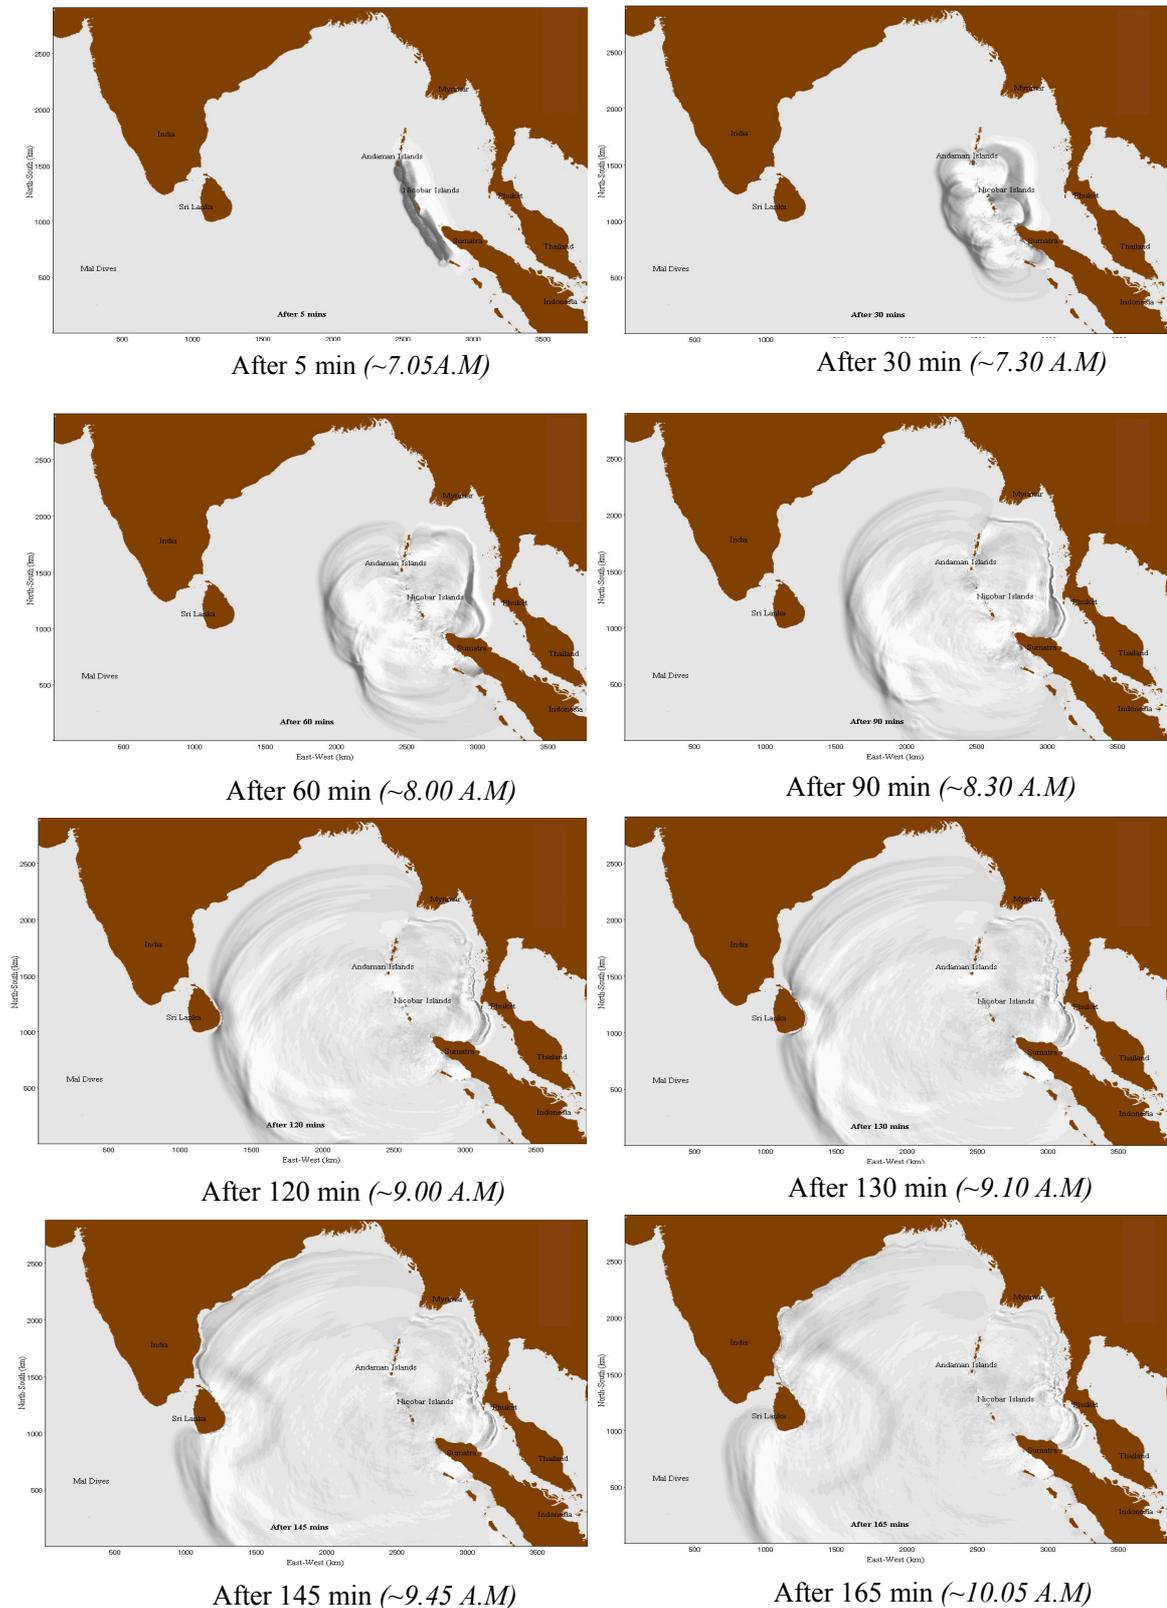
Fig 5.7: Arrival time of Tsunami (from the time of tsunami initiated at Sumatra)

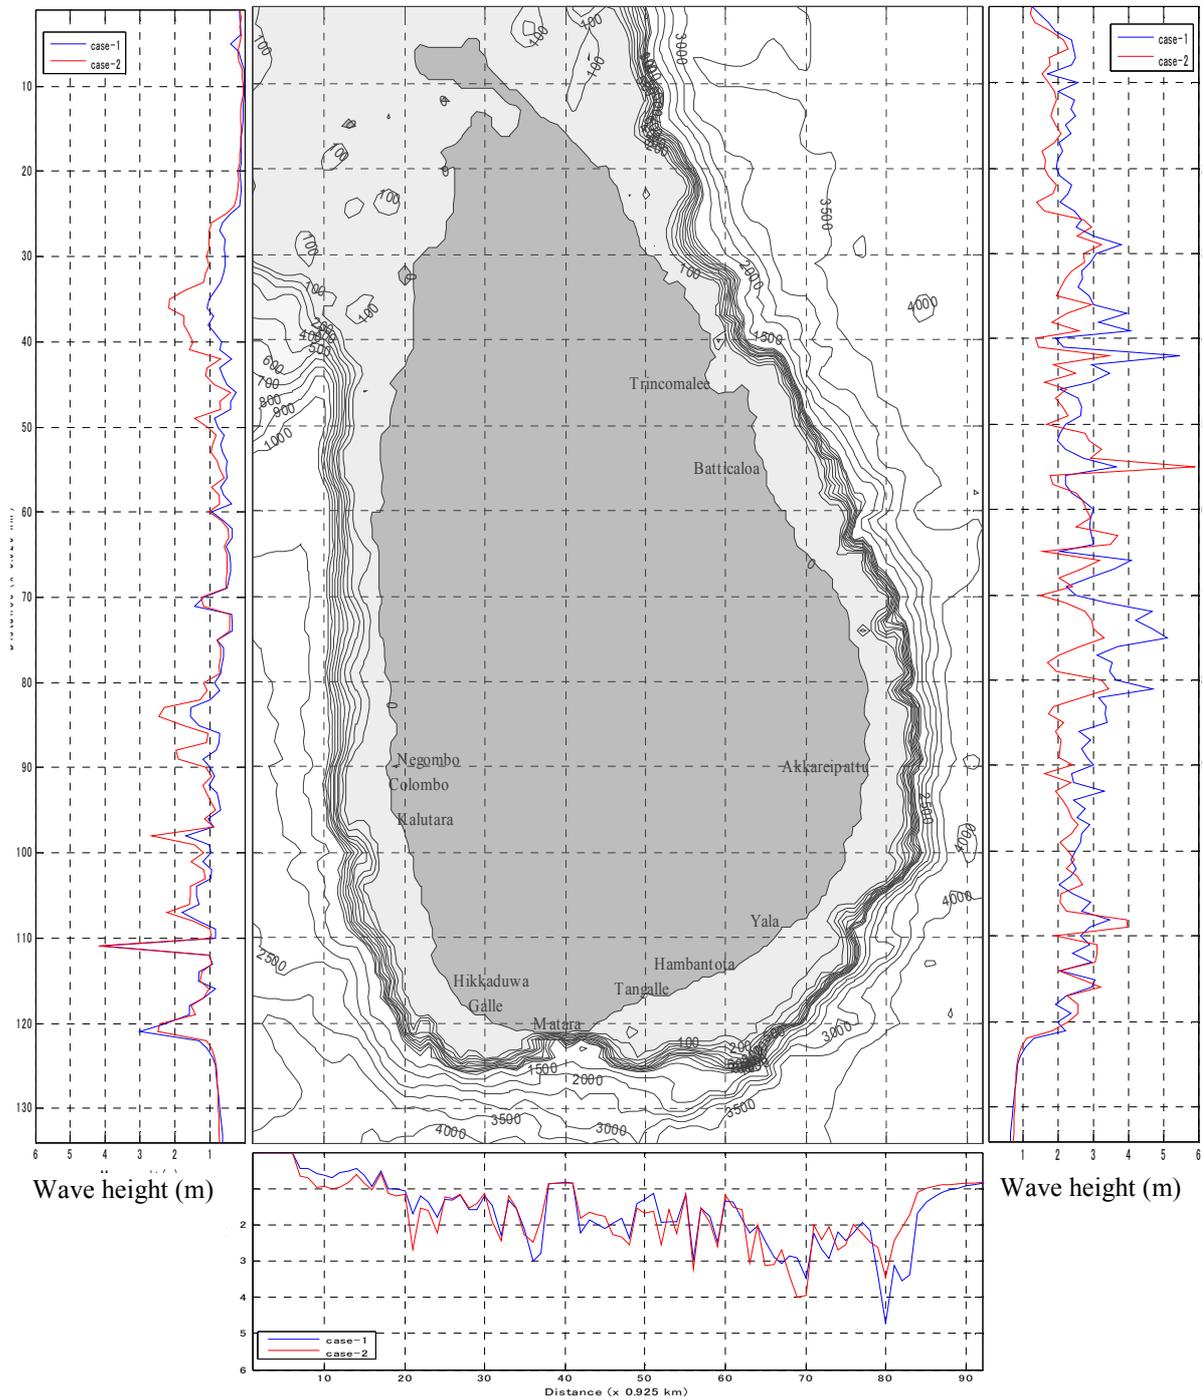
Fig 5.8.: Maximum inundation heights calculated based on two tsunami initiating conditions, by Koshimura and Okadas model.

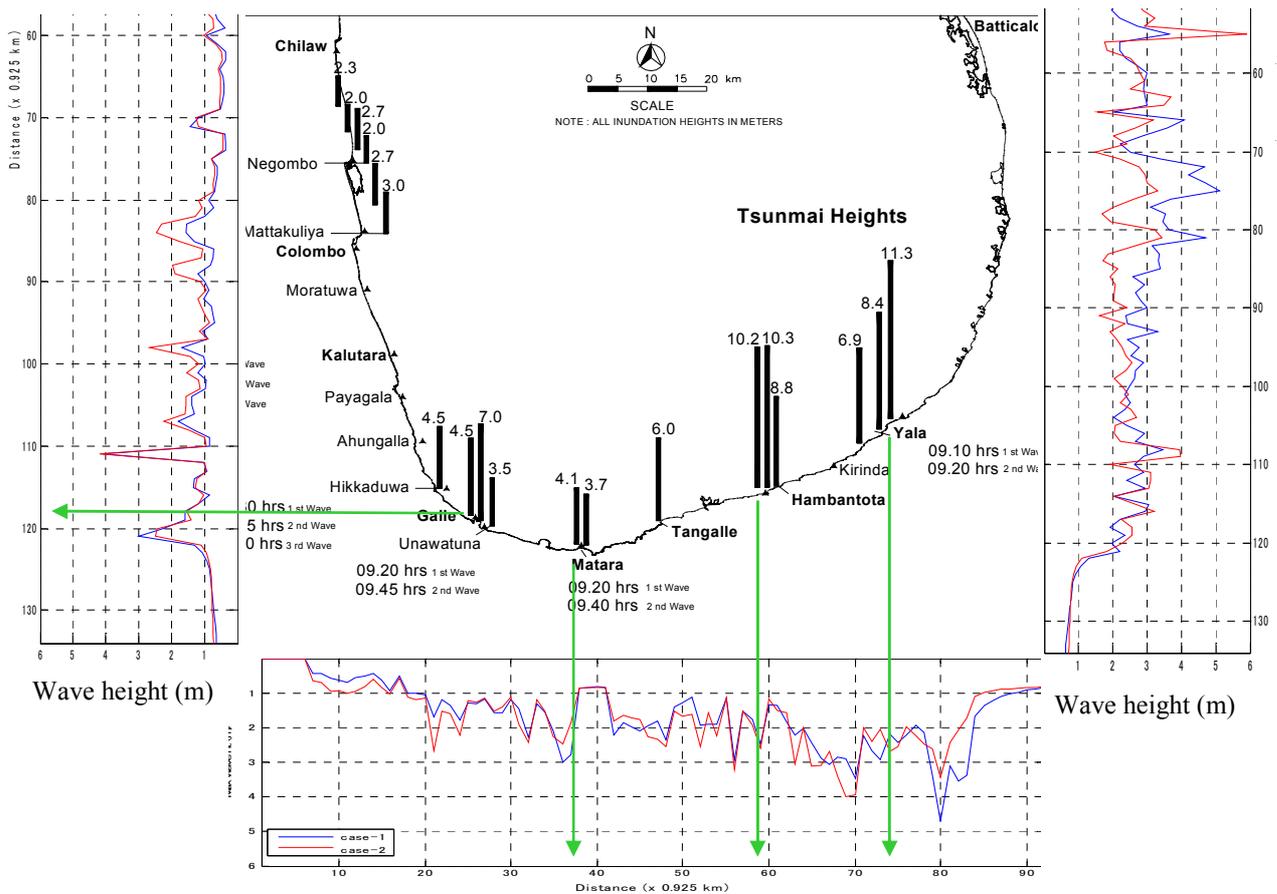
Fig 5.9: Comparison of Inundation heights calculated with inundation heights observed

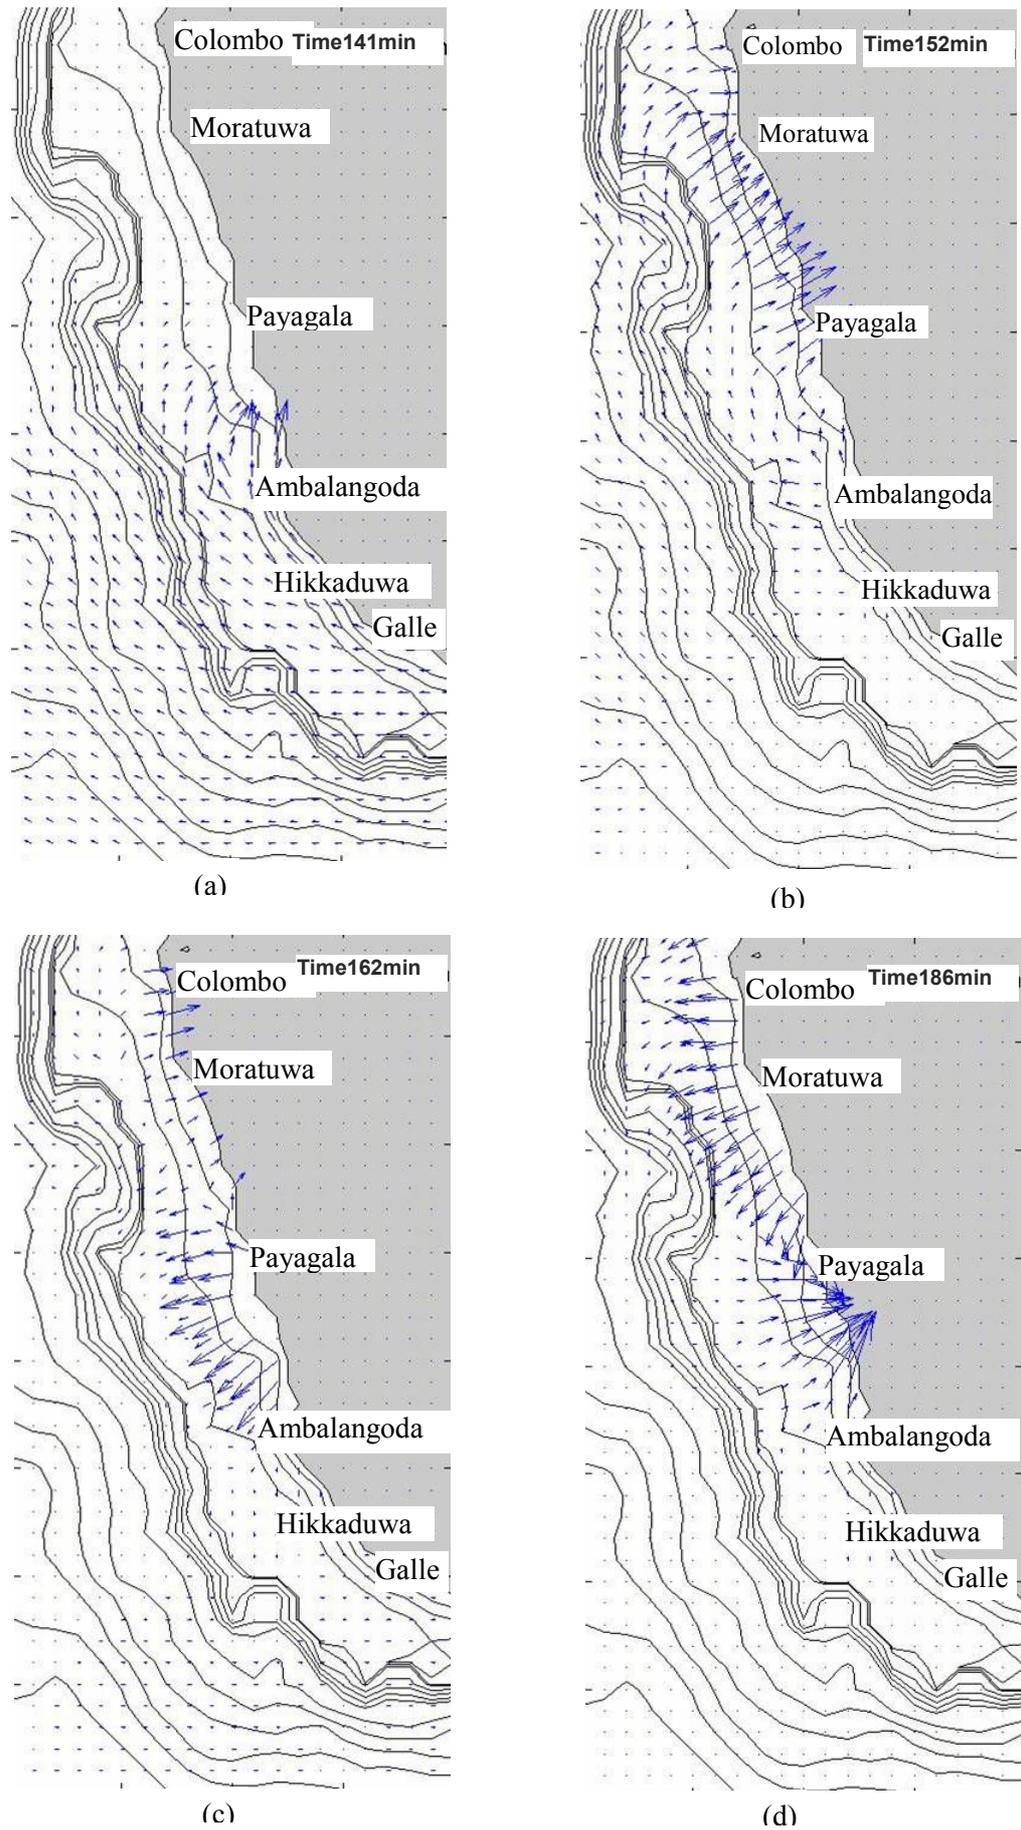
Fig 5.12 : Tsunami Arrival South West Coast

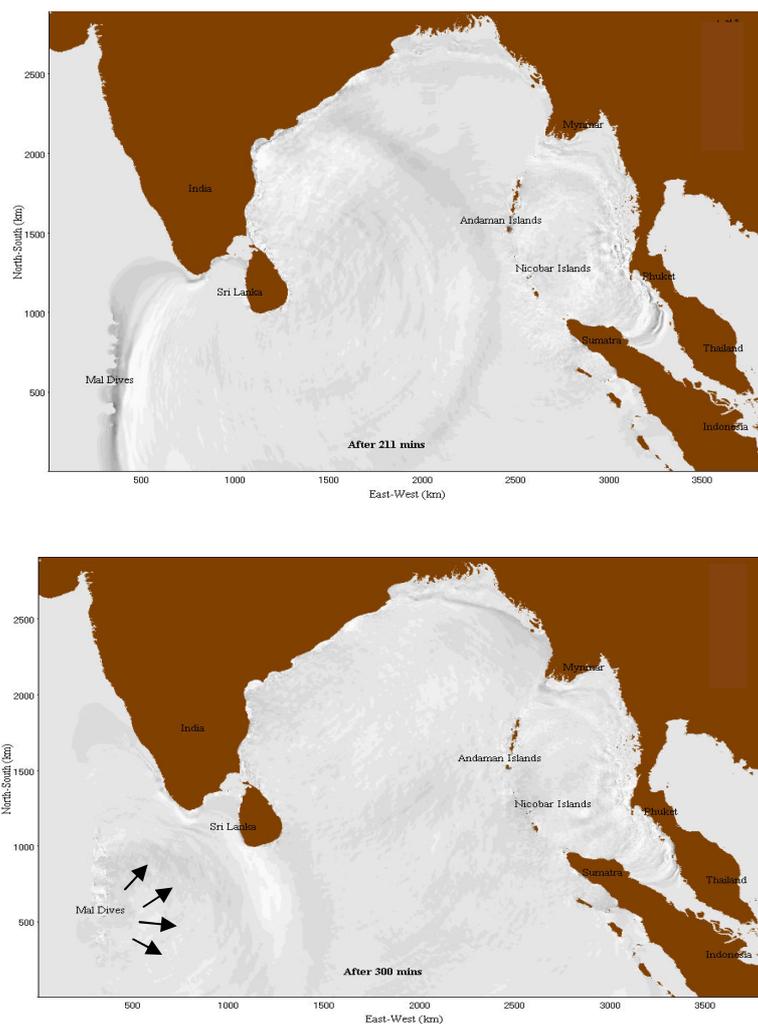
Fig 5.13: Effect of tsunami reflection from Maldives Islands.

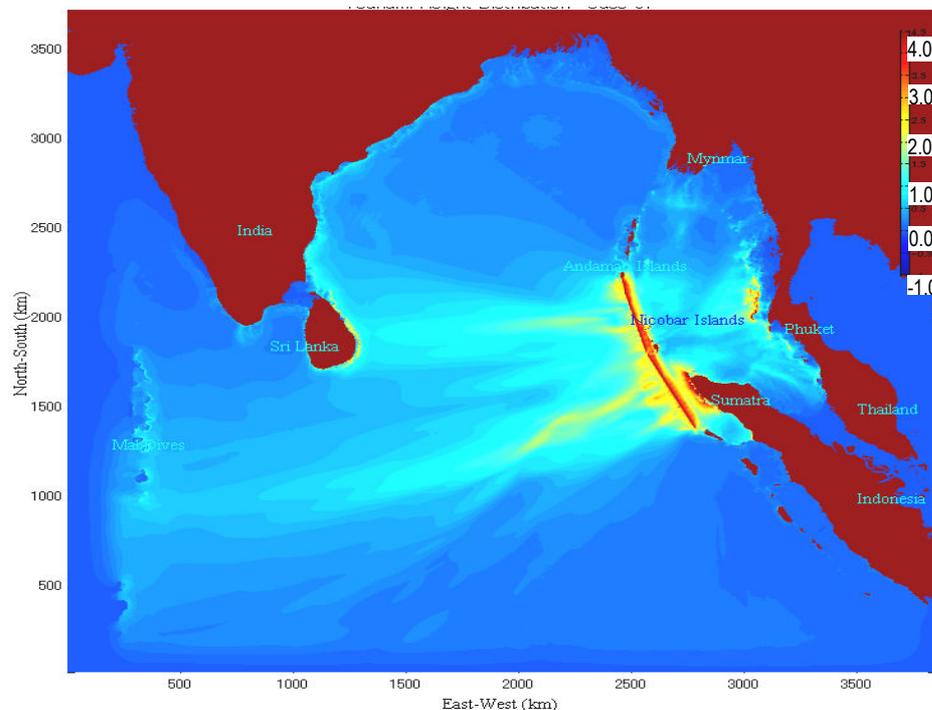
Fig 5.14: Maximum wave height distribution across the Indian Ocean during December 2004, Sumatra tsunami.

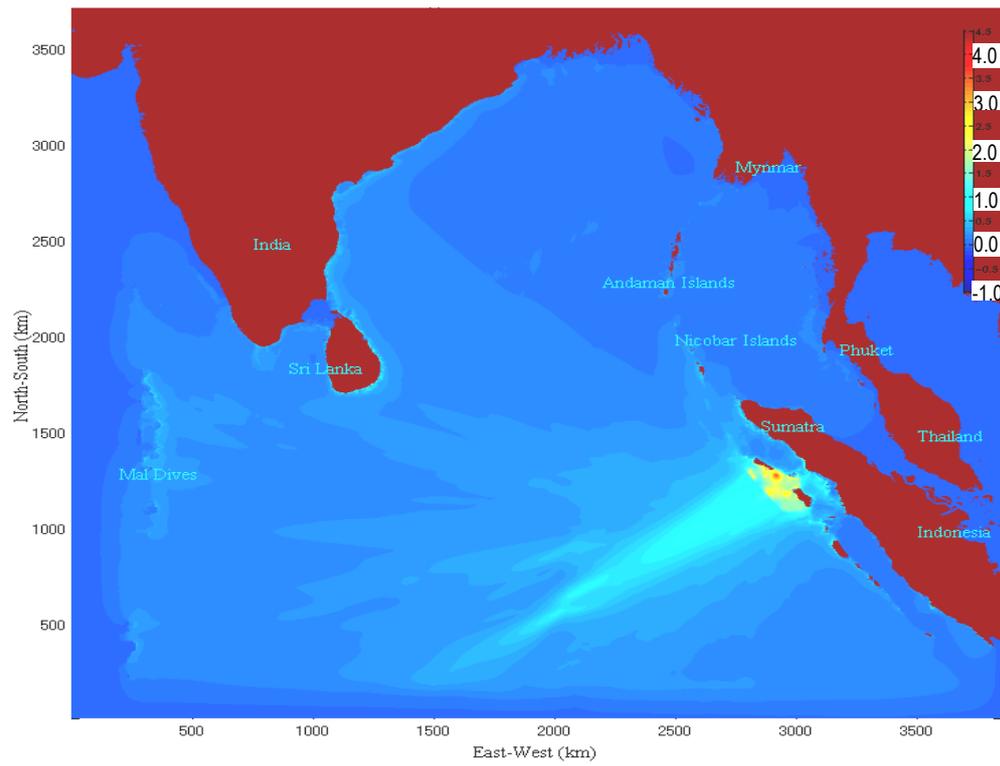
Fig 5.15: Maximum wave height distribution across the Indian Ocean during March, 2005, Off Sumatra tsunami.

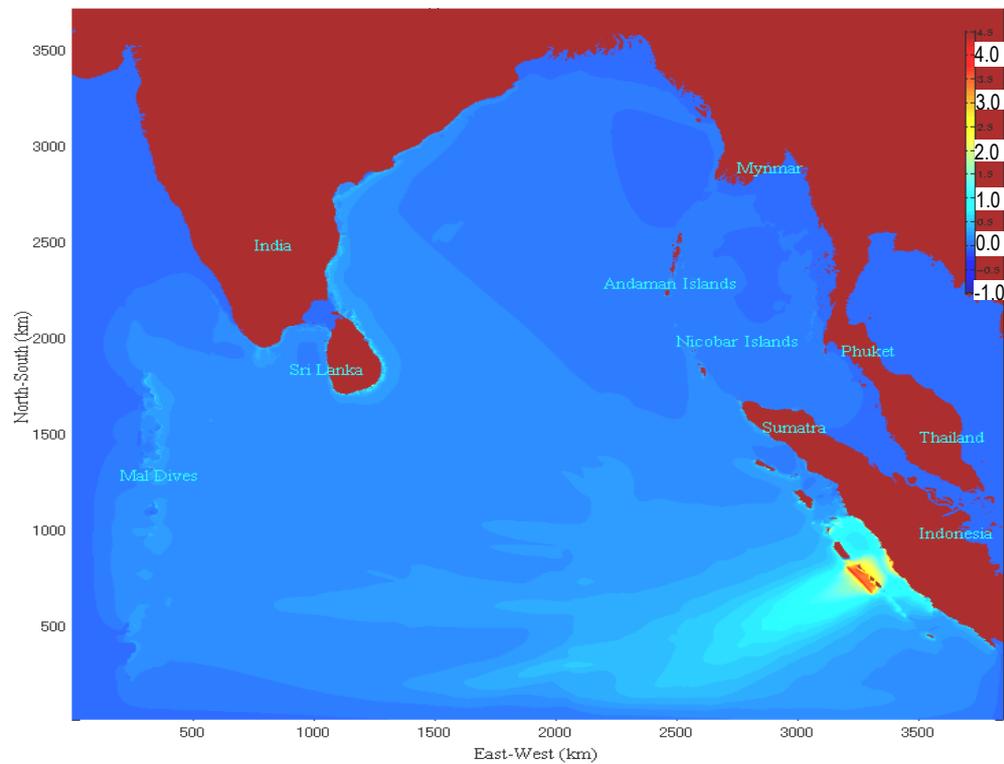
Fig 5.16: Maximum wave height distribution across the Indian Ocean during 1833, Karakatoa tsunami

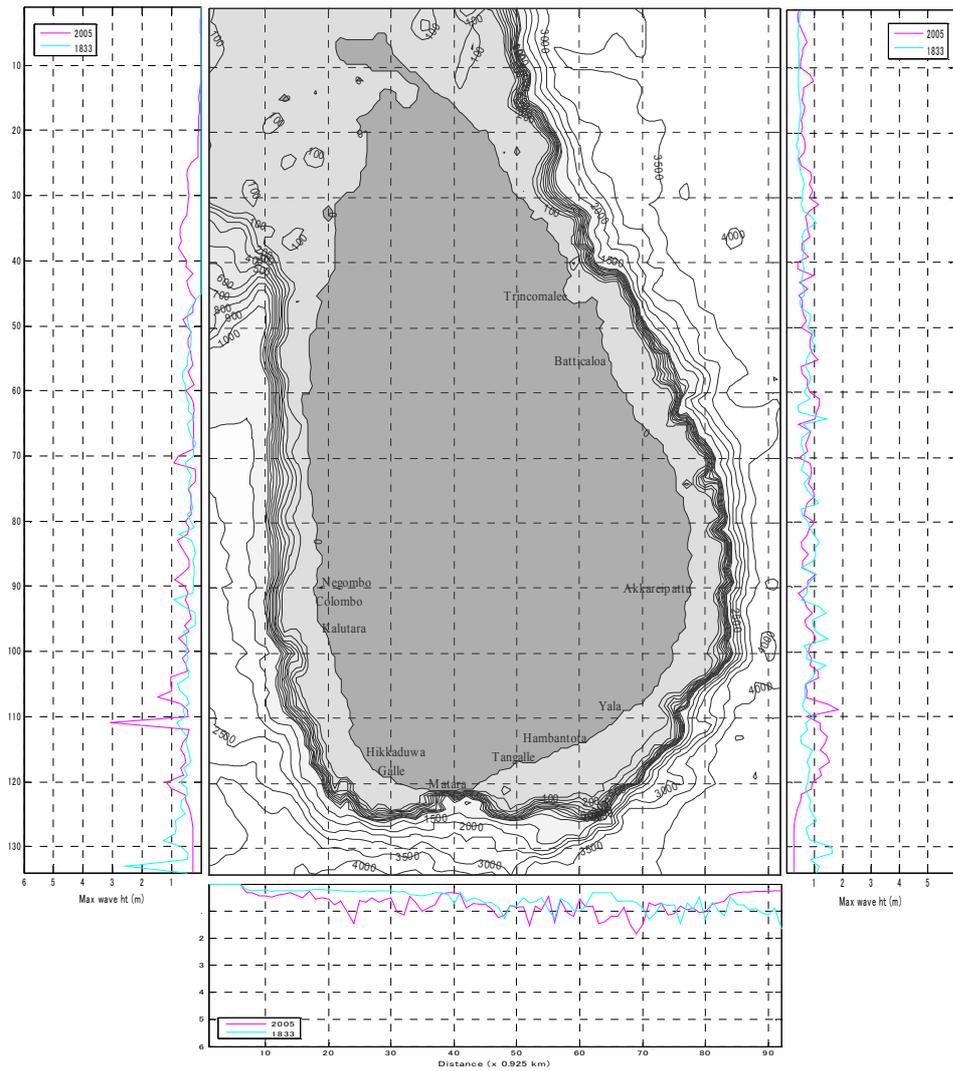
Fig 5.17: Results of the tsunami inundation due to March 2005 Sumatra tsunami (pearl color) and 1833 Karakatoa earthquake tsunami (light blue)
