### 33. *Surface Faulting Associated with the 1978 Izu-Oshima-kinkai Earthquake.*

By Yukimasa TSUNEISHI\*, Tanio ITO\*\* and Ken-ichi KANO\*\*

#### 1. Introduction

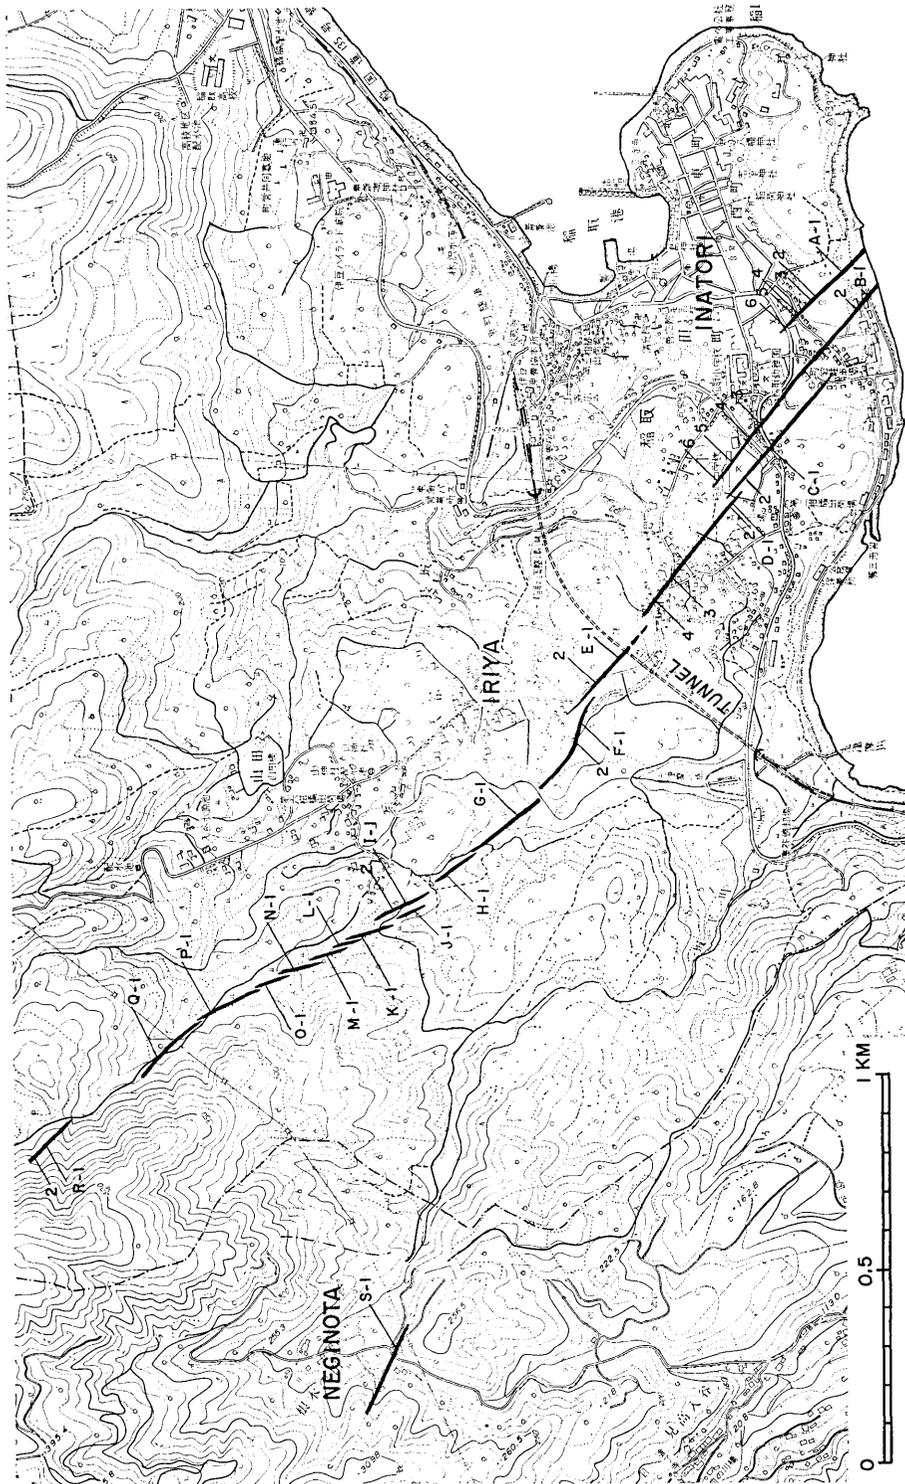
As shown in Fig. 2, the fault observed on the land area is traced northwestward for about 3 km from the coast at Inatori. More precisely, it runs N55°W for 1.5 km from the coast to Iriya and N30°W from there on, but it turns N55°W near its northwestern termination. Another strand lies at Neginota.

Fig. 2. En-echelon fissure zones at Inatori. Letters and figures denote the locations of displacement measurements.

are indicated by solid lines, and designated alphabetically. They are distributed en-échelon within a narrow belt of 30–200 m width, below which we inferred a buried fault. Thus, the surface trace of faulting is double échelon in pattern, inasmuch as the zones of en-échelon cracks are themselves distributed in an en-échelon pattern.

The trend of individual fissure zones is oblique to the inferred fault about  $10^\circ$  in a clockwise sense, whereas the trend of individual cracks is oblique to the corresponding fissure zone about  $20^\circ$ – $30^\circ$  in a clockwise sense. The manner of en-échelon arrangement, as well as the displacement of man-made structures, indicates that the fault is a right-lateral strike-slip fault.

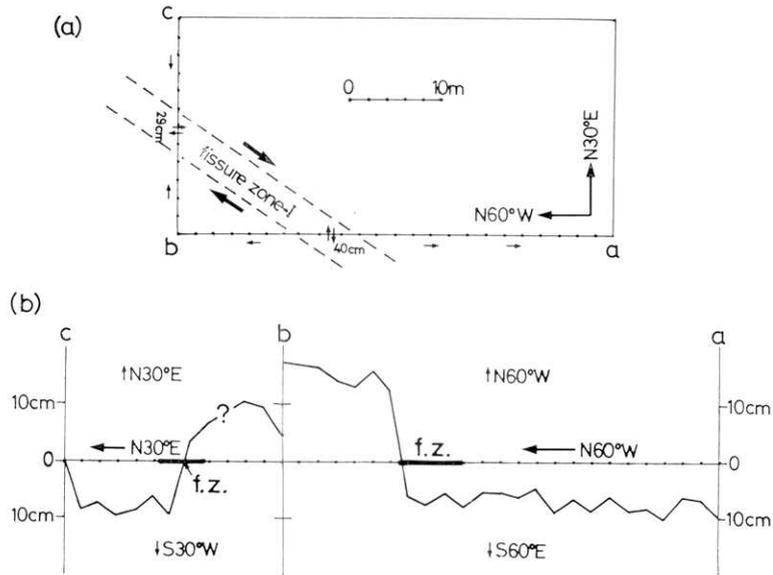
A vinyl hothouse was obliquely traversed and distorted by fissure zone-I at Loc. I-2. Fig. 17(a) shows a sketch map of the vinyl hothouse of which three corners are lettered a, b and c. The fissure zone traversed the western corner-b of the hothouse and displaced the adjacent walls. Fig. 18 shows the displaced wall a-b on the southwestern side of the hothouse. The fault movement not only offset the walls, but lengthened the wall a-b and shortened the wall b-c. The pillars in the walls are aligned at an interval of 2 meters. The bases of the pillars are fixed on the ground and the tops are attached to the crossbeams. Because the tops of pillars are restrained by the crossbeam, the pillars lean over from the vertical position, as shown in Fig. 19. Conversely, we are able to determine the relative displacement of the ground by setting a temporary vertical line from the top of the pillar and measuring the distance between the foot of the pillar and the vertical line. Fig. 17(b) shows the result of measurement. The direction

Fig. 17. (a): Sketch map of a deformed vinyl hothouse (Loc. I-2).  
 (b): Displacement of pillars due to faulting.

of the displacement is clearly different on opposite sides of the fissure zone.

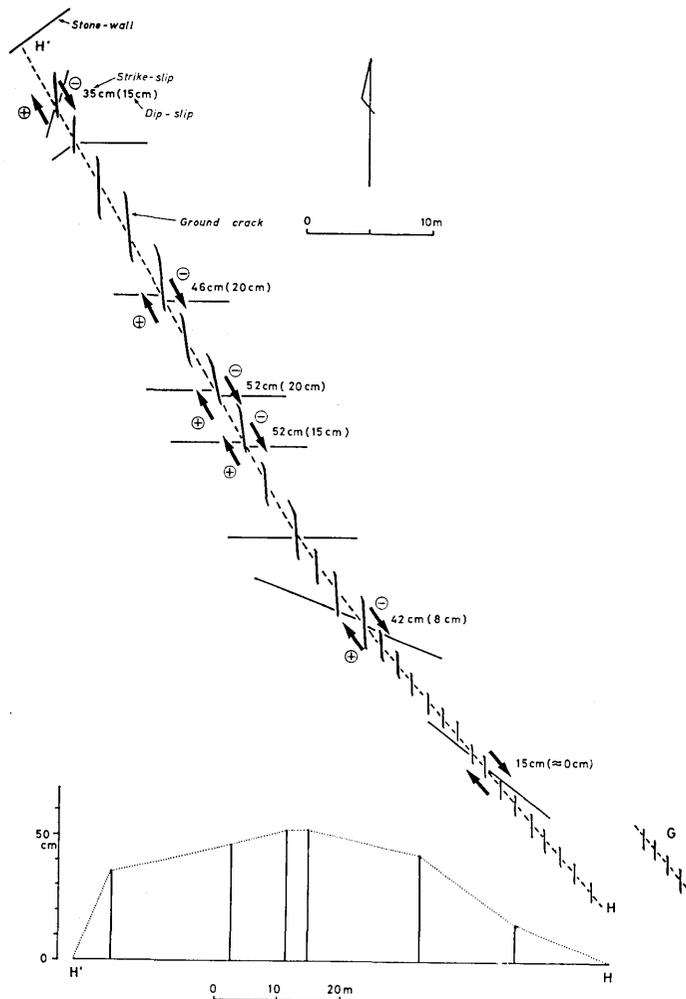
Fig. 21. En-échelon ground cracks on fissure zone-H and the distribution of displacement.  $\oplus$  and  $\ominus$  denote up-thrown and down-thrown sides, respectively.

Fissure zones-H and K were precisely mapped, as shown in Figs. 21 and 22, in order to examine the distribution of displacement along the fissure zones. The amount of displacement is distributed rather evenly along the fissure zones and diminishes at the terminations.

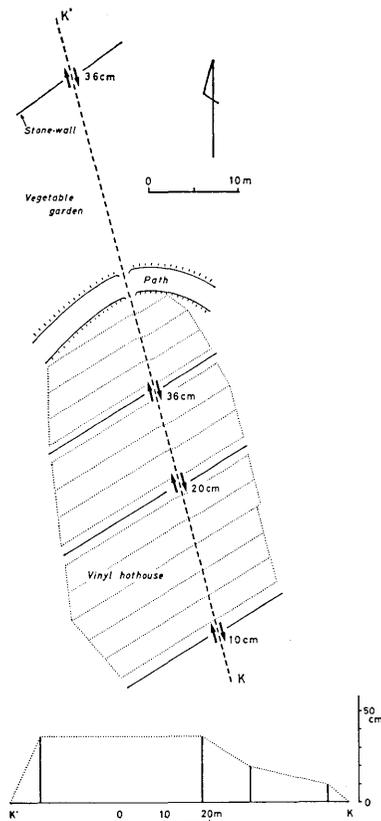
Fig. 22. Sketch map of fissure zone-K and the distribution of displacement.

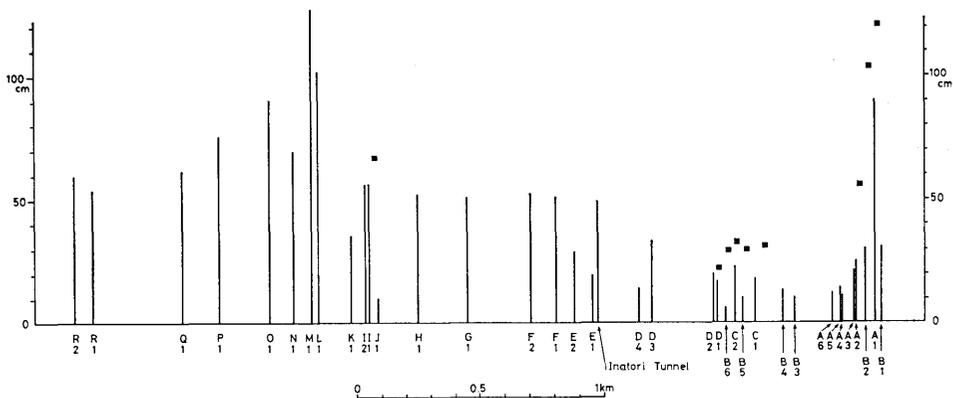
The distribution of displacement along the fault is shown in Fig. 23. In places where adjacent fissure zones overlap, the sum of the amounts

of displacement along them is indicated as a solid square in Fig. 23. The amount of displacement attains a maximum of 128 centimeters on fissure zone-M and diminishes from there, but it increases again toward the coast. Fig. 23 also shows the amount of displacement of a railway tunnel. The amount of displacement observed in the tunnel is consistent with the values measured on the ground surface.

Fig. 23. Distribution of displacement along the fault. See the test for the mark of solid squares.

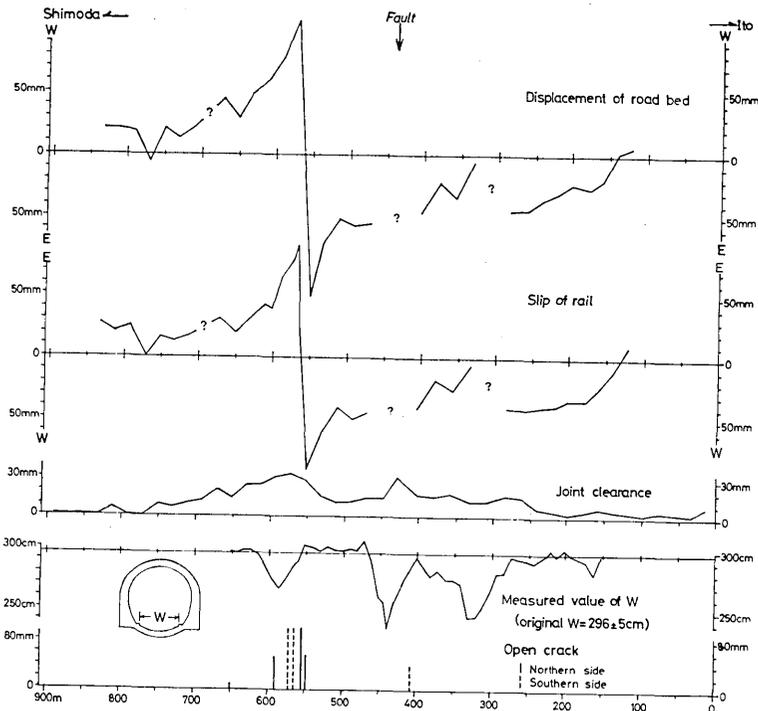
Fig. 24. Tectonic features of deformation of the Inatori Tunnel. The left and right sides of the figure correspond to the SW and NE entrances of the tunnel, respectively. See the text for details.

The Inatori Tunnel is a single track railway tunnel of 906 meters in length. Its location is shown in Fig. 2. Fig. 24 shows the results surveyed by us. The axis of abscissa expresses the distance from the northeastern entrance of the tunnel.

The concrete lining of the tunnel was fractured in many places in a complicated manner (Figs. 25 and 26). Among those fractures we picked up tension cracks that occurred on the side walls of the tunnel and measured their openings. Open cracking is concentrated in the section 540–590 m, as shown in Fig. 24. The most conspicuous open crack observed on the side wall of the tunnel is 9 cm wide (Fig. 27).

distance  $W$  are plotted in Fig. 24. The distance  $W$  is smaller near three points 330 m, 440 m and 580 m than its original value of  $296 \pm 5$  cm. The maximum decrease reaches 62 cm at the point 440 m. These phenomena resulted from the destruction of the inverted arch of the tunnel due to lateral compression. The geology around the tunnel consists of volcanic mud flow deposits that have been altered into clay by hydrothermal action. The complicated deformation of the tunnel is probably ascribed to the particular mechanical property of faulted bedrocks around the tunnel.

The amount of slip of rails, shown in Fig. 24, increases toward the point 560 m, and the direction of slip abruptly changes at that point. However, the amount of slip of the rails does not denote the displacement of the tunnel, because rails are elongated at their joints. Hence the cumulative increments of joint clearance over the original value of 6 mm should be added to the slip of the rails. The result is given in the uppermost figure of Fig. 24. The amount of elongation of the tunnel reaches 22 cm at the point 560 m. The value is nearly equal to the sum of the openings (20 cm) of the side wall of the tunnel.

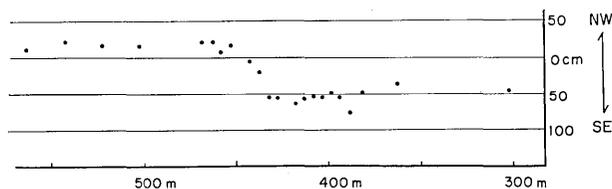
Fig. 30. Displacement of the tunnel center at the rail level. (after ONODA et al., 1978)

The precise survey of the deformed tunnel was done by the Izukyu Corporation (ONODA et al., 1978). Fig. 30 shows that the center of the tunnel at the rail level was displaced right-laterally by 50–70 cm within the zone 20 m of the point 440 m. Right-lateral deformation of the tunnel should result in lengthening the tunnel. Many exfoliations of the concrete lining as shown in Fig. 25 occurred near the point 440 m. However, the position of the actual extensional deformation of the tunnel determined by the relative slip of rails lies 120 m southwest (point 560 m) of the position of the lateral shifting of the tunnel detected by the precise surveying. This discrepancy is explained as follows.

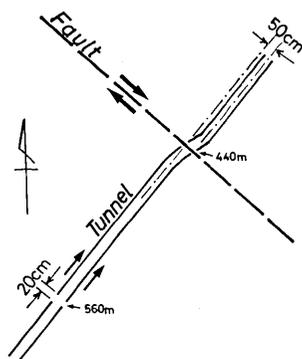
Fig. 31. Schematic diagram of the deformation of the tunnel.

It is probable that the concrete lining of the tunnel between the points 440 m and 560 m slipped to the northeast through the bedrock of hydrothermally altered mud flow deposits, and was eventually torn at the point 560 m. Horizontal striations were observed on the surface of the bedrock behind the concrete lining when the fractured slab of lining was removed for the repair of the tunnel (personal communication of Mr. Takagi). This fact supports the above-mentioned inference.
