Reliability Assessment for Residual Bearing Capacity of a Railway Bridge Foundation after Scouring

H. Nishioka¹, T. Sanagawa² and Y. Otake³

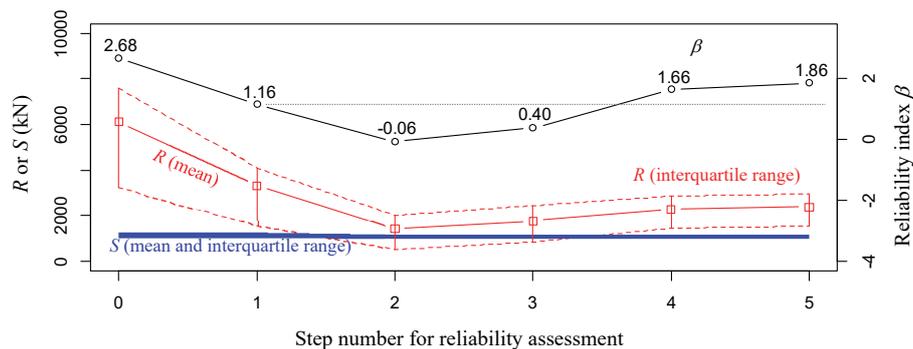
Figure 8. Transitions in external applied force S , resistance R , and reliability index β for each step

In Step 0, the reliability index β was calculated as 2.68. This value can be regarded as adequate, as the foundation has safely supported train loads for over 80 years.

In the virtual Step 1, the SPT-N value does not change; however, the embedded depth D_f is decreased, and the reliability index is decreased to $\beta = 1.16$. Assuming that this virtual situation actually occurs, it is expected that normal train operation resumes because there is no residual displacement, and the track inspection can satisfy the operation standards. A decrease in D_f will be detected at the next two-year periodic inspection. After that, repairs (such as restoration of D_f) are performed, and the original (Step 0) β is restored. In other words, the value of β in the virtual Step 1 is practically acceptable in the short term (less than 2 years) and is one of the indicators for determining the possibility of emergency recovery and operation restart after a disaster.

In Step 2, significant residual subsidence occurred (see Figure 1), and the bearing capacity may have been reduced by erosion of the ground under the foundation. However, since the information on the ground has not been obtained yet, the strength is smaller than that in Step 0, and the distribution of the SPT-N values was reduced to a uniform distribution from 0 to the mean value of Step 0 ($N = 30$). Because β for the slow trainload was a small value ($\beta = -0.06$), the train could not resume operation.

In Step 3, the effect of improving the reliability of the bearing capacity of the foundation by low accuracy boring inspections conducted at 5 m away was evaluated. As a result of the Bayesian update, the reliability index increased to $\beta = 0.40$; however, the β value did not reach that in Step 1 ($\beta = 1.16$). In other words, the reliability of the boring inspection was not enough to decide whether to resume operation.
