AN ARCHITECT'S NOTES ON THE GREAT EARTH-
QUAKE OF OCTOBER, 1891.

By JOSIAH CONDER, F.R.I.B.A.

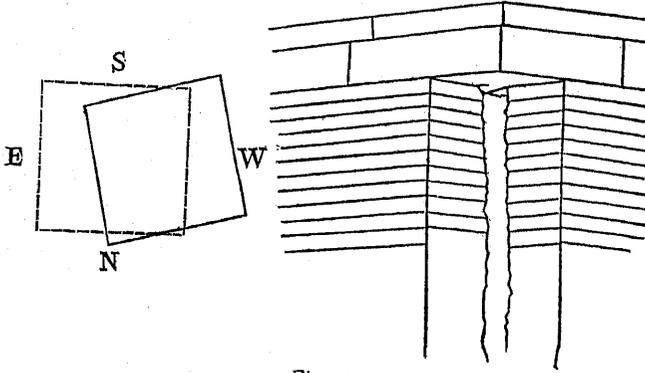
Fig. 5.

The outer entrance gates were of iron, with granite piers. Some of these piers had fallen, but one remained partially leaning over, propped up by the iron gate and showed that it had rotated from East to North as well as sliding in a N.W. direction (see Fig 5). The Gate Keeper's Lodge, a low brick building with walls one brick thick, remained standing, but showed a curious injury in one corner. Granite quoins, of straight joint with the brickwork, and occupying the whole thickness of walls, had been used at the corners, and one angle of such quoin work had been shaken out, leaving the ends of brick walls exposed and a daylight space between (see Fig. 5). The fallen granite blocks were in long vertical lengths and very rough on their backs and beds; they had formed, therefore, only a loose straight-joint with the brickwork. The conclusions arrived at from the inspection of this building were as follow :—

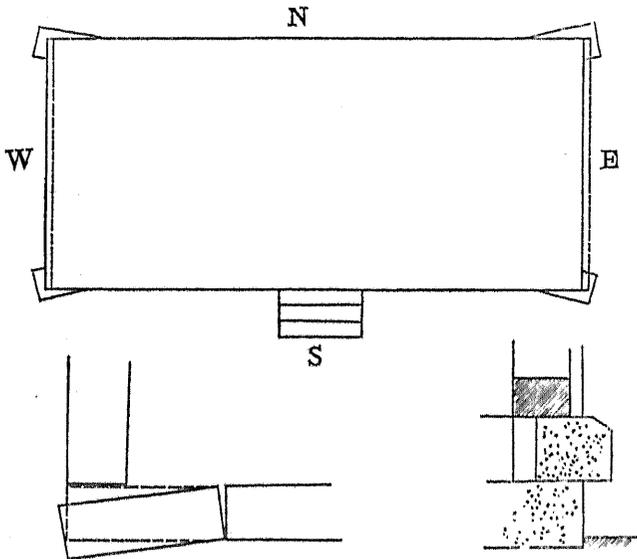
Fig. 7.

In another part of the Castle grounds were to be seen the buildings of the Military Hospital connected with the garrison. These were separated blocks of one-story buildings of wood, in pseudo-European style, erected on a plinth formed of two courses of hard stone. One ward in the N.W. corner exhibited signs of very curious disturbance in the stone plinth, and between the plinth and wall cill (see Fig. 7). A rotation of the four corner stones of the upper plinth course had taken place, and in different directions.

The bottom course, being partly bedded in the soil, had remained stationary, or rather followed the motions of the ground, but the whole of the upper course, together with the superincumbent wood-and-plaster building had been shifted a few inches to the West. This sliding movement had been re-

gistered by the stationary steps on the South side which were also bedded in the ground. In addition to this general sliding, the four corner stones had been forced out, as if by a centrifugal force, and, in one case, the corner block had dragged the second block partly with it. Conclusions drawn from these effects, and from an examination of the construction, were :— That the stones of the plinth had rough loose beds and backs and were imperfectly cemented together. The superstructure being light, and only laid upon the stone base, did not by its weight offer any considerable resistance to the movement that had occurred. A system of sinking or notching the wall plate into the plinth, and of notching together the different courses of the plinth, as adopted in the Powder Magazine referred to above, (see Fig. 6) would probably have prevented this movement. The writer is of opinion that even proper square beds and backs properly united with adhesive mortar or cement would have been almost sufficient to obviate the movement; but in this respect the conditions of light superstructures like the present one and those of heavy brick structures were somewhat different.

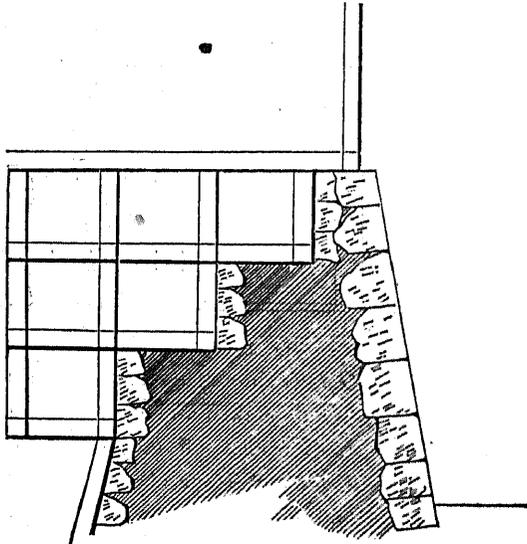
Fig. 9.

The *Tenshu*, or Keep, appeared not to be injured with the exception of a few ashlar of the stone-faced earthwork which

had fallen on the inside. This building is roughly speaking of the following dimensions:—Ground storey 108ft. by 120ft.;

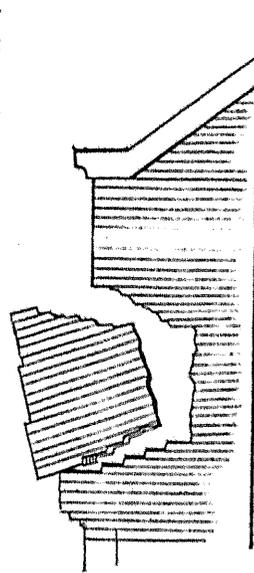
Fig. 14.

A sort of buttress wall inside the Engine Room, at right angles to the brick divisional wall between Engine Room and Spinning Hall and partly corbelled out from below, was damaged, a portion of the centre being detached and partly thrown out (see Fig. 14). This wall was reported to have been cracked previously, owing to a sinking occasioned by defective foundations. The mortar was found to be poor in quality. The adjacent brick chimney had fallen, damaging a portion of the roof of the Engine Room.

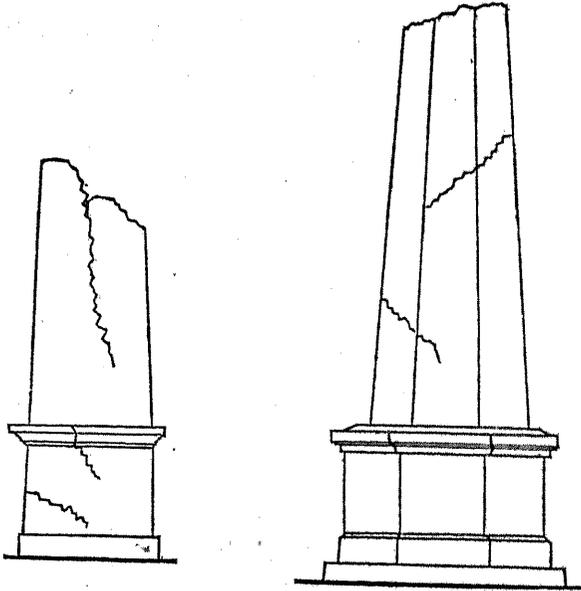
Fig. 17.

The top portion of a large octagonal brick chimney 14 feet wide at the base and originally 85 feet high had fallen from a height of 35 feet. The greatest thickness of the brickwork was three bricks and a half, at the point broken off it was two bricks and a half, and at the top one brick and a half. The

pedestal portion below had been constructed in cement mortar, and the upper part—where broken—with common lime mortar. The remaining portion of the chimney above the pedestal was much bent and cracked (see Fig. 17). Bricks manufactured by the Toyokumi were used, and this chimney was constructed about $3\frac{1}{2}$ years previously by an Engineer from the Ishikawa-jima Zosenjo, Tokio. Close by was another smaller round chimney 8 feet in diameter at the base, originally 55 feet high, 6 feet in diameter above, and of this about 30 feet had fallen, the part remaining being severely cracked right down to the base. The bottom was two bricks and a half thick and the top only one brick thick, and it had been constructed 8 years ago of the first bricks made by the Toyokumi in Nagoya. No cement mortar was used, even in the base, common lime mortar being employed throughout.

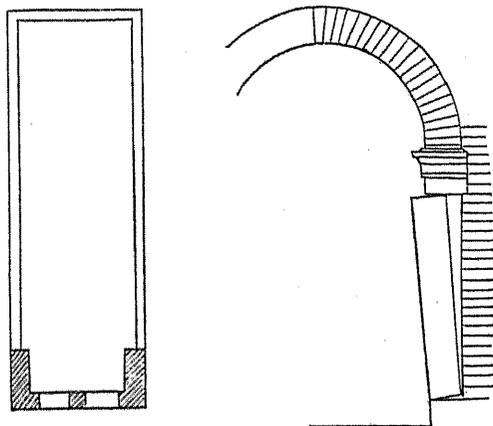
brick and the upper walls 1 brick thick. The lower part of the façade had two wide arches with a central granite pier and side pilasters of granite let into the brickwork. Above had been two windows. The top story had fallen to the level of the window sills. An examination of the mortar showed it to be have been almost useless. The stone jambs of the archways

had been thrown out, one remaining caught under the cap as in Fig. 19. It seemed unnecessary to dwell on the defects of this building which was of the falsest and worst construction; a typhoon alone would have probably been sufficient to destroy it. The brick portions of the structure were weak, unstable, and badly built with useless mortar, and they only had three sides to stand upon. The swinging of the wooden portions behind had probably assisted in pushing over the upper walls. The projected stoned jambs afforded another example of the pushing or shaking out of stone not bonded, cemented, or cramped to the brickwork, and especially of long blocks having little penetration in proportion to their height.

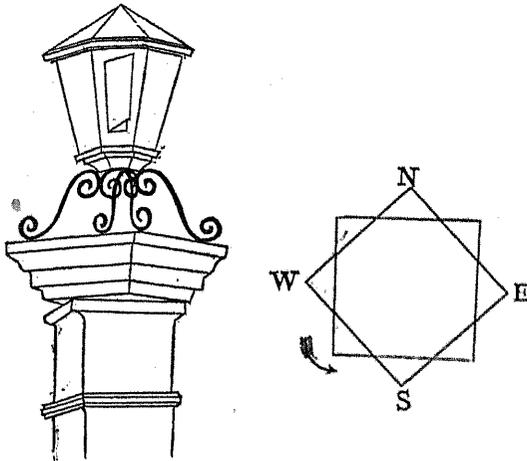
Fig. 21.

The gateway entrance of this Japanese hotel was in foreign style, and the tops of the stone pillars presented an interesting example of rotation during the earthquake, the glass lamp box above serving as a guide to the direction the rotation had taken (see Fig. 21). The tops of some stone lanterns in the inner garden were thrown over. Round the front garden was a high wood-and-plaster fence with projecting roof of boarding, and part of this roof had been thrown off.

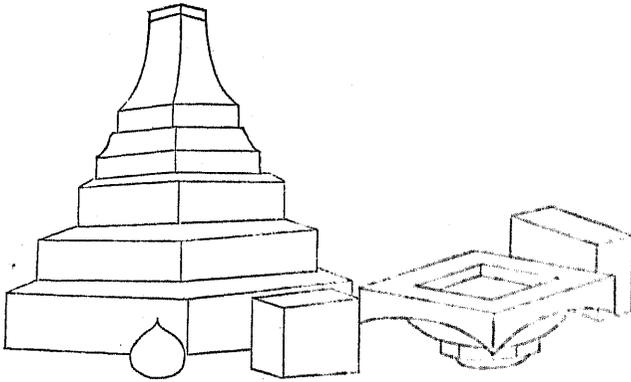
Fig. 24.

which had moved and fallen were examined and sketched. The top of a large stone lantern, Fig. 24, had been thrown over in a South direction. Another had remained standing but had been moved and twisted at the joints (see Fig. 25). The plan shows

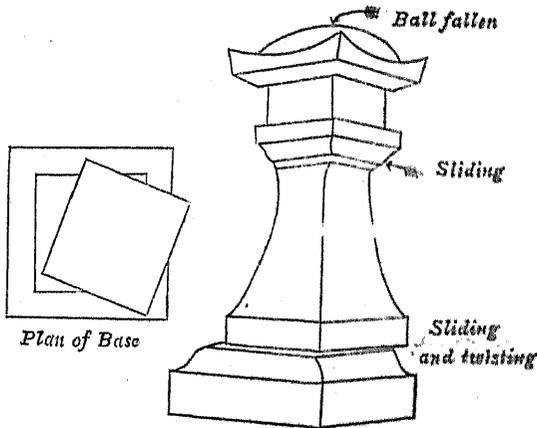
Fig. 25.

the sliding movement at the base in a South direction, with a twist toward the West. The cap had also slid about 1 inch East; and the top ball had fallen and rolled to a considerable distance South. The above lanterns were of no very great size. Another colossal stone lantern about 16ft. high had fallen to pieces, spreading out in a direction S.W. by W. (see Fig. 26).

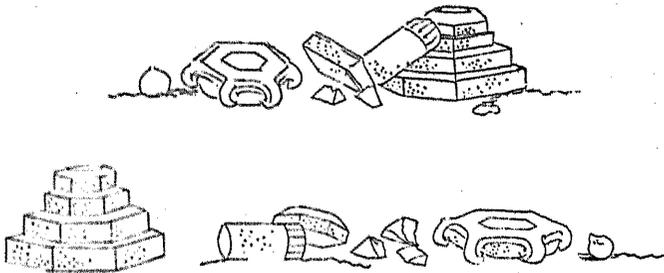
Fig. 27.

The separate stones showed no dowels, dowel holes, or connections of any kind. Opposite the dancing stage (*Kagura-do*) of the same temple two similar stone lanterns had fallen in exactly opposite directions (see Fig. 27). Numerous other small lanterns had been thrown down.

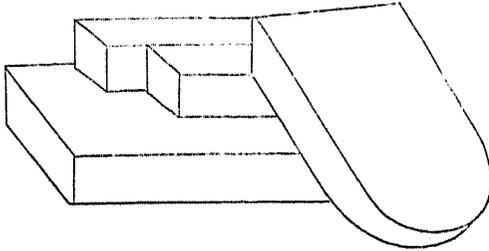
Fig. 29.

some cases of overthrow the scarf joint had given, in others the granite root had been drawn out from the earth. Some gateways had the posts merely loosened, but the handsomely carved wooden doors thrown out of their sockets and the panels smashed. Some of the stone cenotaphs, of flattish form curved at the top, had been thrown over in a S. direction

(see Fig. 29.); but their form was unfavourable to overthrow in any direction but S. or N. The local priest reported that, generally

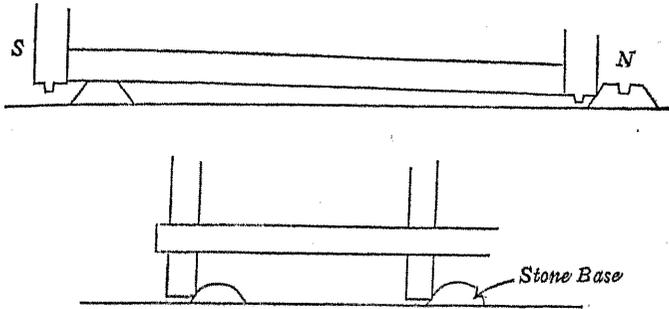
Fig. 33.

A curious case of lifting and sliding was shown in a closed well shed, the pillars having been lifted off the stone bases although dowelled into them (see Fig. 33). The dowels remained unbroken. In another instance the posts of a Prayer Shed had been slid off the rounded stones which carried them (see Fig. 33).

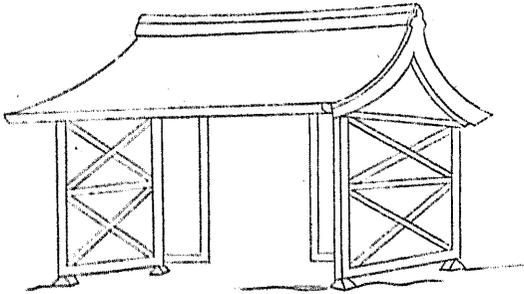
Fig. 36.

isolated ones remaining standing, but very much distorted. An interesting example was here observed of a light Japanese gateway having its side pillars tied by diagonals; this had fallen over bodily, the framework being uninjured (see Fig. 36). The diagonals appeared to have prevented any movement in the joints of the framework, and, instead of the posts giving at the connections and the roof falling, the whole had been tipped over in a mass. This could hardly have happened if the structure had in some way been fixed to the ground at its base. The loose isolated supports of a Japanese building here showed a decided disadvantage.

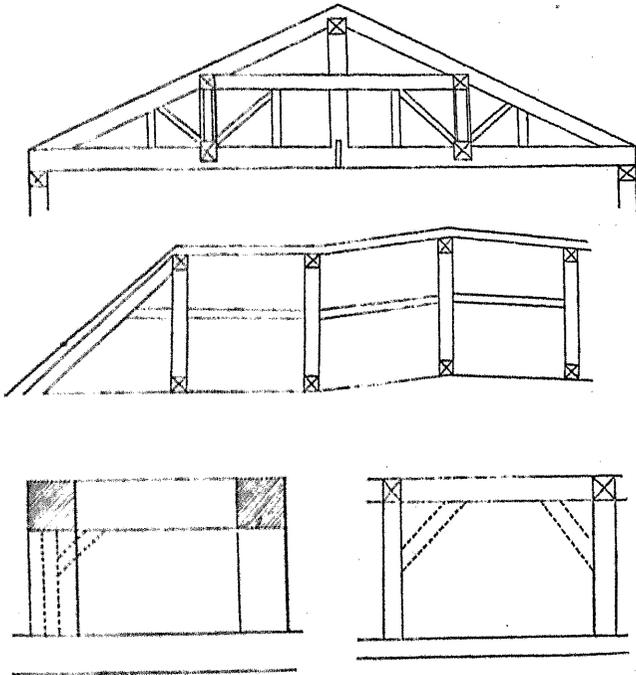
Fig. 37.

The Shihan Gakko, a semi-foreign wooden building of two stories, was much cracked but still standing erect. A common shed-like dining hall, in the yard behind the main school, had fallen. A separate wooden building about 35ft. by 50ft., used as a Gymnasium, of one story but 16ft. high to the beams, was intact. It had an open roof, which showed an arrangement of queen and princess roof-trusses of light timbers but stiffly strutted and also trussed longitudinally between the princesses. The posts of the wooden walls were also well strutted with diagonals. This building exhibited scarcely any signs of shaking, the roof (see top of Fig. 37) showing no contortion or signs of movement whatever. Other roofs of much stronger build had been seriously twisted and injured, especially those of so-called European construction. The ordinary European roof consisted of trusses scientifically framed with struts and braces, which were placed at distances of from 8 to 12ft. apart and tied longitudinally only by the purlins, ridge pieces, and pole plates, which were merely notched on to the principals; thus, though the trusses in themselves were stiff, the roof had no stiffness longitudinally, and the trusses could work independently during a violent upheaval and shaking. Many cases of broken wavy roofs showed that this had happened (see middle of Fig. 37). Here, on the contrary, was a roof which was trussed in both directions, and it had apparently vibrated

in one mass. This was exactly the same principle of construction as was carried out, though in a less scientific manner, in the large temple roofs and other well built Japanese roofs which had given such good records. As already pointed out, these roofs were as stiff in one direction as another, tie beams and collar pieces being carried both cross-ways and longitudinally. In the poorer and lighter Japanese structures, though the same principle was followed, the smaller scantlings of the timbers, weakened at the joints by much cutting, and having no

triangular bracing, rendered movement possible in the different parts; but even these inferior roofs had in many cases retained their shape in falling and were still used as huts of temporary refuge by the inhabitants. The enormous timbers

used in the *temple* roofs, enabling stronger and stiffer joints without appreciable weakening of the structure, to a great extent compensated for the absence of triangles (see bottom of Fig. 37).

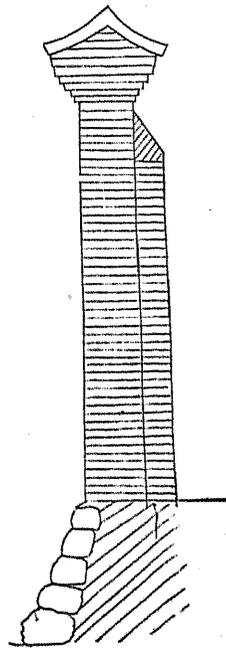
Fig. 38.

Continuing the inspection of buildings at Gifu, it was found that the Training School near to the Shihan Gakko had received considerable damage, many of the buildings having fallen flat. Part of the prison wall of the Gifu Jail had fallen, and remaining portions were much cracked, always at the brick joints. The prison wall was a brick structure about 18 feet high, and 2 bricks in thickness with corbelled brick top, tile-covered, and internal buttresses every 9 or 12 feet. The wall on the outside rested upon a sloping base of stone boulders forming the escarp of a small outer moat (see Fig. 38). One corner of this wall had a brick building attached, and on this account had bulged out considerably, cracking the adjoining wall.

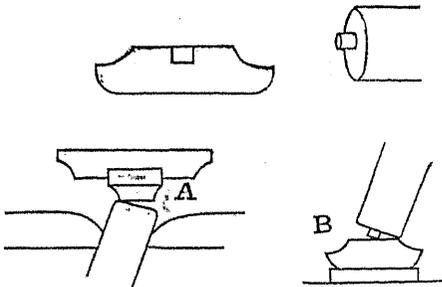
The bending over of this structure, which like most Japanese buildings consisted entirely of framed parallelograms, was accompanied by openings and fractures at the points A. above, and B. below in Fig. 40.

the bronze bell being projected some distance. The posts of this tower or shed showed very small pins or tenons which had been let into the stone bases (see top Fig. 40).

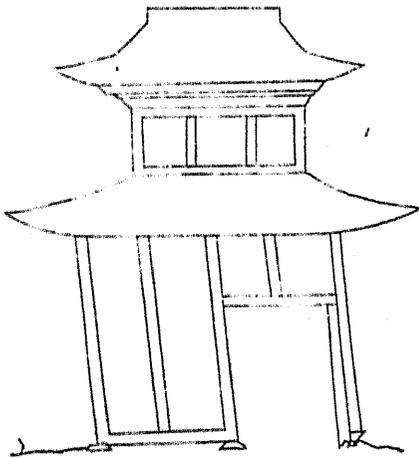
Fig. 41.

Close by, an interesting example was observed of a two-storied structure the upper stage of which remained vertical

and apparently undamaged whilst the lower one was bent and reeling (see Fig. 41). The upper story being, like many Japanese two-storied structures, of smaller plan than the lower, the posts were not continuous the upper pillars being carried on heavy beams supported by the lower. Hence

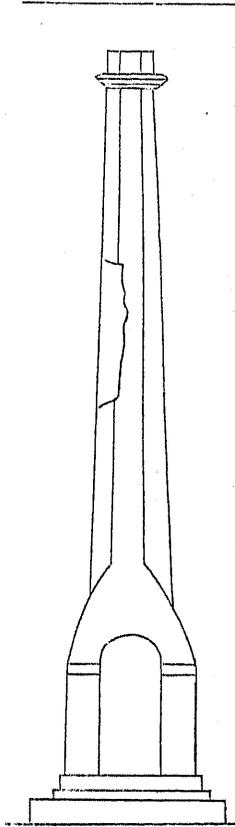
Fig. 44.

The first building inspected in this city was that of the Electric Lighting Co. in Nakashima 3 chome. The tall brick chimney, about 125 ft. high, had suffered considerable damage, a portion about 15 ft. long at a height of 72 ft. had opened in the side in a fissure about 5 inches wide (see Fig. 44.) No crack was observable above this fissure, but cracks extended below it to a point about 60 ft. from the soil. The chimney was in a dangerous condition, and it had to be taken down as far as the bottom of the fracture. It had apparently been substantially constructed, being 2 bricks thick at the top, then 3 bricks, and 4 bricks thick at the bottom. It rested on a wide footing above a concrete base 28 ft. square,

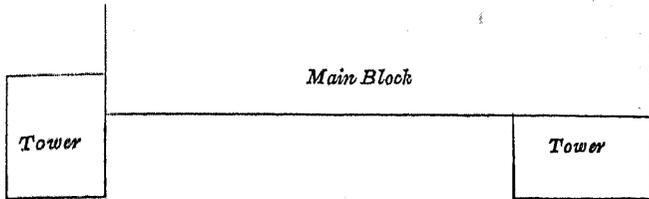
Fig, 46.

Some of the brick arches of the top floor and roof had opened a little in one place, letting in the water from the flat tank-roof. The iron girders and joists carrying these arches were built into the walls without any anchoring. The larger girders had cast supports for receiving the ends of iron joists. The tops of internal door openings were supported on iron lintols and in one or two cases the movement of these, or the vibration of the brickwork in contact with them, had caused cracks in the brickwork. Slight injuries had occurred to the parapets at the corners of the building, which were constructed of thin brick balusters supporting heavy stone copings.

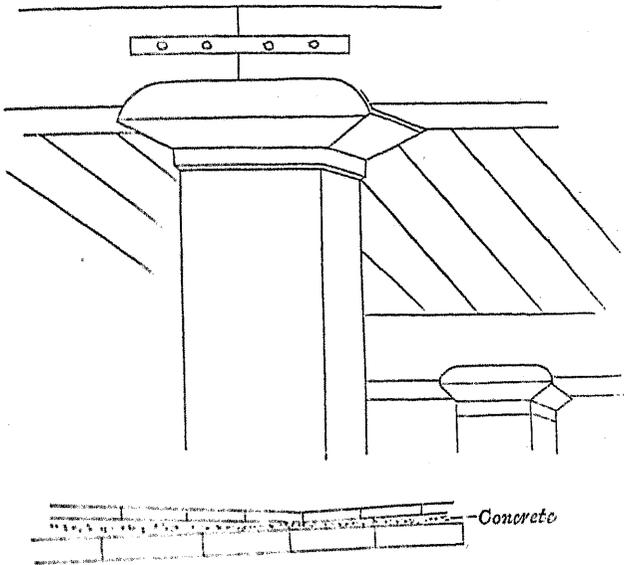
Fig. 47.

surprising that so little damage had occurred, only a few arches being injured (see Fig. 47). The lightness of the flattish roof and the moderate size of the openings had no doubt been favourable. Some architects have been inclined to detect a virtue in the method of constructing the upper story with wooden pillars free from the brick walls, carrying the wooden roof. Considering the report made by eye-witnesses, that the brick walls and woodwork had opened as much as 2 ft. during the shock, and also

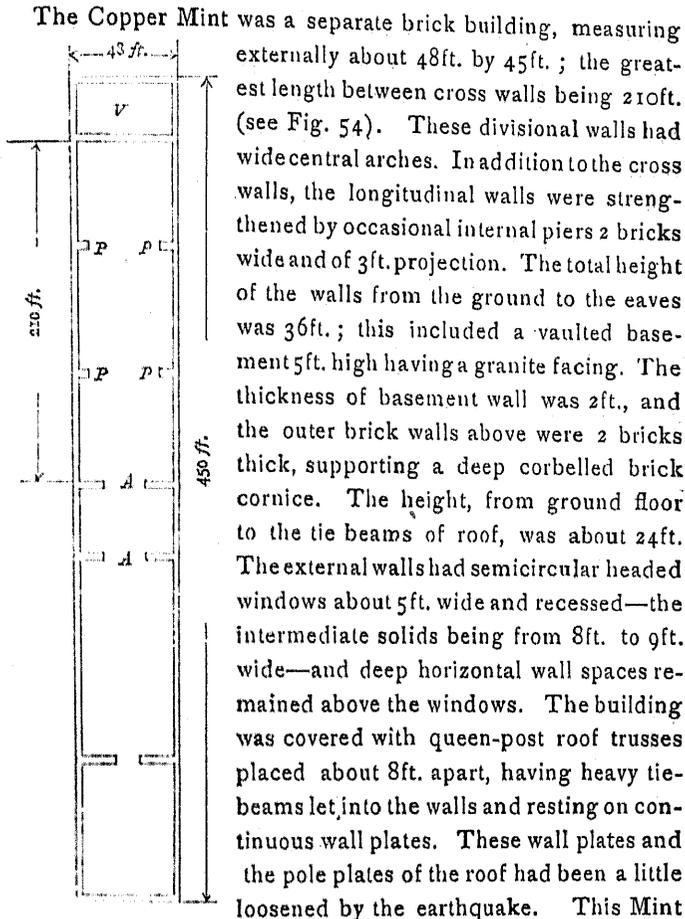
Fig. 54.

The Copper Mint was a separate brick building, measuring externally about 48ft. by 45ft. ; the greatest length between cross walls being 210ft. (see Fig. 54). These divisional walls had wide central arches. In addition to the cross walls, the longitudinal walls were strengthened by occasional internal piers 2 bricks wide and of 3ft. projection. The total height of the walls from the ground to the eaves was 36ft. ; this included a vaulted basement 5ft. high having a granite facing. The thickness of basement wall was 2ft., and the outer brick walls above were 2 bricks thick, supporting a deep corbelled brick cornice. The height, from ground floor to the tie beams of roof, was about 24ft. The external walls had semicircular headed windows about 5ft. wide and recessed—the intermediate solids being from 8ft. to 9ft. wide—and deep horizontal wall spaces remained above the windows. The building was covered with queen-post roof trusses placed about 8ft. apart, having heavy tie-beams let into the walls and resting on continuous wall plates. These wall plates and the pole plates of the roof had been a little loosened by the earthquake. This Mint contained heavy tanks of water for cleaning and separating the ore, and the earthquake shock had been

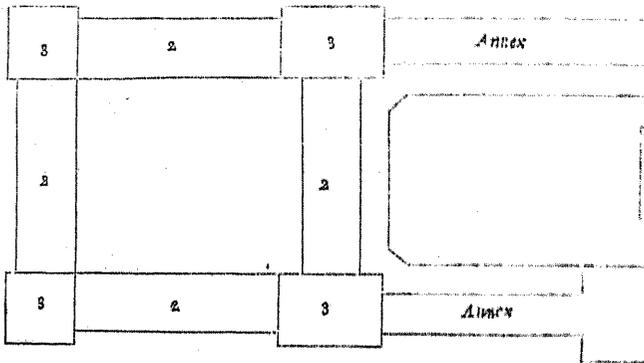
Fig. 56.

It remains to allude to one other building in the city of Osaka which was barely completed, viz.,—the Post and Telegraph Offices. This was a large brick and stone building in the Palladian style, having four corner pavilions of three stories and the remainder being of two stories in height (see Fig. 56). It had a large central or office hall measuring about 40ft. by 70ft. surrounded by piers $2\frac{1}{2}$ bricks thick and 2ft. 9" wide, with round arches constructed in four half-brick rings. The floor above was carried by large wooden beams penetrating the walls over the crowns of the semicircular arches, and supported internally on two cast iron columns. The thicknesses of the lower walls were, at the corner pavilions $3\frac{1}{2}$ bricks, and in the two-story portions 3 bricks thick, very thick mortar joints (nearly $\frac{1}{8}$ inch) had been used, and the brickwork rough externally as well as internally being to receive plaster. The mortar had been composed of 4 parts of lime to 6 parts of granitic sand, and had been partly mixed by mortar mill and partly by hand. The windows were of medium size, being from 4ft. 6" to 5ft. wide, with intermediate wall spaces from 7 to 8ft.

The earthquake had in no way damaged the main building though it was quite new and of varied heights. The low two-story annex, of cheaper and weaker construction, with walls only $1\frac{1}{2}$ bricks thick at the top, had several cracks. These were observed at each end of a cross wall which carried a roof-
