Investigation and Analysis of Damage to Buildings during the 2003 Bam Earthquake

Hossein Mostafaei* and Toshimi Kabeyasawa

Earthquake Research Institute, The University of Tokyo

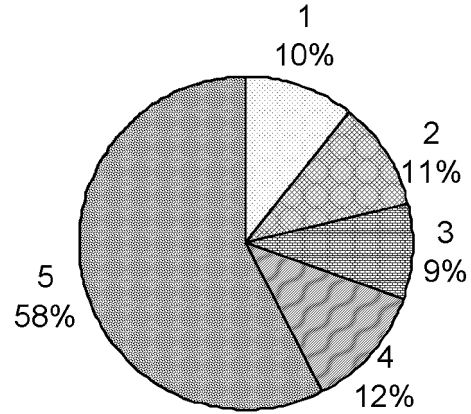
Fig. 19. Damage grades for all types of building in Bam.

grade 1: negligible to slight damage, grade 2: moderate damage, grade 3: substantial to heavy damage, grade 4: very heavy damage, and grade 5: destruction. Figure 19 illustrates the survey results of total structural damage grades for the different types of building. The figure indicates that almost 70% of the buildings in Bam city suffered very heavy damage or complete destruction, with grade 4 or grade 5, and only 10% of the buildings in the city were observed with slight damage or grade 1.

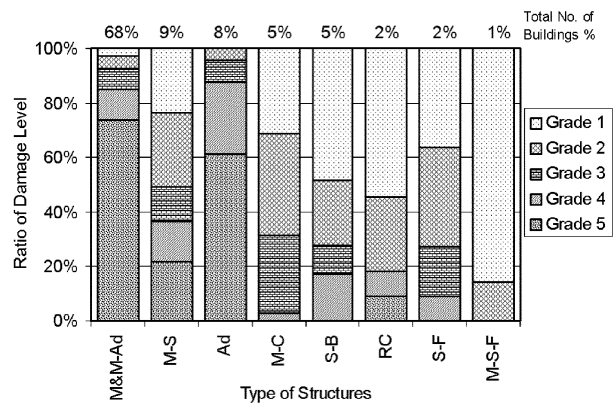
Fig. 20. Building damage grades for different types of structure.

A further estimation was made to obtain damage grades for different types of structure. Figure 20 shows the outcomes of the study. As indicated by the figure, masonry buildings, types M and M-Ad, and also adobe constructions, type Ad have the highest rates of damage among the different types of structure. The main reason for such a high level of destruction is the very low lateral load-bearing capacity of their structural systems against seismic loads. On the other hand, reinforced masonry buildings such as type M-C and M-S had considerably lower damage rates compared to those of masonry or adobe buildings. These results emphasize the importance of reinforcing masonry buildings, which is also outlined in the seismic code of Iran.

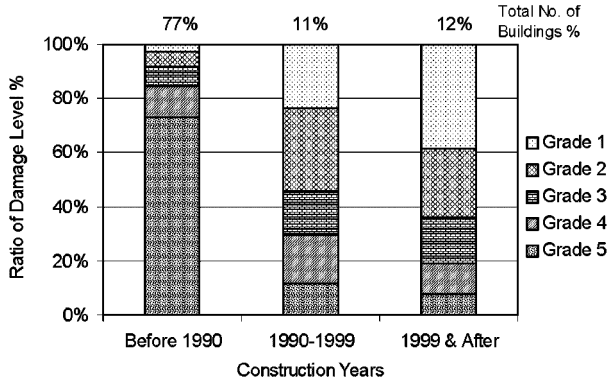
Fig. 24. Damage rates based on year of construction.

Figure 24 shows damage rates for buildings sorted by construction date. As the statistical results indicate, 77% of the buildings in the city were constructed before 1990, the mandatory year of the seismic code, and suffered very high rates of damage. However, among buildings built from 1990 and after the second edition of the seismic code was published in 1999, the damage rates were significantly reduced, which shows efficient results of applying the seismic code.

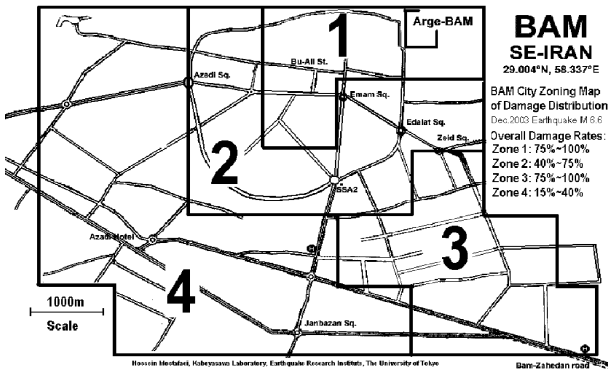
Fig. 25. Zoning map of building damage distribution in Bam city.

The 4 zones of Bam city, zones 1 to 4 in Fig. 18, are shown magnified in Fig. 25. This map shows the zoning map of building damage distribution, as well as overall damage ratios in each zone based on data collected only in Bam city. By comparing Figs. 18, 25, and 26-a, it can be inferred that the damage rates decreased significantly in zones 4, 8, and 9, although they are not far from the epicenter. According to the results, zone 3 followed by zone 1 show the highest damage rates in the area. However, zone 2, which is located between zones 1 and 3, shows lower damage ratios. Figure 26-b illustrates damage ratios in Zones 1 to 4 for only one type of structure, masonry buildings. Based on the figure, zone 2 again has lower rates of damage than zone 1 and zone 3. Therefore, the different damage rates might be due to other factors such as fault mechanism. Further study is recommended on this outcome.

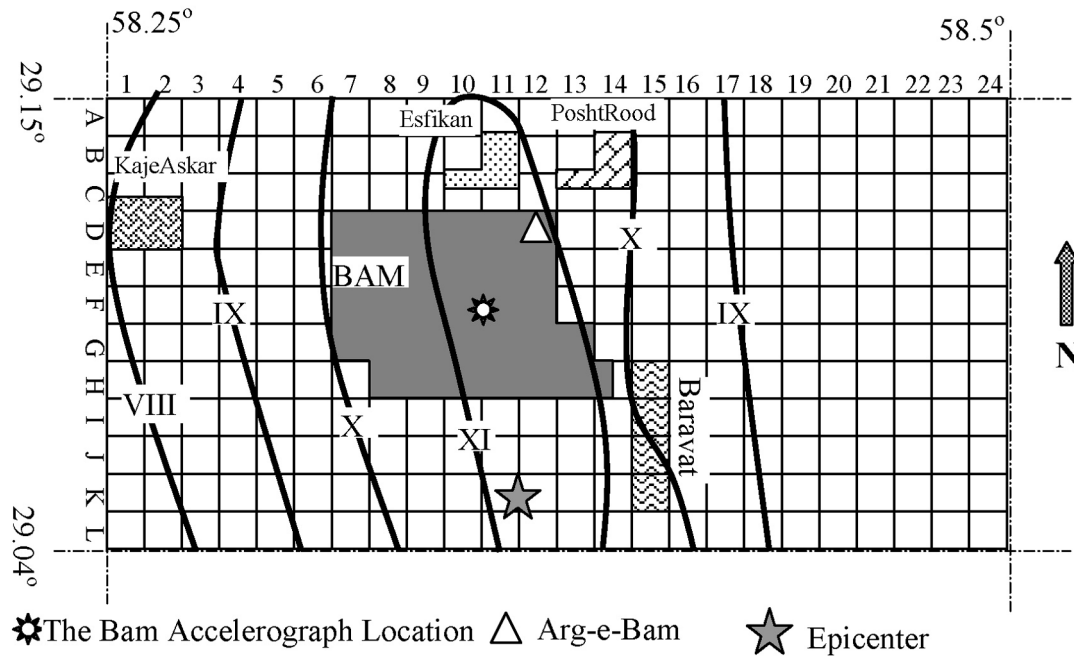
Fig. 28. MSK intensity contours for Bam earthquake applying vulnerability class B.

Bam in the preliminary report of BHRC (2004), it can be inferred that most of the buildings in Bam are located in the area with an intensity of XI on the

MSK scale, which is about X on the Modified Mercalli Scale. The conversion can be applied using Fig. 29. According to the figure, the maximum acceleration for intensity X may be estimated at between 800 cm/s^2 and $1,000 \text{ cm/s}^2$, which are almost in the same ranges as those recorded.
