13. Landslides in the Epicentral Area of the Matsushiro Earthquake Swarm—Their Relation to the Earthquake Fault.

By Ryohei MORIMOTO, Kazuaki NAKAMURA, Yukimasa TSUNEISHI,
Joyo OSSAKA and Nobuko TSUNODA,

Earthquake Research Institute.

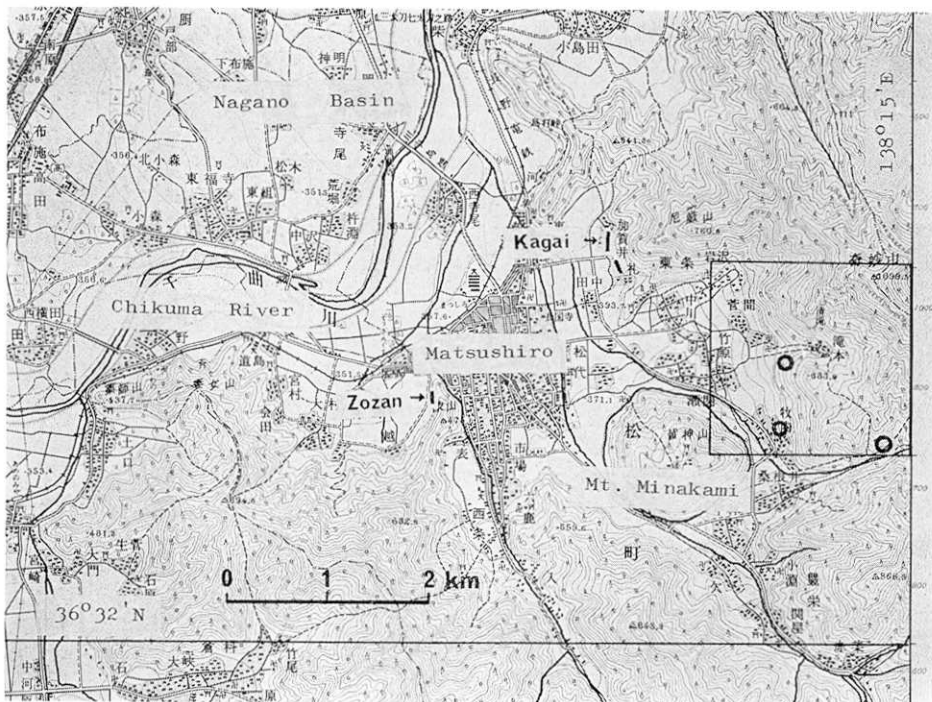
Fig. 1. Index map showing the central part of epicentral area of Matsushiro earthquake swarm. Square indicates the area covered by Fig. 2. Three open circles are the landslides listed in Table I.
