Fatigue Cracks under Plane Stress in Electrodeposited Copper Single Crystal — Part III

平面応力下における電着銅単結晶の疲れき裂 (3)

Yoshiaki HAGIUDA* and Masahisa MATUNAGA*

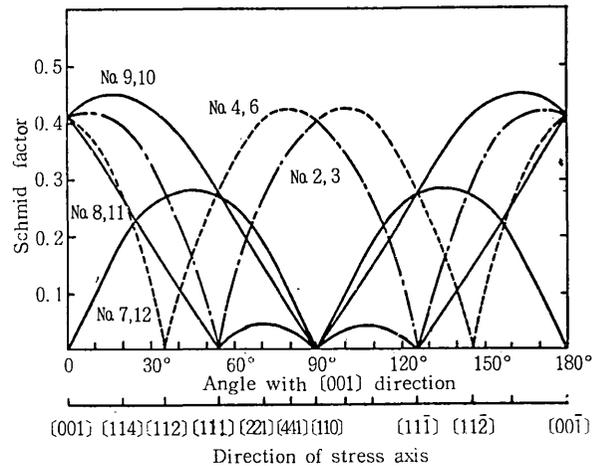
Fig. 1 Values of Schmid factor on $\{1\bar{1}0\}$ plane

Schmid factor in respect to slip plane, slip direction and stress axis on $\{1\bar{1}0\}$ surface, and Fig. 1 shows the relationship, Fig. 2 illustrates crystal planes,

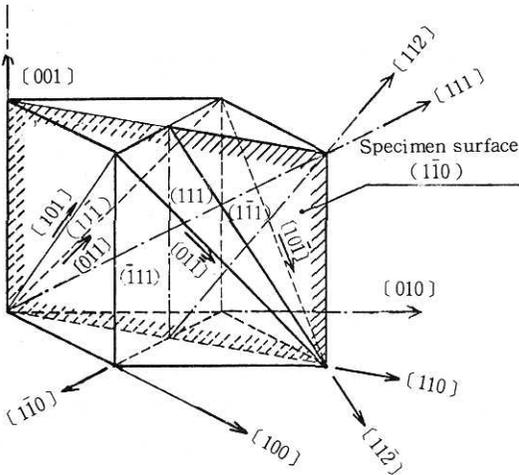
Fig. 2 Crystallographic representation on $(\bar{1}\bar{1}0)$ plane. slip planes and slip directions in fcc. The slip planes are (111) , $(11\bar{1})$, $(\bar{1}\bar{1}1)$ and $(\bar{1}\bar{1}\bar{1})$. The cracks appeared along $[112]$, $[11\bar{2}]$ and $[110]$ orientations which are the crossing lines between $(\bar{1}\bar{1}0)$ surface and the slip planes.

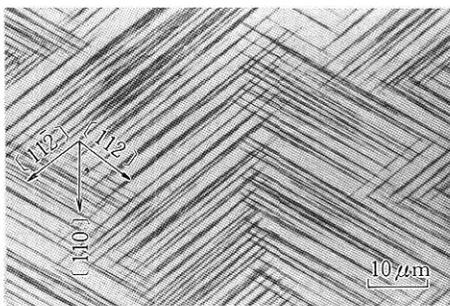
Fig. 3 Figure of crack on $(\bar{1}\bar{1}0)$ plane and $[110]$ stress axis, $\epsilon_a = 1.2 \times 10^{-3}$, $N = 1 \times 10^5$

Symmetrical cracks were easily formed in $[110]$ stress axis. The direction of cracks were along $[112]$ and $[11\bar{2}]$ which are cross lines of $(\bar{1}\bar{1}0)$ surface and (111) , $(11\bar{1})$ slip planes. These directions formed $54^\circ 44'$ with stress axis and cross angle between these cracks was $70^\circ 32'$. Fig. 3 shows a typical crack pattern of this kind at strain amplitude $\epsilon_a = 1.2 \times 10^{-3}$, $N = 1 \times 10^5$. Fig. 4 shows an electron-micrograph of the same specimens. This figure indicates clearly that fatigue slips in the order of 300 \AA in distance appeared on whole surface and that the

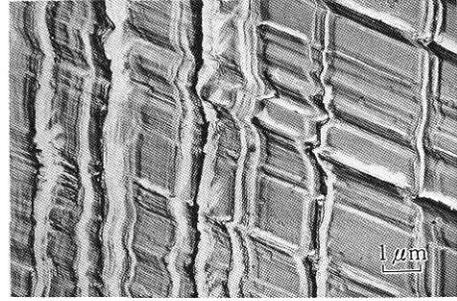
Fig. 4 Electron-micrograph of the same crack as Fig. 3.

$\epsilon_a = 1.2 \times 10^{-3}$, $N = 1 \times 10^5$

cracks were formed along the slip lines. An example of the minimum repetition was $N = 1 \times 10^5$ for $\epsilon_a = 0.69 \times 10^{-3}$.

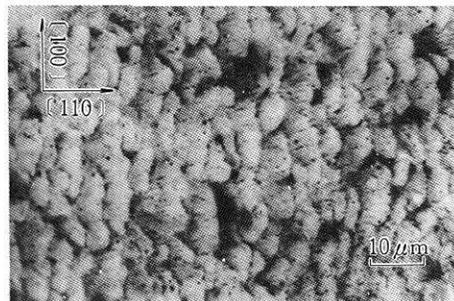
Fig. 5 Structure of fatigued surface on $(\bar{1}\bar{1}0)$ plane and $[001]$ stress axis. Cottrell's sessile dislocation worked. $\epsilon_a = 1.38 \times 10^{-3}$, $N = 1.5 \times 10^6$

Since values of Schmid factor are the same as that of the case in $[110]$ stress axis and eight slip systems might be activated, it was anticipated that three directions of cracks along those of $[112]$, $[11\bar{2}]$ and $[110]$ would be formed. Contrary to the anticipation, few slip lines could be observed, and no crack was formed at strain amplitude $\epsilon_a = 1.38 \times 10^{-3}$ and $N = 3 \times 10^6$. Which are larger values than these of $[110]$ stress axis. Fig. 5 shows an optical micrograph of the fatigued surface and this shows a different appearance in compared with other micrographs. This consists of boundaries and dense slip lines. The boundaries were imagined to be sub-grains. An electronmicrograph in Fig. 6 shows that minute slip lines at intervals of 500 \AA . Orientation of this slip

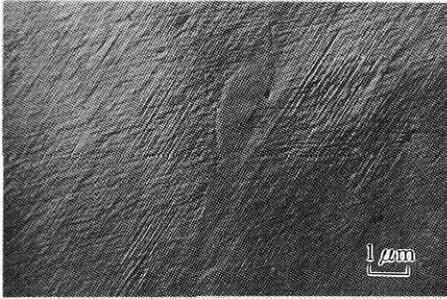
Fig. 6 Electron - micrograph of the same specimen as Fig. 5.

system was estimated as $[112]$ or $[11\bar{2}]$ and $[110]$ for a crossing slip system. The angle had a deviation of about 5 degrees and the other slip lines had waviness. This was imagined to be originated from a strain inside the sub - grains, but a precise mechanisms were not clarified.

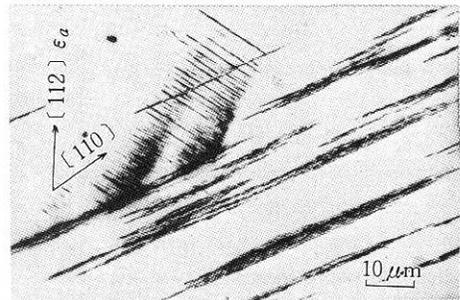
Fig. 8 Crack formation on $(1\bar{1}0)$ plane and $[112]$ stress axis.

$$\epsilon_a = 1.2 \times 10^{-3}, N = 1 \times 10^5$$

Since the maximum Schmid factor was obtained along $[011]$ orientation on $(1\bar{1}1)$ plane and $[101]$ orientation on $(\bar{1}11)$ plane, prominent slips and cracks appeared along $[110]$ orientation which was a intersection of these surfaces and a single crystal surface. Since subsidiary slip orientations would be $[01\bar{1}]$ and $[10\bar{1}]$, a slip system along $[11\bar{2}]$ could be formed, but this was very weak. Fig. 8 shows a

photo - micrograph of these cracks and main slips appeared along $[110]$ direction. Another slip system crossing at 26° with the main slips also appeared and the direction of the slip line crossed along a direction of bisector of (112) and (110) . Fig. 9 shows an electronmicrograph of these slip lines, waviness of these cracks would come from interaction of two slip systems.

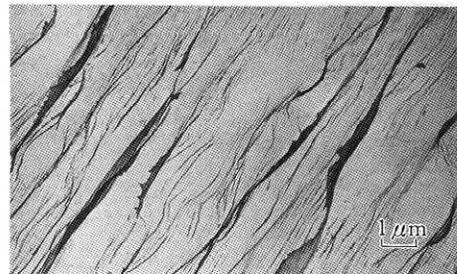
Fig. 9 Electron - micrograph of the same surface as Fig. 8.

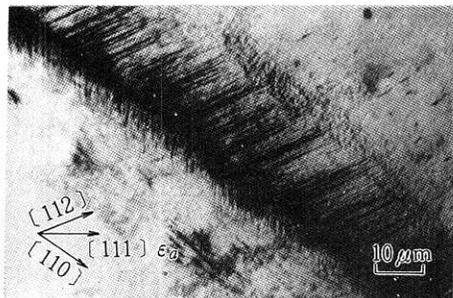
Fig. 10 Crack formation on (110) plane and [111] stress axis.

$$\epsilon_a = 1.2 \times 10^{-3}, N = 1 \times 10^5$$

the slip planes were not symmetrical, but much complicated. Fig. 10 shows a photo-micrograph of the cracks. Broad and black line was along a [110] orientation. Its slip planes were (111) and (111) and crossed with the specimen surface at an angle of 35° 16'. Fine cracks were linear and along [112] direction. Its slip plane (111) was vertical to the specimen surface. Out of three slip planes, [101] and [011] orientations are common in the specimen plane. Since [110] orientation became unbalanced by interaction of Burgers vector on (111) plane, the slip lines near the crack was wavy in shape. Fig. 11 shows an electron-micrograph of these slip lines. This also indicates that these were an initial stage

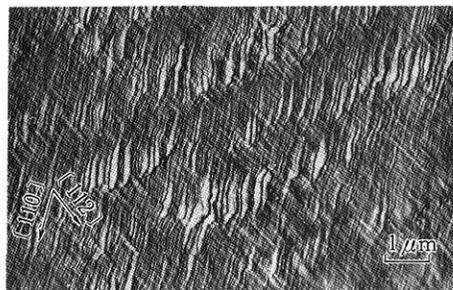
Fig. 11 Electron-micrograph of the same surface as Fig. 10.

of the crack formation, that the wavy lines were along [110]; and that these had a certain cross angle with the specimen surface. Straight slip system had a cross angle with the former system at 54° 44' and was along [112] orientations.

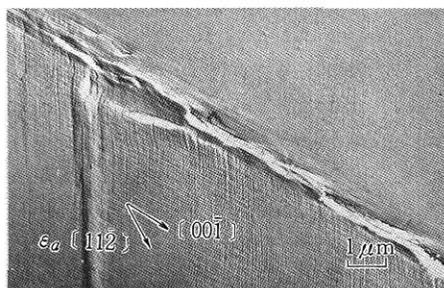
Fig. 12 Slip pattern and crack formation by fatigue test on (111) plane and [112] stress axis.

Table 2 shows the slip systems and values of Schmid factor for each stress axes. Fatigue tests were performed on [101] and [112] stress axes, and the result is shown in Fig. 12 for both cases, which shows slip lines and cracks crossing at 60° each other. For [112] stress axis, these were formed on two orientations which have larger Schmid factors.
