## Behaviour of repaired RC beams under cyclic loading

Sudhir MISRA\*, Harsha P. SOORIYAARACHCHI\*\*, Tsugio NISHIMURA\*\*\* and Taketo UOMOTO\*\*\*\*

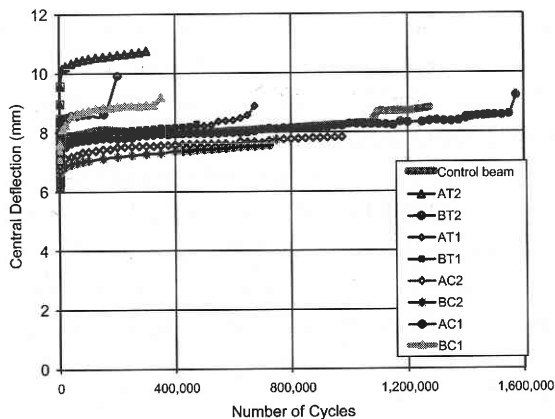
Figure 4 Maximum central deflection of beams vs. number of cycles

The deflection of the beams was observed using inductive type transducers and **Figure 4** shows the variation of the maximum deflection observed in the beams as they were subjected to increased number of loading cycles. The results show that in all cases, the deflection increases rapidly in the initial phase as rapid cracking occurs, followed by a relatively stable phase, during which phase the crack propagation is possibly only nominal. However, as failure approaches, most beams again show a tendency of rapid increase in the deflections, as unstable cracking takes place. In a study on application of acoustic emission to propagation of cracks in concrete, an essentially similar pattern was observed by Uomoto in terms of the rate of emission of AE events<sup>8)</sup>.
